Westcountry Rivers Trust – Opening the Sid Catchment Assessment – River Sid - 2025

Barrier photos for **Burscombe Brook** BB1 – BB9

Extracted from Appendix 16

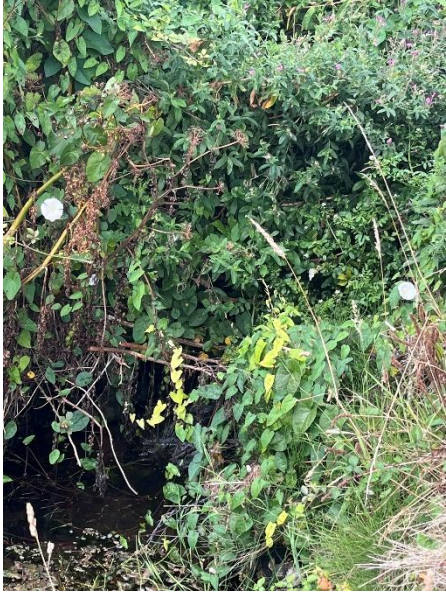
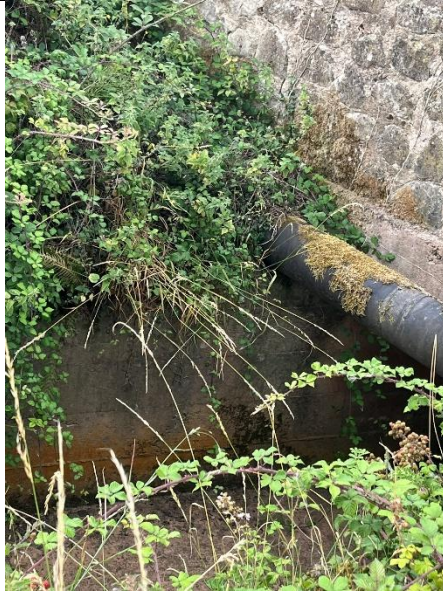
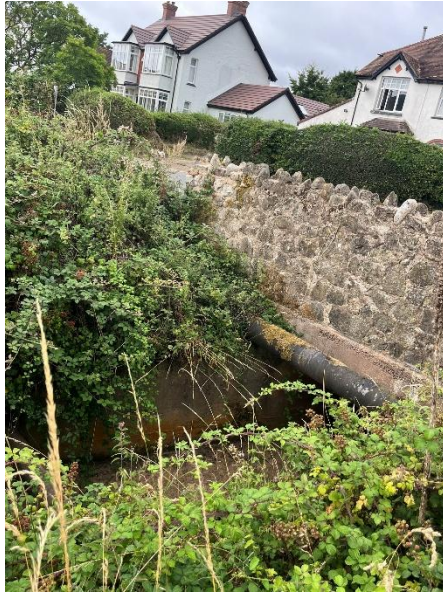
Culvert under road		Baffles and pre-barrage	concrete apron and culvert under road. Difficult to see structure fully as overgrown, appears perched. Further step weir approx. 10m DS of culvert.

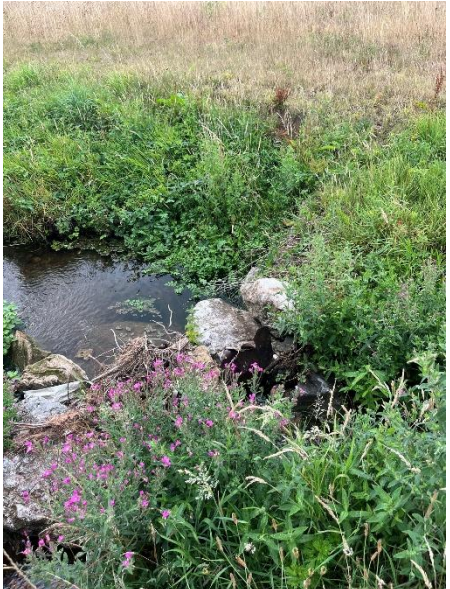
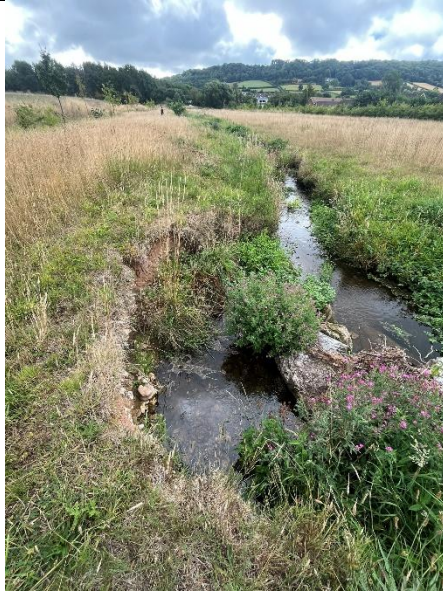
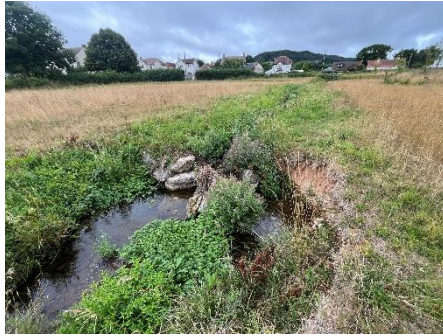
Boulder weir and sheet piling		Remove	Boulder and sheet piling in stream, river eroding around on left bank. Easy fix with removal.

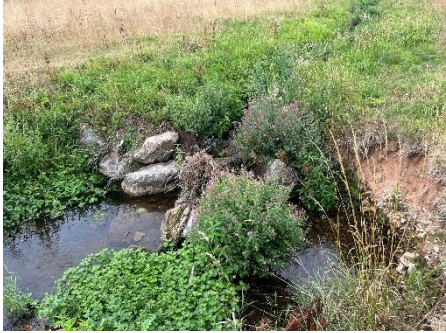
BB3	Burscombe Brook	SY 13633 90214	31.07.25					Weir past the end of T.Ford landholding. Unable to see structure but can hear a drop of water. At boundary of field, tried next door landowner at time of visit but they don't own any river frontage.

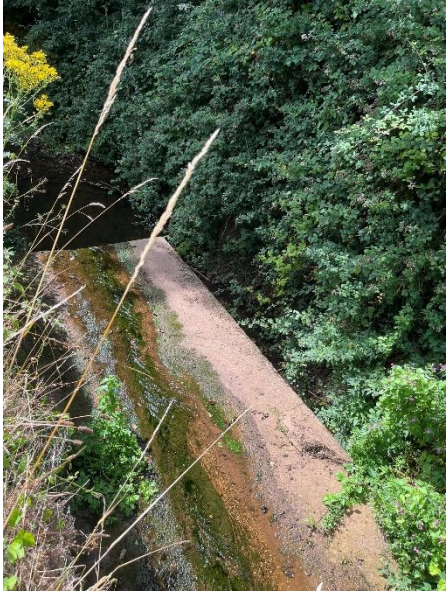
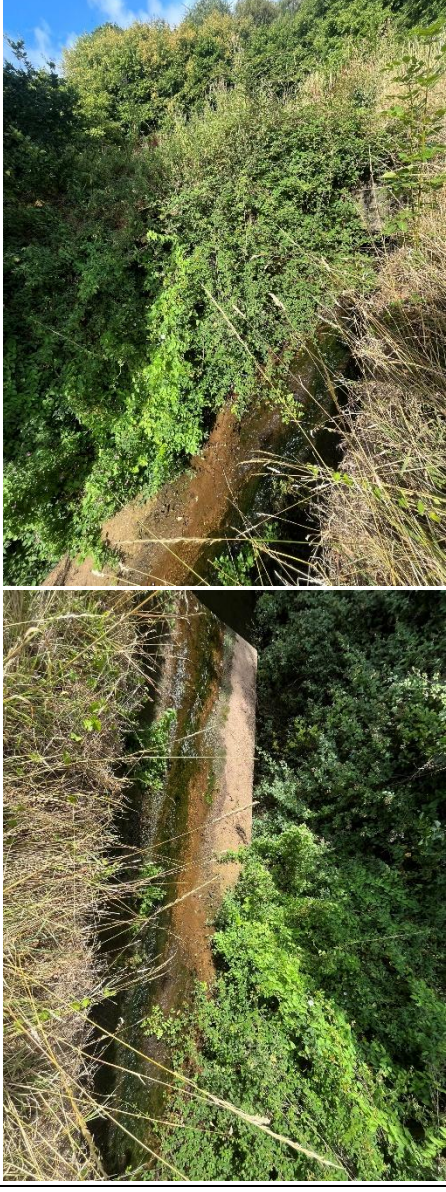
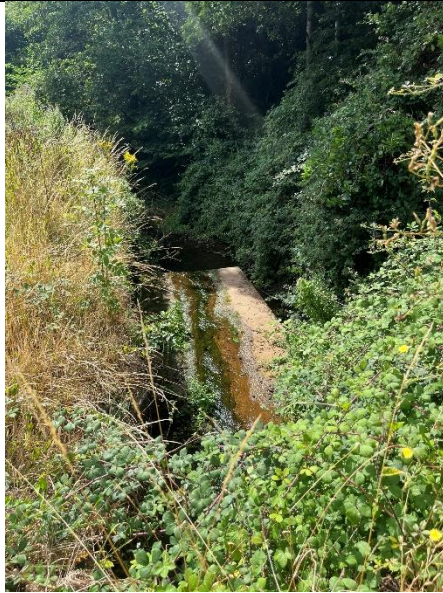
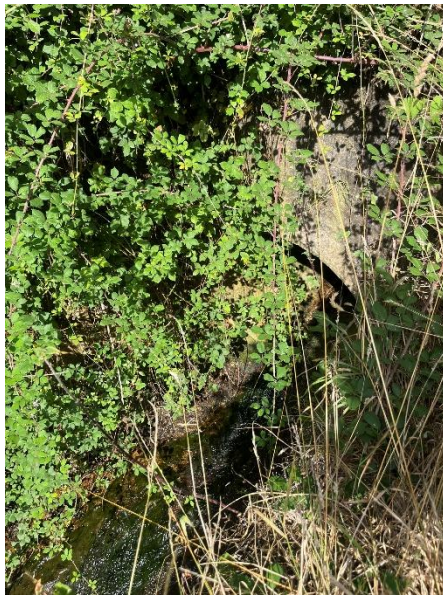
Concrete bridge footing	adherent over footing, non-adherent at apron lip	Remove	Approx 7m concrete block weir and culvert under farm bridge, with a 1-2m drop at lip DS. Thin channel of water across surface. Bulk to concrete 2-3m. Structure extends 1.5m US of bridge.

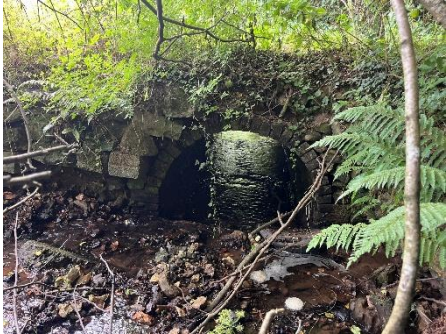
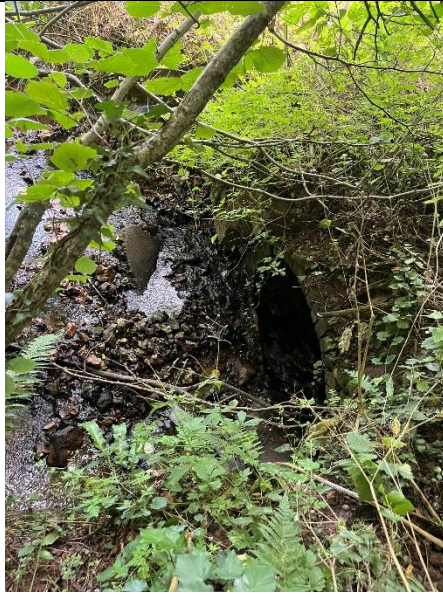
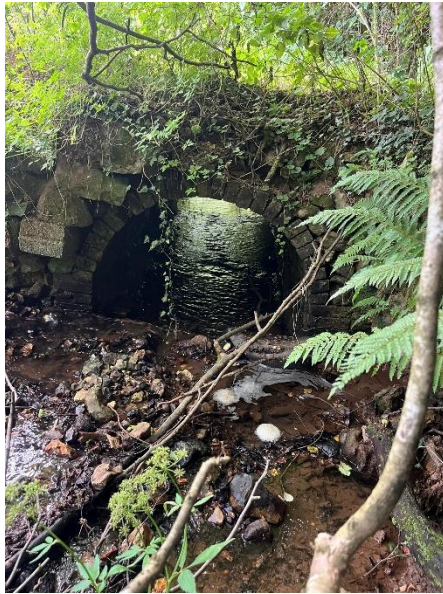
Culvert (flat bottom)	adherent across face, non-adherent at lip		Historic bridge culvert, perched at exit DS, debris blocking inlet US.

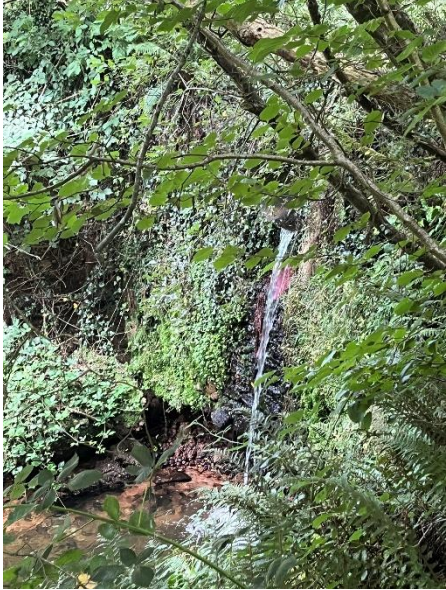
Perched culvert			Perched culvert with approx. 5m drop DS. Couldn't access US entrance safely.

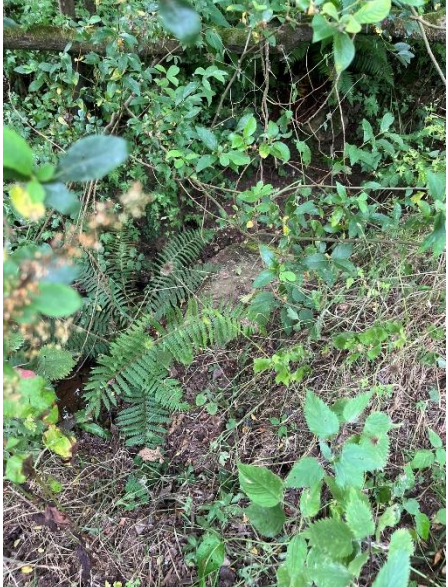
BB7	Burscombe Brook	SY 12538 90849	31.07.25

Perched culvert			River trying to cut around. Bridge/path on top overgrown and not visibly in use.
------------	-----------------	----------------------	----------	--	-----------------	--	--	--

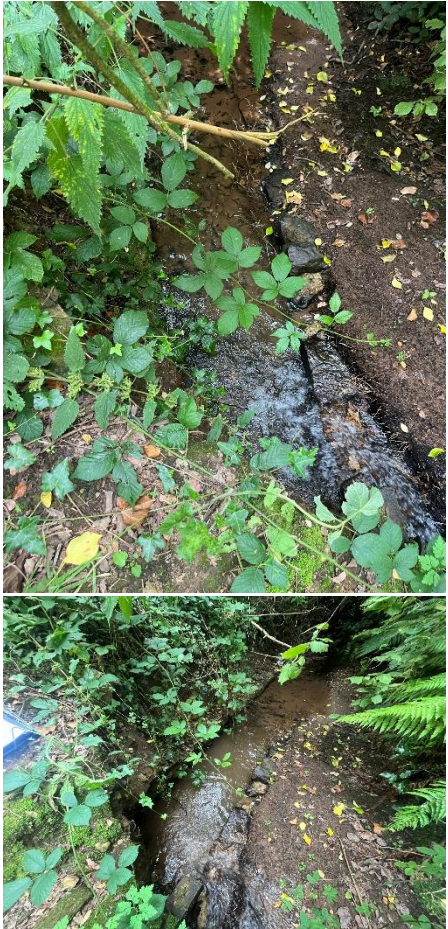
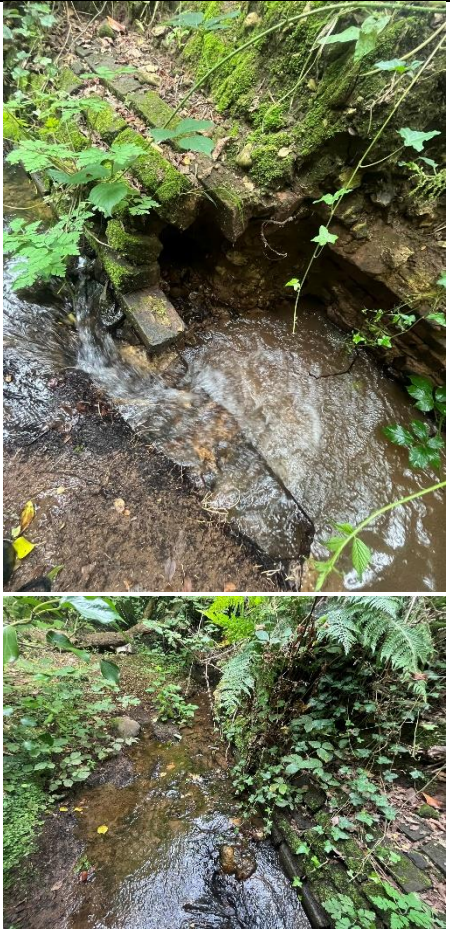
Brick culvert	adherent through, and eroding around	Remove	Old brick culvert, river eroded around on right bank.

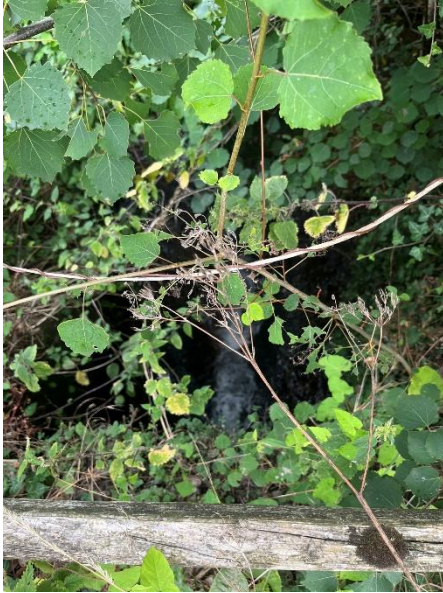
Perched culvert			Perched culvert under road, approx. 1m drop at exit DS.
