# Appendix 9: Salmonid Habitat Walkover Maps – Lincombe Stream

## Appendix 10: Habitat walkover Photos – Lincombe Stream

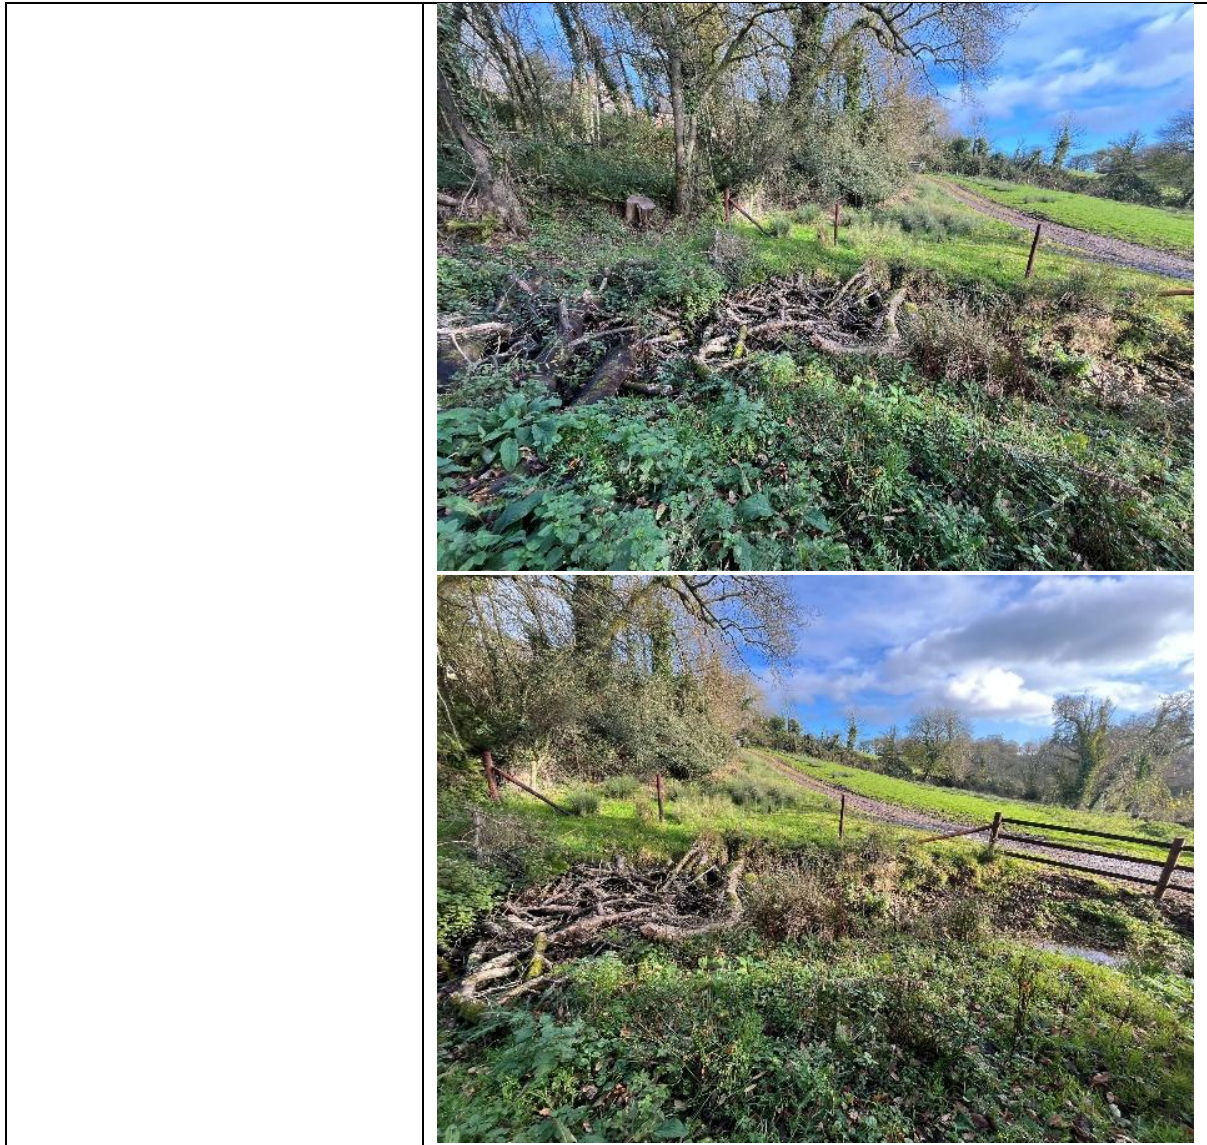
| Description | Photograph |
|--|---|
| <p>Lincombe Stream – SY 13050 93298</p> <p>Large scale NFM has been implemented on the Lincombe Stream and Sidbury Manor, with full trees used to create woody dams (photo 1 and 2) to slow flow and increase water retention. No flow seen in/around structure on initial visit in late May.</p> <p>Revisit to Sidbury Manor on 28.11.25 seen in photo's 3 to 5 shows the woody dams and brash have filled out since installation. Limited flow seen during visit, but pools filling from winter rainfall events.</p> | |

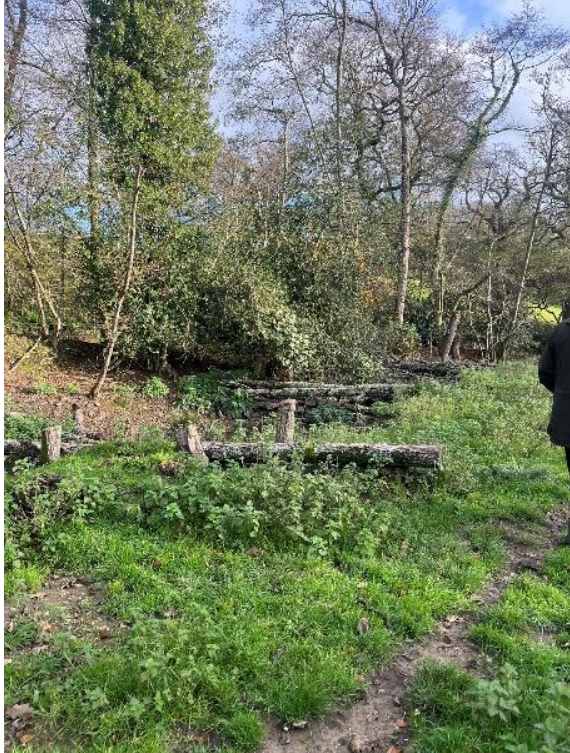
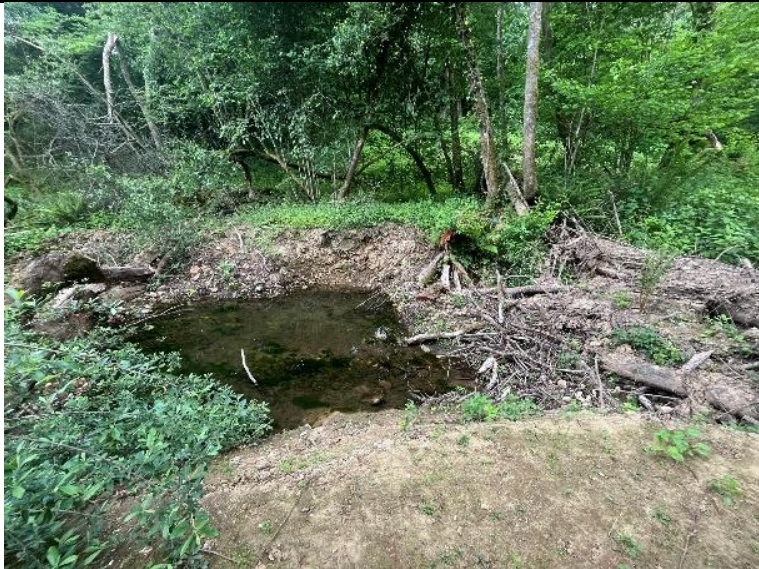
| Description | Photograph |
|--|---|
| <p>Lincombe Stream –<br/>SY 13057 93400</p> <p>Woody dam and brash creating pool as seen in late May, however no flow visible over or through structure.</p> | |

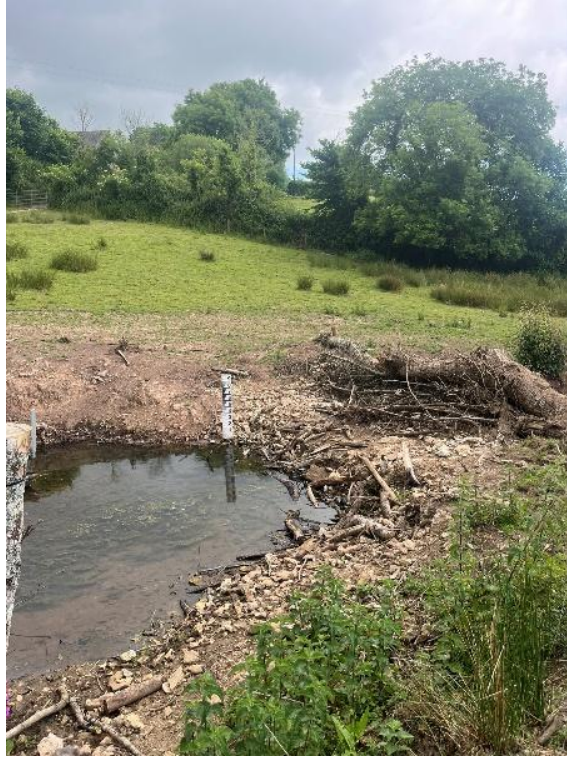
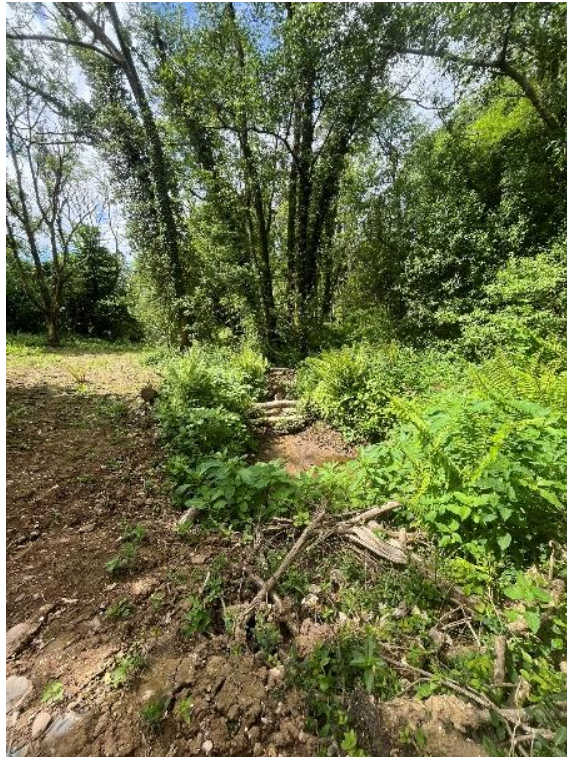
Lincombe Stream –  
SY 13063 93263

Gauge monitoring of NFM  
interventions under  
Environment Agency  
funding requirement.

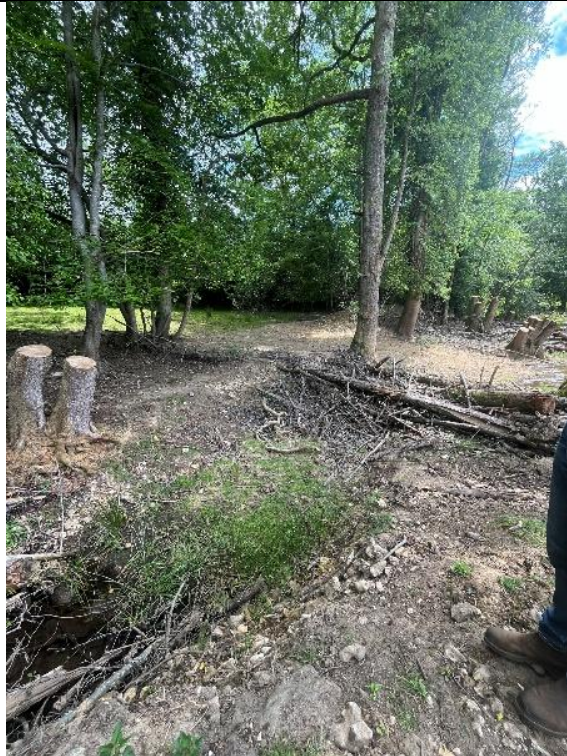
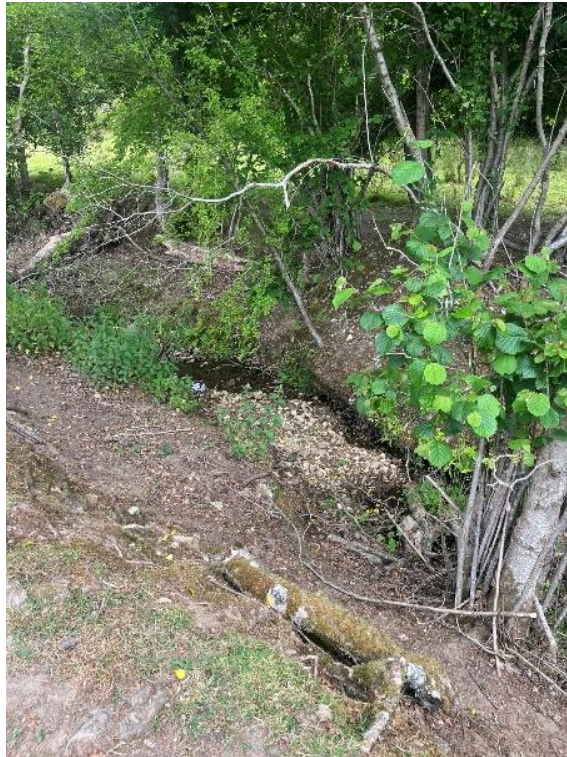
Lincombe Stream –  
SY 13080 93238

Large woody dams on the Lincombe Stream with sections in-filled with brash. No flow visible at time of survey in late May. Photo 2 shows a pocket of potential spawning gravels if there was more flow present, unable to determine extent of previously available habitat due to scale of NFM interventions.

Revisit to Sidbury Manor on 28.11.25 seen in photos 5 and 6 shows pools forming from winter rainfall, however no flow visible over or through the woody structures.

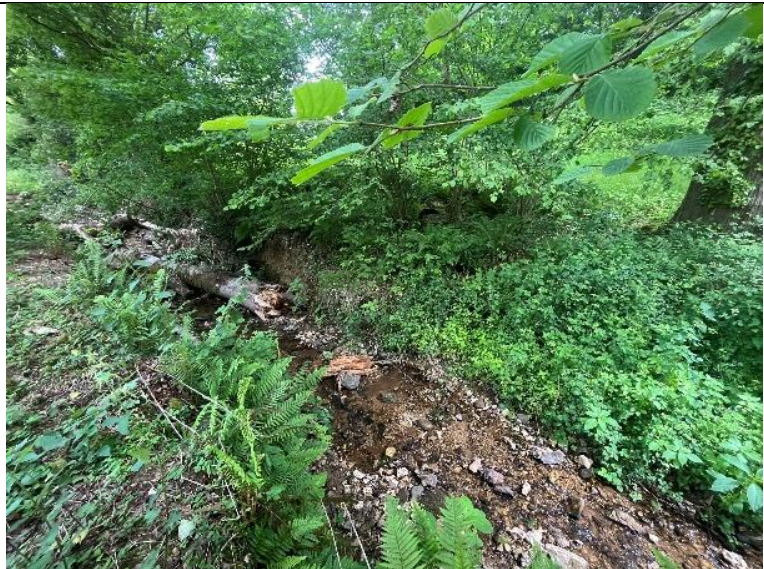
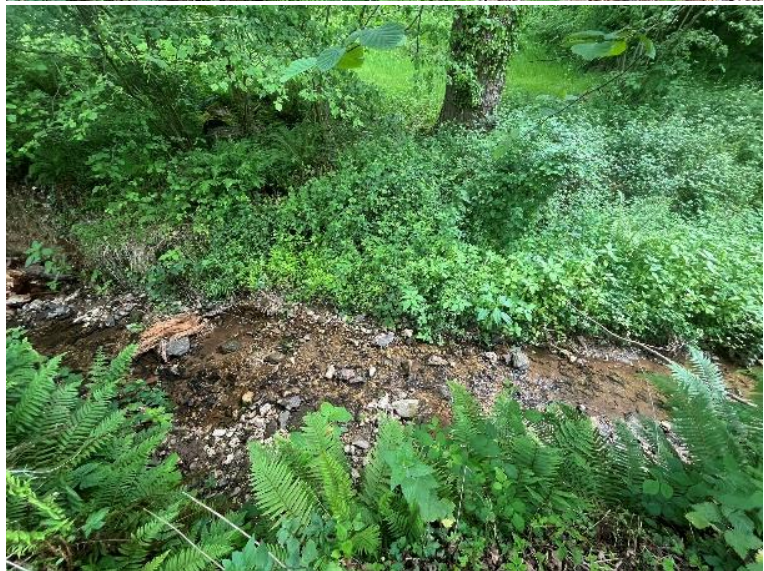
Lincombe Stream –  
SY 13172 92971

Section between NFM interventions where the flow was visible and there is more diversity in habitat, with some spawning gravels as well as a few deeper sections of water.

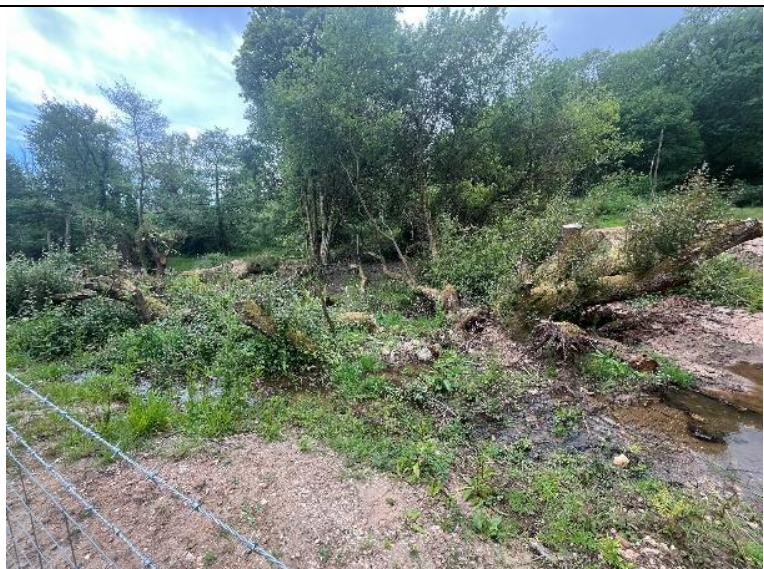
Lincombe Stream –  
SY 13096 92796

Large scale woody dams with re-growth present. Flow visible here, with a channel forming on true left bank to flow around large wood structure.

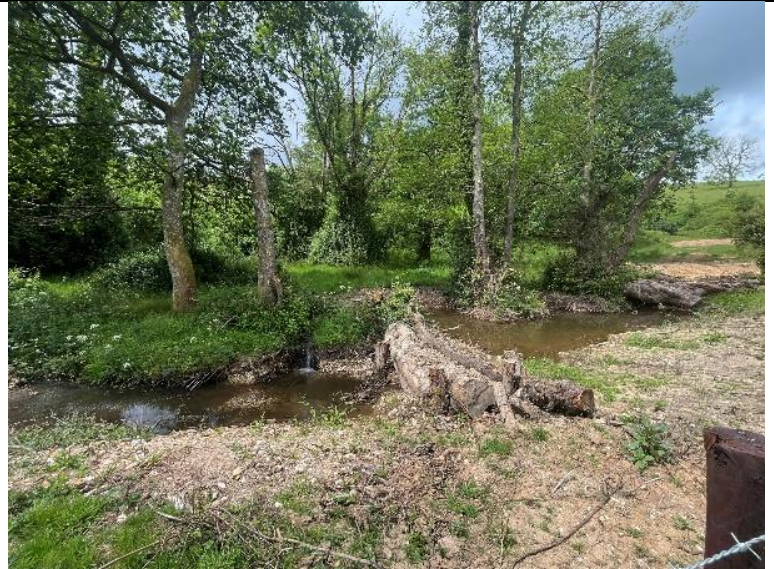
Lincombe Stream –  
SY 13120 92725

Mid reach of Sidbury Manor NFM, pools present upstream and downstream of large woody structure, no flow visible over or under structure, although small channel of flow visible on true right side of wood structure.

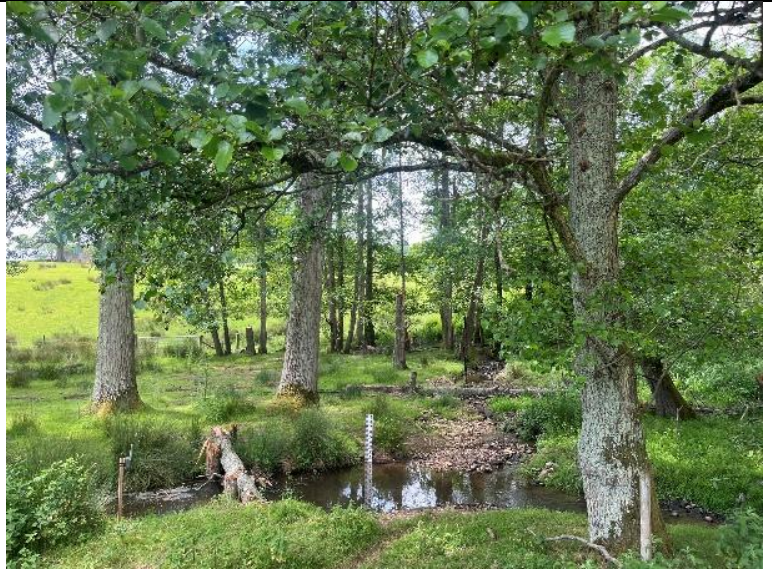
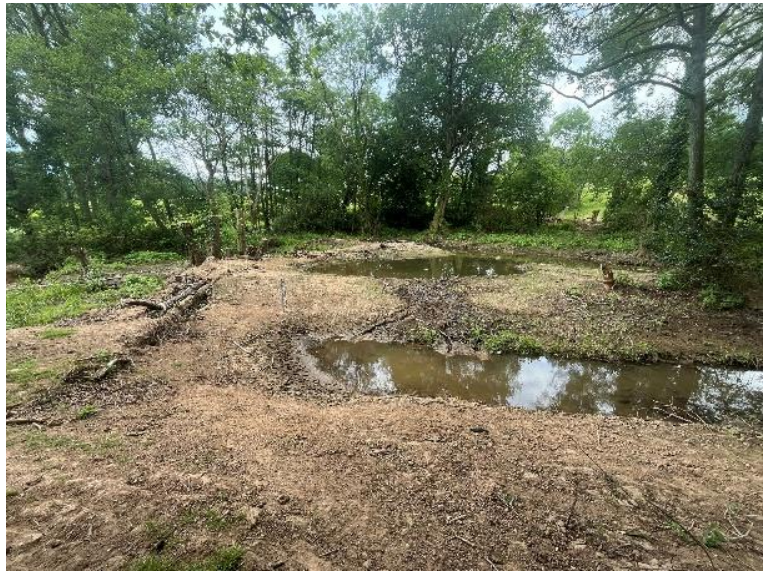
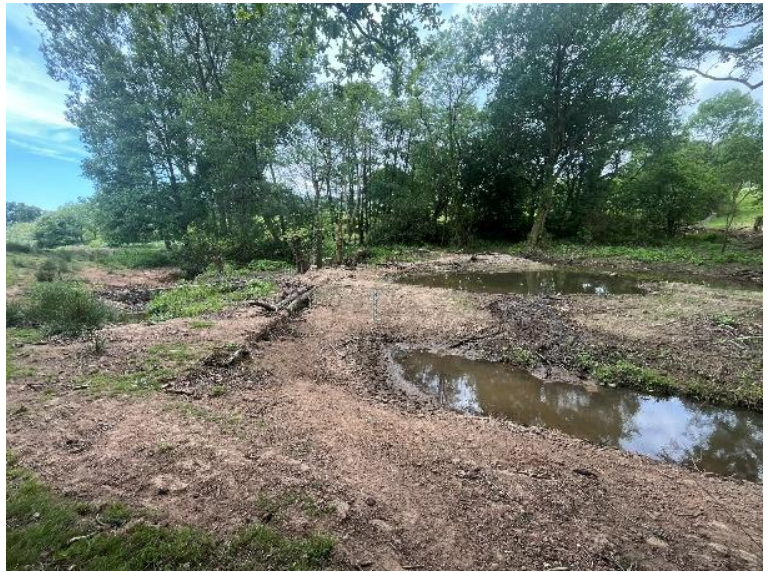
Lincombe Stream –  
SY 13271 92505

Lower reach of Sidbury Manor NFM Phase 1. Sections shows mixed habitats with an additional stream joining on the true right bank (photo 1). Large pools have been created, minimal flow visible between pools.

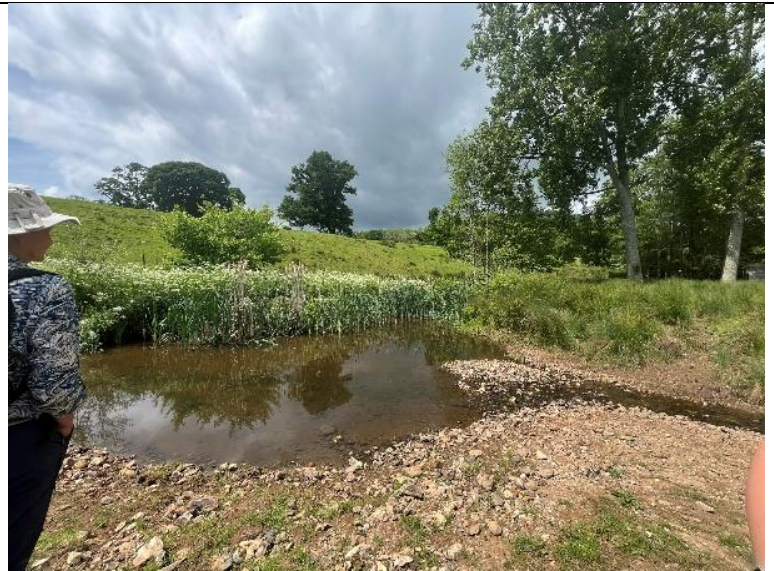
Lincombe Stream –  
SY 13273 92450

Top Victorian pond at  
Sidbury Manor, often fully  
sedimented, but dredged  
prior to visit in late May.

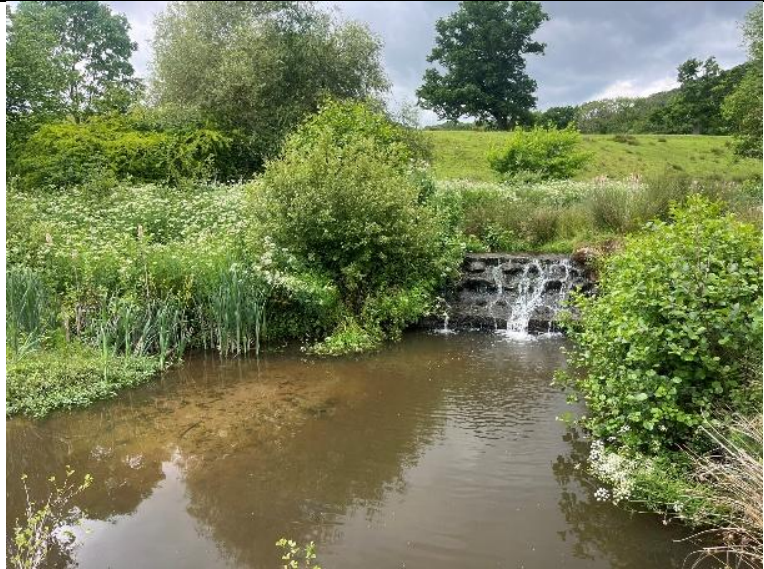
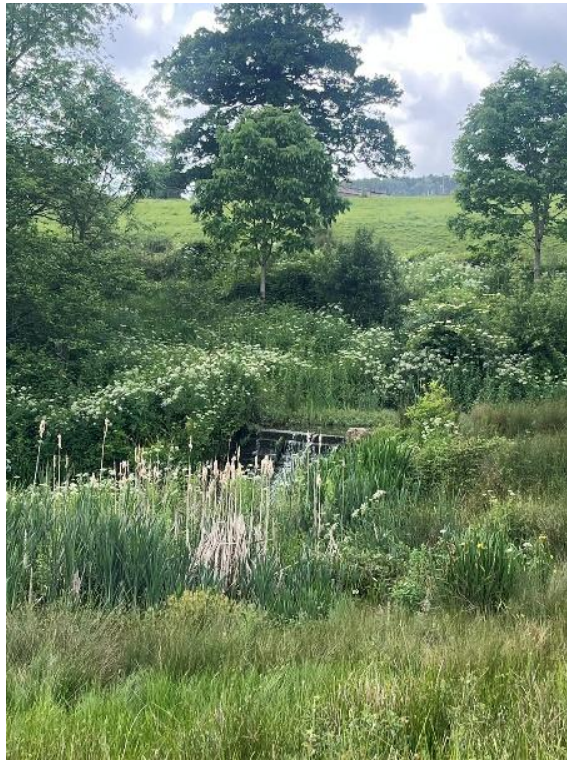
Lincombe Stream –  
SY 13288 92441 to SY 13471  
92181

Series of on-line historic dams and ponds at Sidbury Manor, the most downstream of these likely limits the passage of migratory fish (barriers above this and NFM were not included in the barrier prioritisation exercise. The ponds have become sedimented over time resulting in low water depth and succession of emergent plants.

Although no migratory species can access the Lincombe Stream above these dams, it is possible that resident populations may be present. It is recommended for future NFM works that fish surveys are conducted.

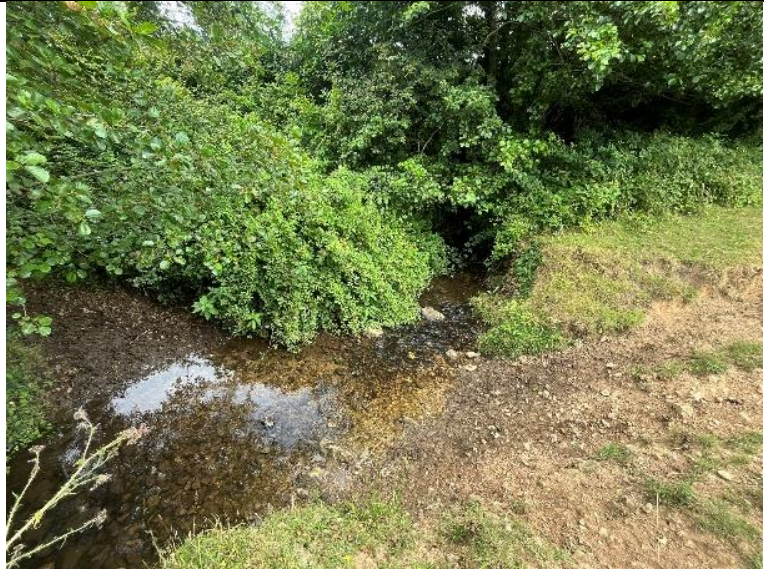
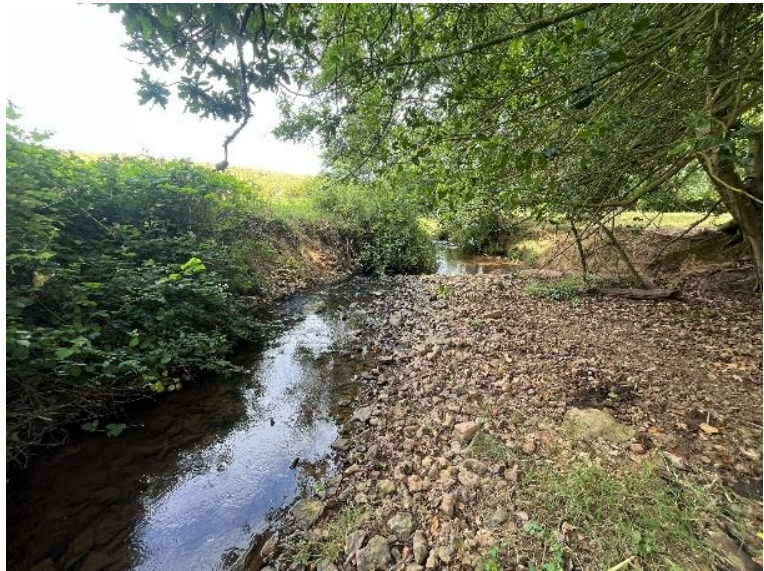
Lincombe Stream –  
SY 13556 92078 to SY 13608  
92046

Downstream of Sidbury Manor ponds there is a range of habitat types, with sections of good spawning gravels, although these are silted. The stream is constrained by high incised banks that are eroding, and animal access is present along the stretch.

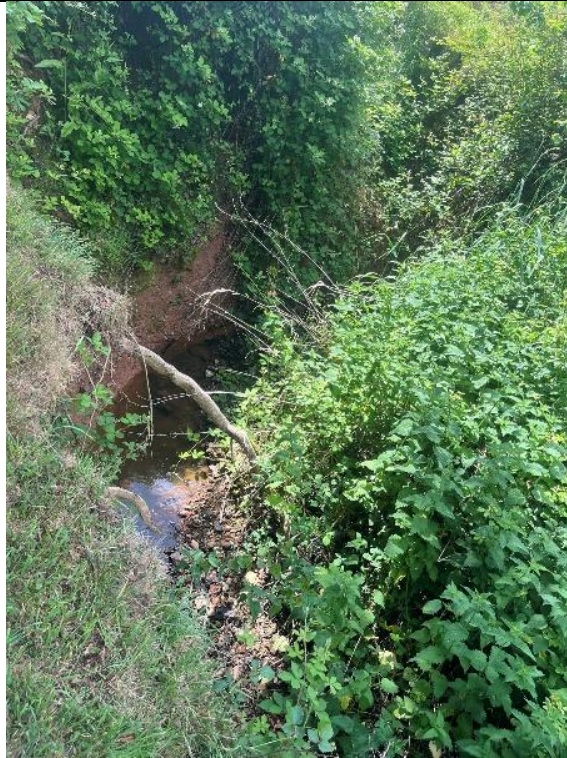
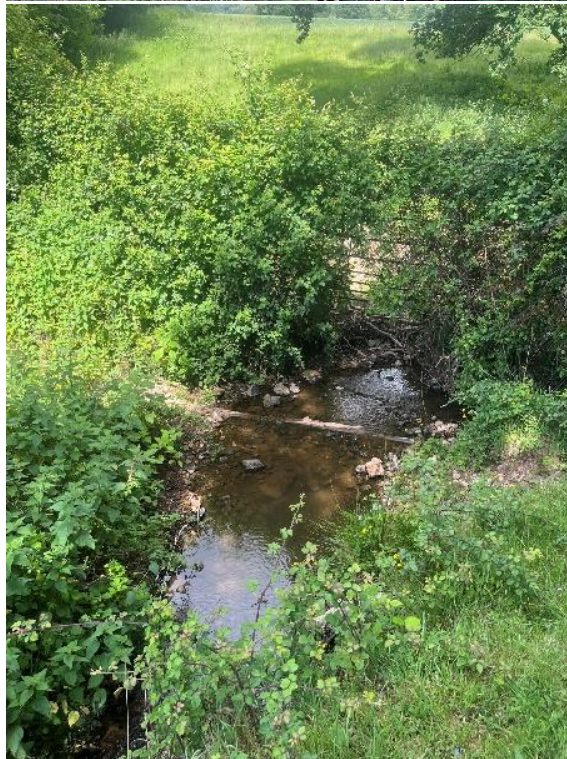
Lincombe Stream –  
SY 13526 91968 (Two  
Goyles')

Two Goyles, a tributary of the Lincombe. Photos taken upstream of the culvert show a stream with steep incised and eroding banks, though there is potential habitat for juvenile salmonids and eel. Fish surveys (either electric fishing or eDNA, or a combination of both) are recommended prior to large scale NFM interventions similar to those seen further up the Lincombe to mitigate any potential negative impacts.

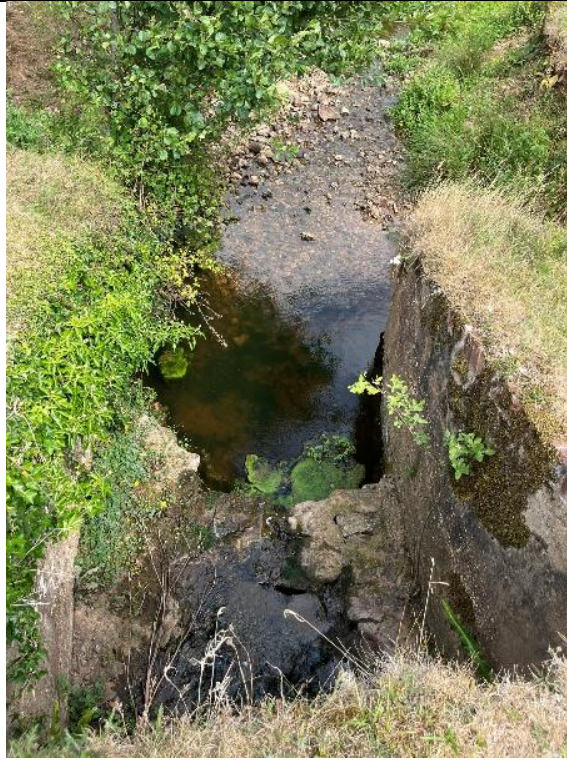
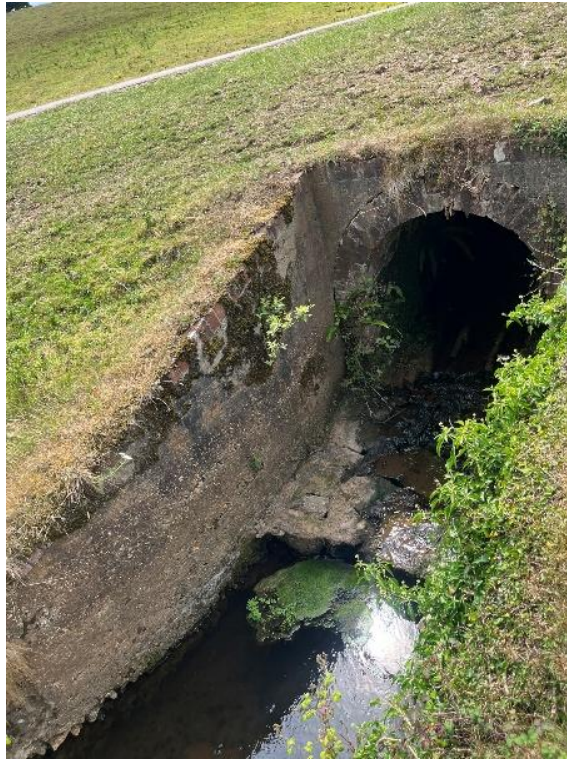
Lincombe Stream –  
SY 13571 92009 (Two  
Goyles')

Perched culvert on Two  
Goyles, not included in  
barrier prioritisation as  
tributary was not a focus  
area. Relatively deep pool  
below structure, but shallow  
through culvert.

Mixture of juvenile and  
adult habitat downstream  
of culvert, banks incised and  
eroding.

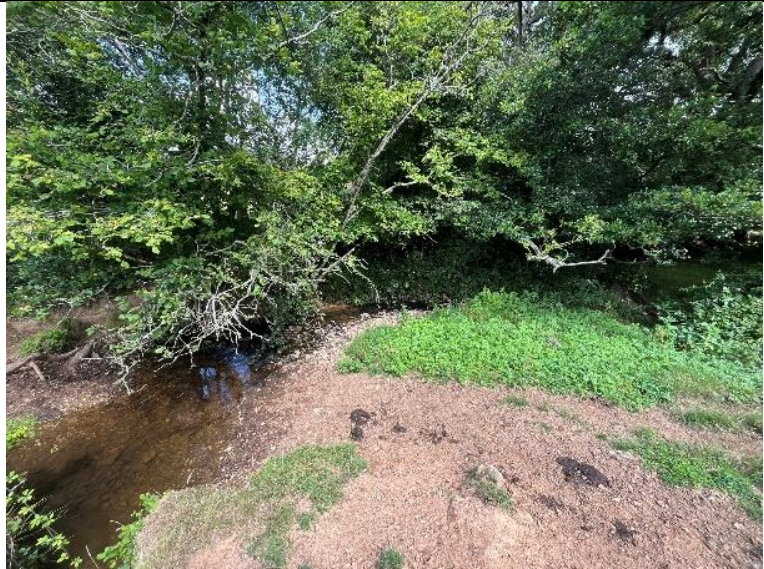
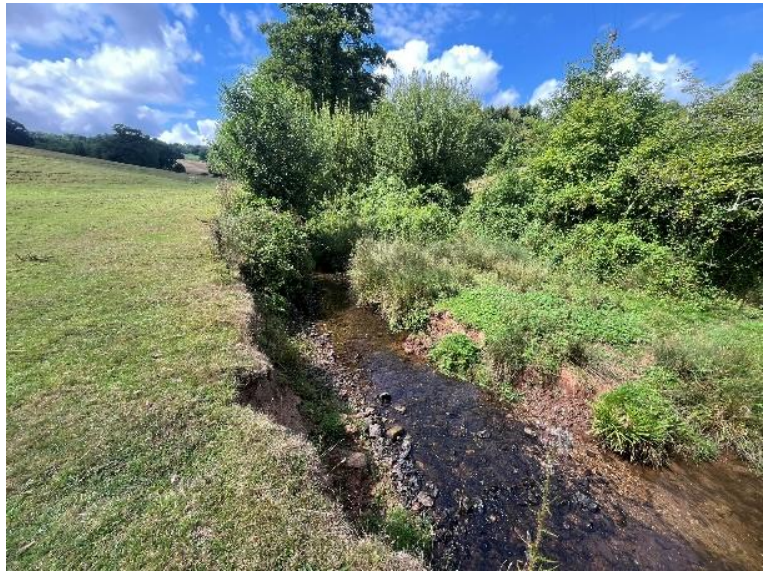
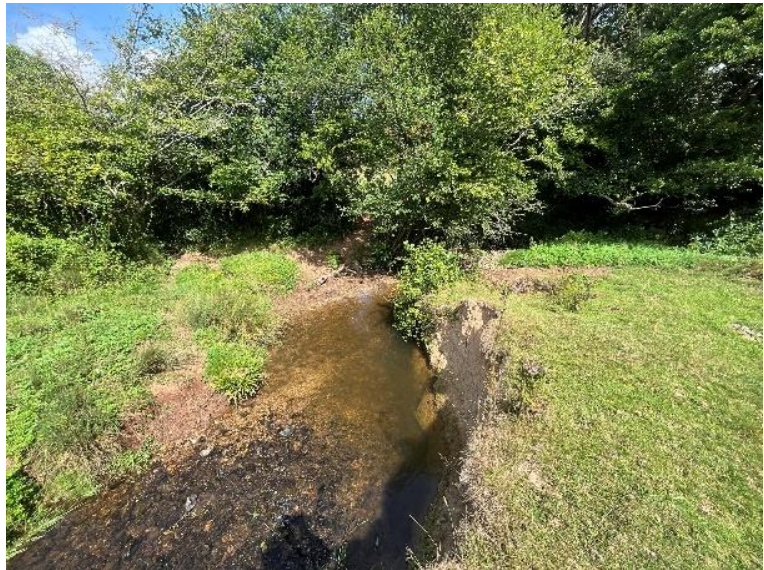
Lincombe Stream –  
SY 13777 91932

Good mix of habitat types, but of poor quality. Banks are incised and eroding, with areas of poaching due to animal access. Gravels are also sedimented. Reach would benefit from installation of fenced wide riparian buffers to limit animal access to the stream.

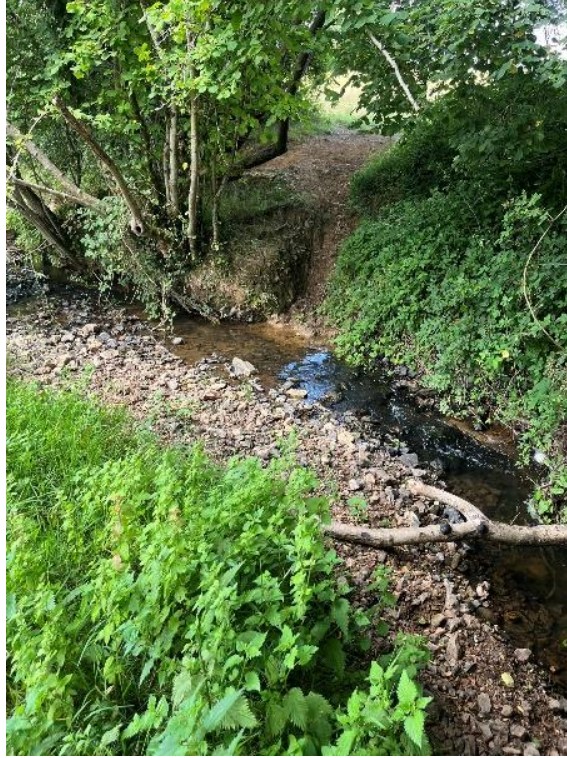
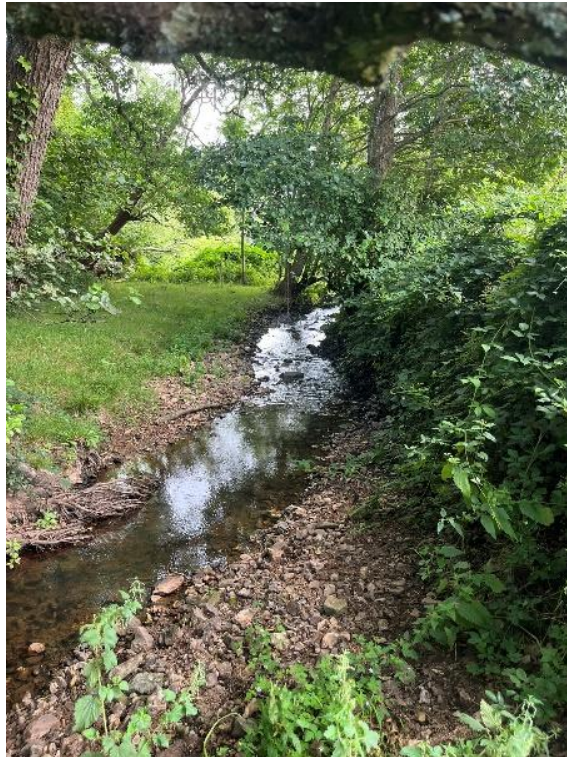
Lincombe Stream –  
SY 13779 91936

First photo shows animal access site and poaching on the true right bank. Second photo shows section of dappled shade. Lateral connectivity is constrained by steep bank.

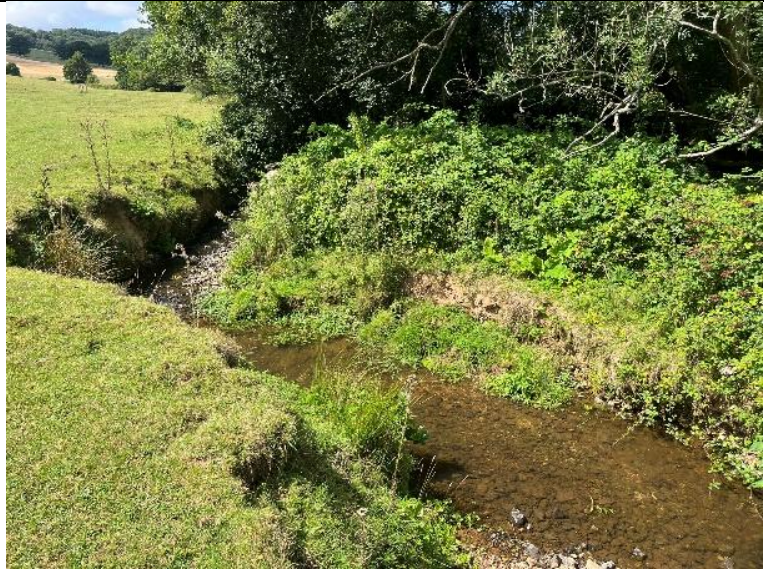
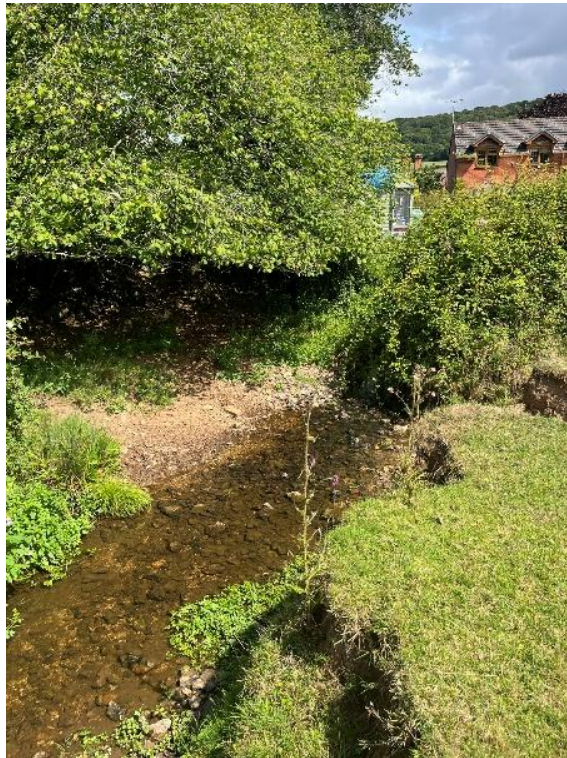
Lincombe Stream –  
SY 13812 91892

Lower section of the Lincombe Stream at Sidbury Manor shows juvenile habitat potential, with good sized gravels and riffle areas, however banks are incised and eroding, with animal access along the entire stretch and no riparian buffer. Some sections are heavily shaded whereas others have no tree cover. Gravels are heavily silted and lots of algae present on substrate at time of survey.

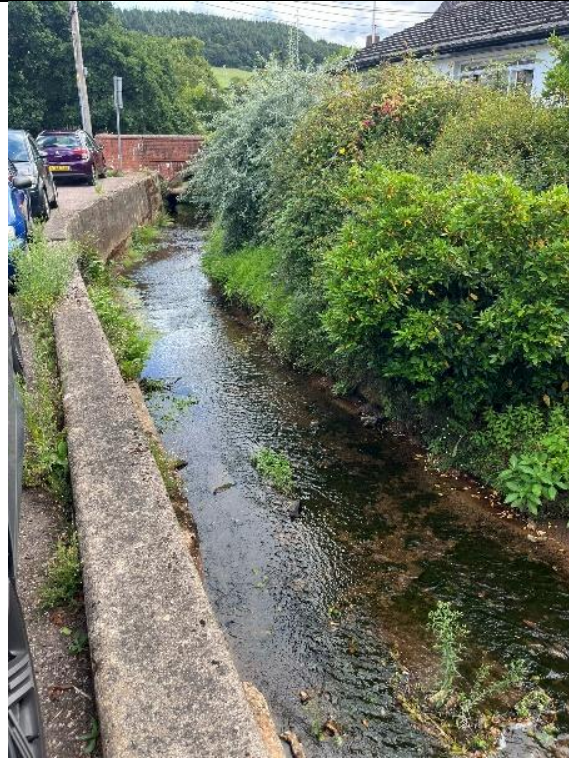
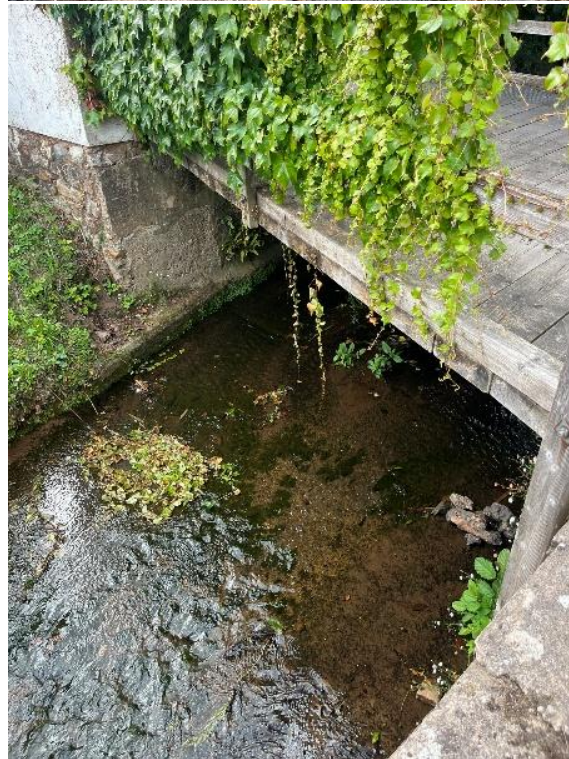
Lincombe Stream –  
SY 13923 91841

Modified concrete channel  
of the Lincombe Stream,  
downstream of Sidbury  
Manor Estate. This is not  
favourable for fish as there  
is no channel or habitat  
diversity.

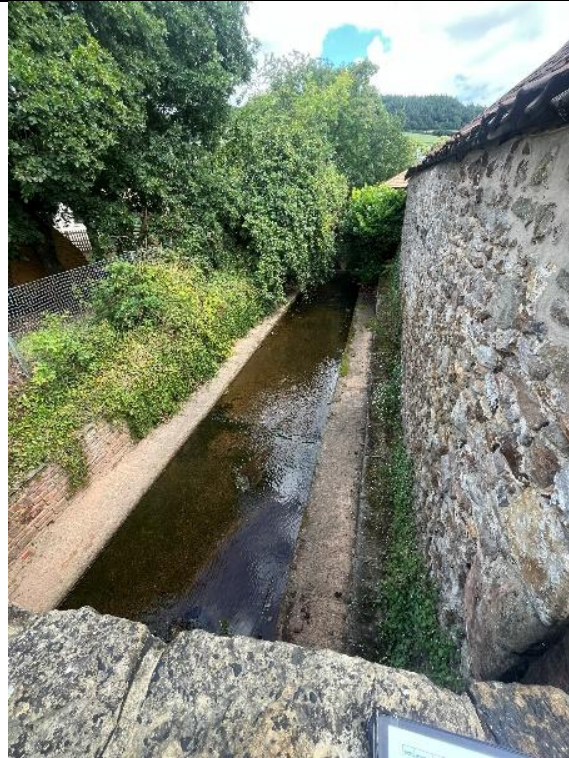
Lincombe Stream –  
SY 13956 91819

Lower section of the Lincombe downstream of bridge is a modified concrete channel for the entire reach to the confluence with the River Sid. This unnatural channel is not favourable for fish.
