# Appendix 3: Salmonid Habitat Walkover Maps – River Sid

## Appendix 4: Habitat walkover Photos – River Sid

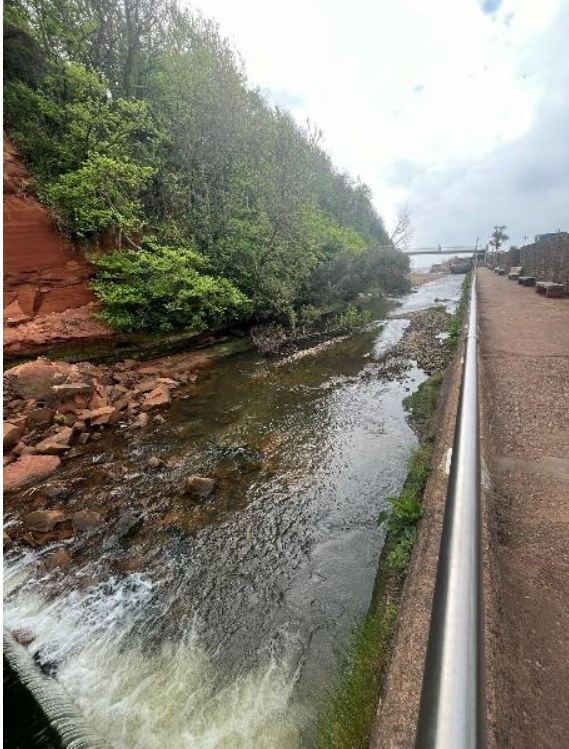
Description	Photograph
<p>River Sid – SY 12859 87459</p> <p>Tidal reach of the River Sid, revetment along the true right bank, and steep cliffs along the true left bank, resulting in a constrained river.</p>

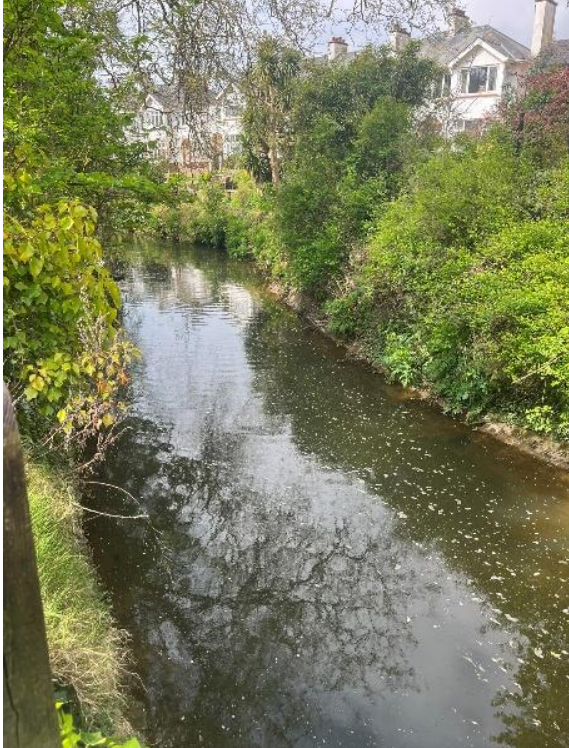
<p>River Sid – SY 12781 87770</p> <p>Impoundment as a result of Mill Ford, consisting of long glide with deep pools with limited habitat variability.</p>

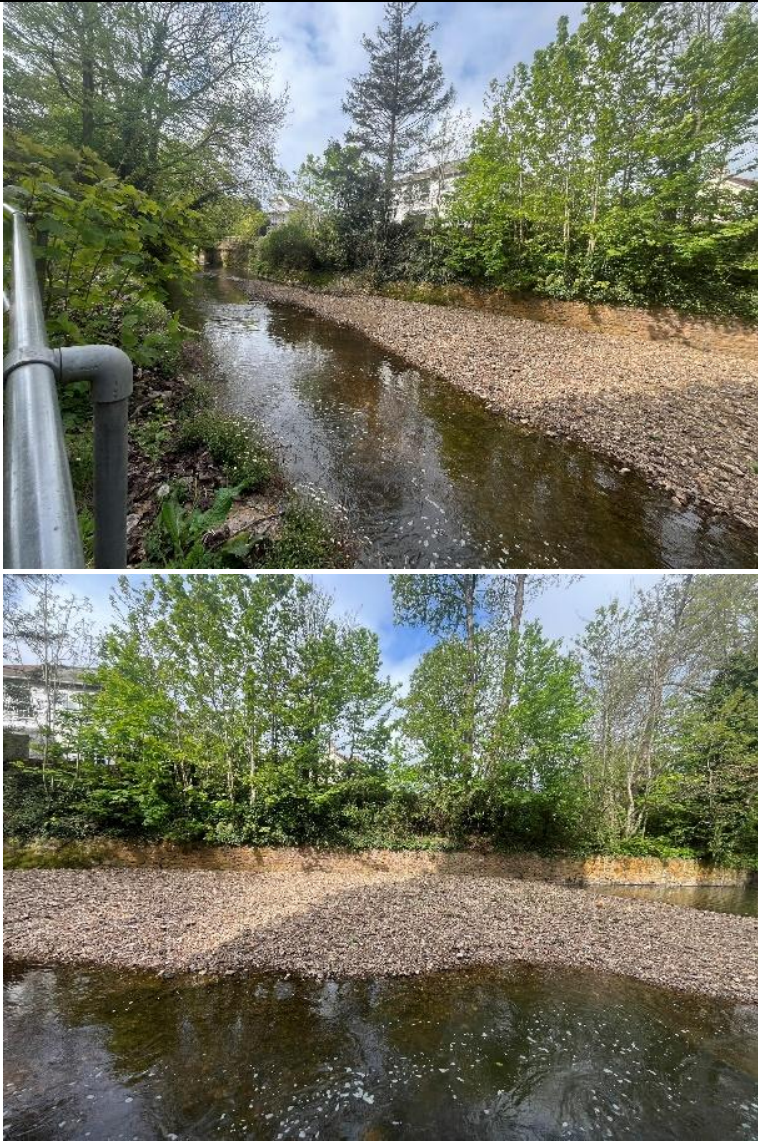
Description	Photograph
<p>River Sid – SY 12789 87866</p> <p>Gravel deposition downstream of School weir, creating some diversity and fry habitat. Environment Agency removed this during September 2025 for flood alleviation. Revetment on both banks through flood alleviation scheme down to river mouth.</p>

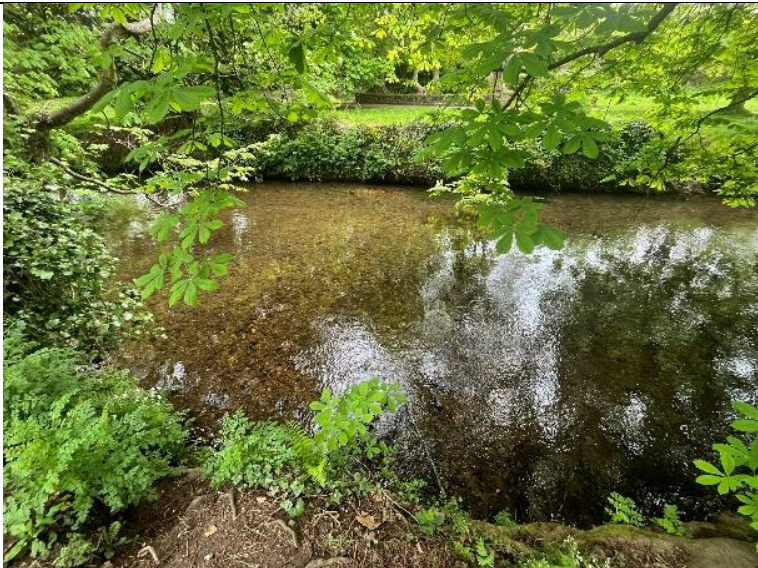
<p>River Sid – SY 12900 88396</p> <p>Homogenous habitat through the Byes. Areas of bank erosion from dog access to the river and undercutting due to the river being constrained by revetment and footpaths along both banks.</p>

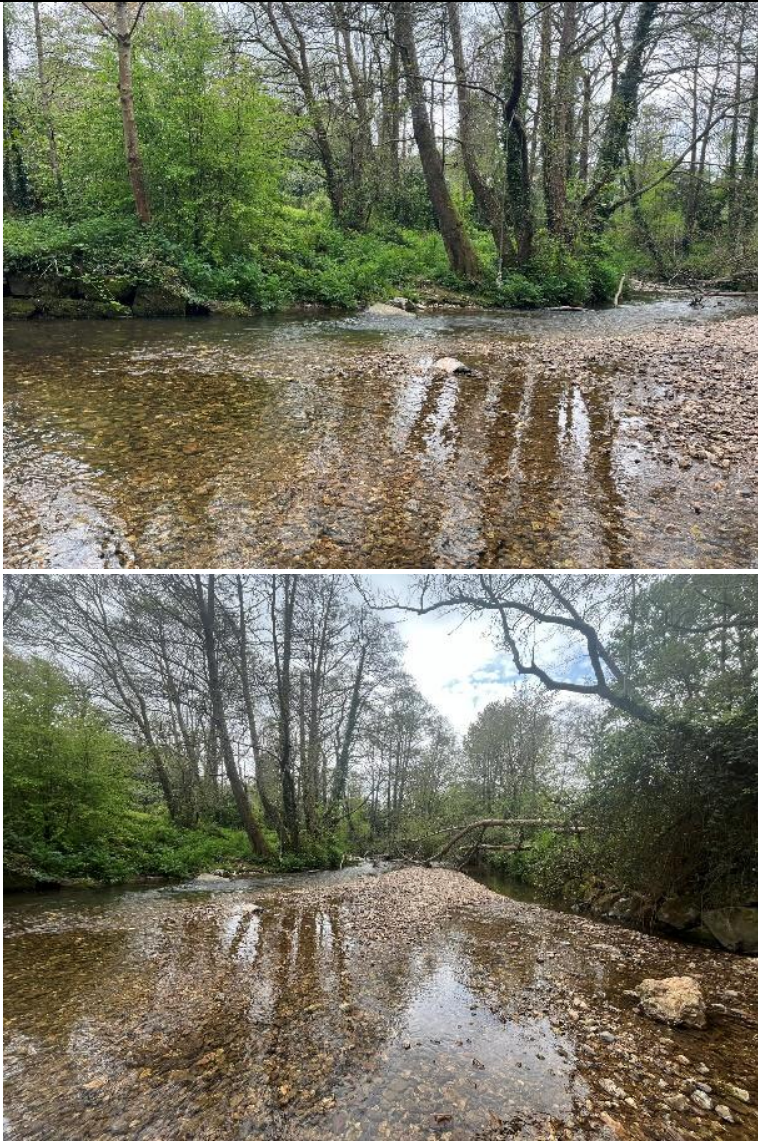
Description	Photograph
<p>River Sid – SY 13299 88911</p> <p>This section of the Sid demonstrates that there is a natural ready supply of coarse substrate, required for salmonid spawning, within the Sid. The river here is heavily impacted by erosion on the true right bank, largely due to dog and public access to the river. The true left banks is revetted with large boulders, and both upstream and downstream of this reach, there are multiple boulder check weirs. These affect the hydrogeomorphological function of the river and limit habitat diversity.</p>

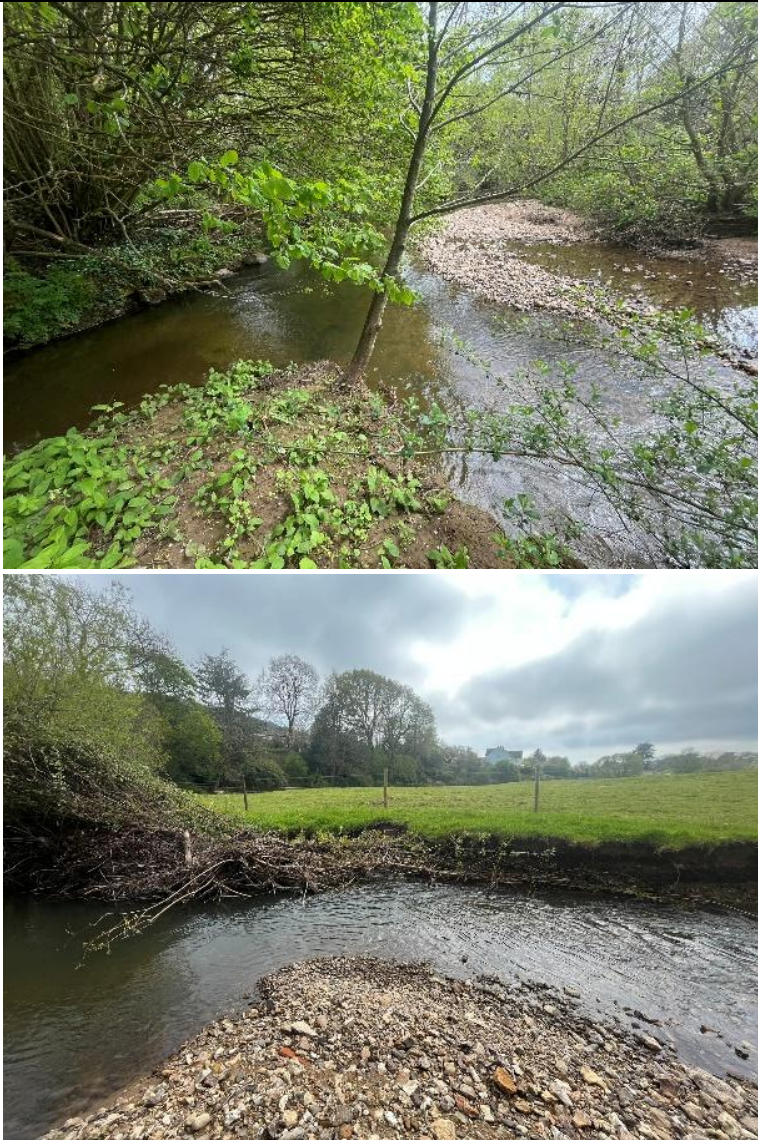
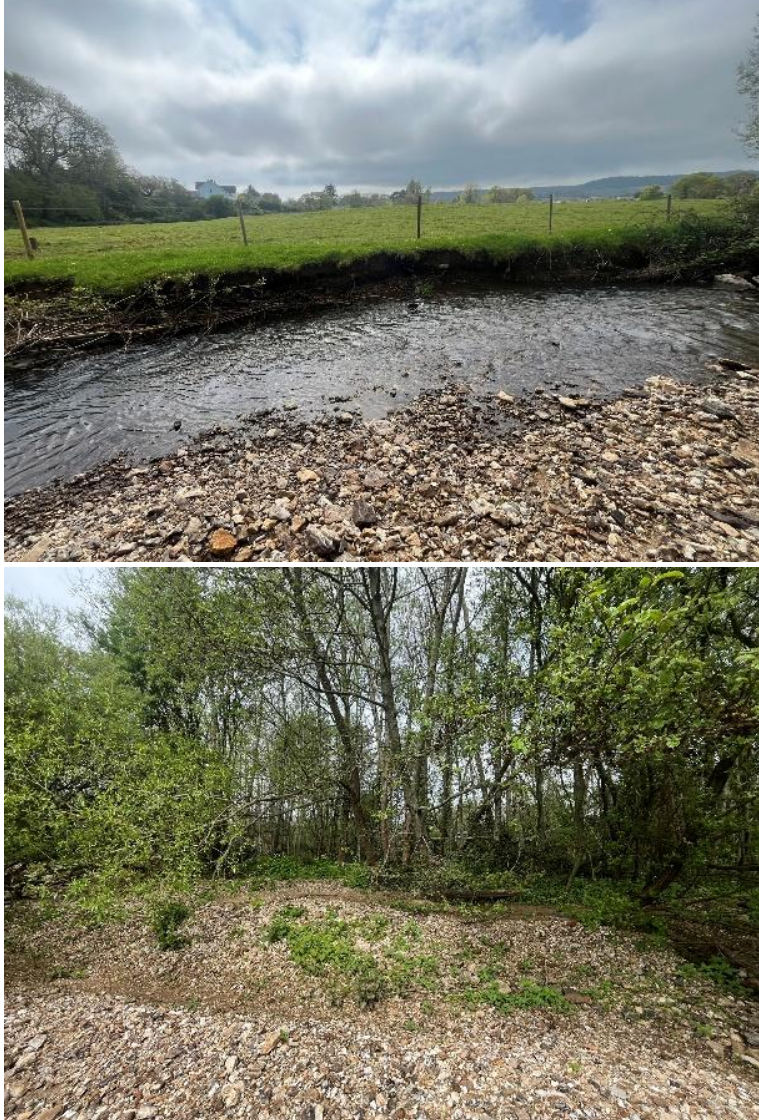
Description	Photograph
<p>River Sid – SY 13512 89198</p> <p>SY 13512 89198 upstream of Fortescue Weir is the start of the most naturalised section of the lower river Sid up to SY 13728 89732.</p> <p>At SY 13512 89198. There is evidence of bank erosion on the true right bank of a meander, however, scrub has infilled this section which will aid in bank restoration by trapping sediment and creating refuge for fish.</p> <p>The pasture on the true right is fenced to minimise animal access to the river, however there is no riparian buffer. This section would benefit from tree planting and the creation of a riparian buffer to minimise further compaction and subsequent bank erosion.</p> <p>Tree planting and the creation of a riparian buffer would also make this section of the Sid more resilient to increasing river temperatures, as well as buffer and agricultural run-off into the river.</p>

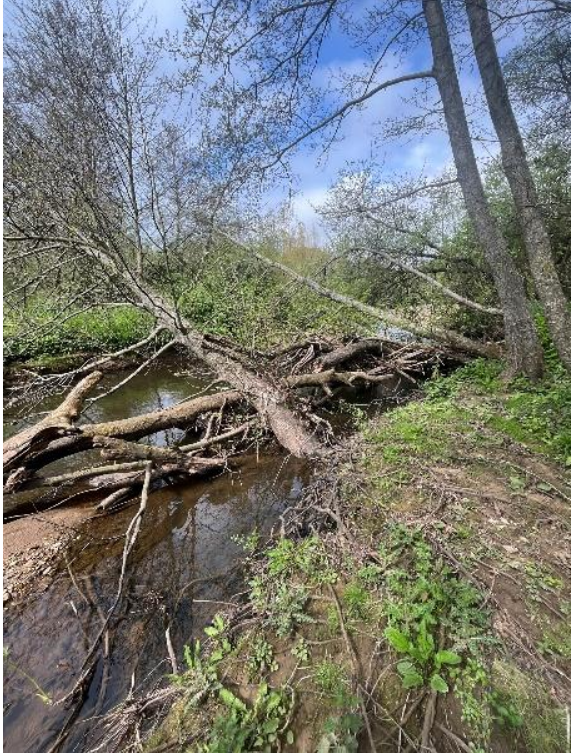
Description	Photograph
<p>River Sid – SY 13492 89243</p> <p>Large woody material in the channel of the River Sid. This is beneficial for habitat diversity by creating pockets of scour, as well as sediment accumulation and providing refuge for fish. Large wood also increases diversity of flow paths and velocity within the channel.</p>

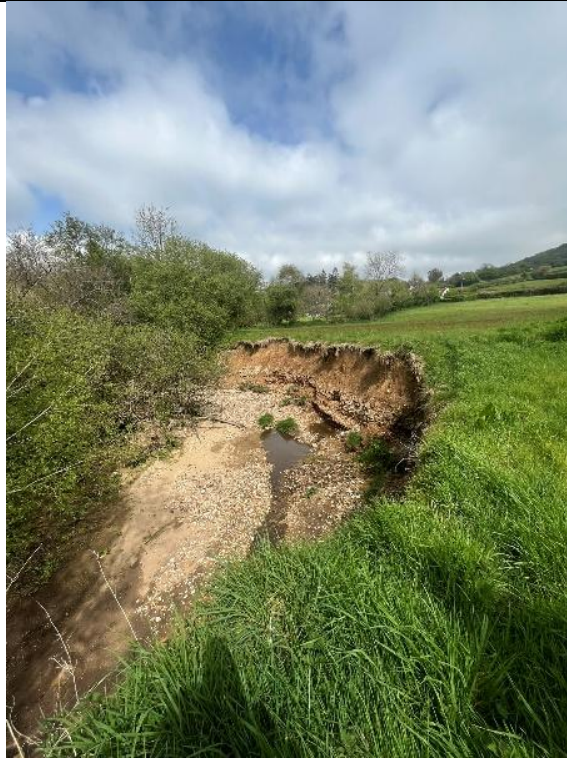
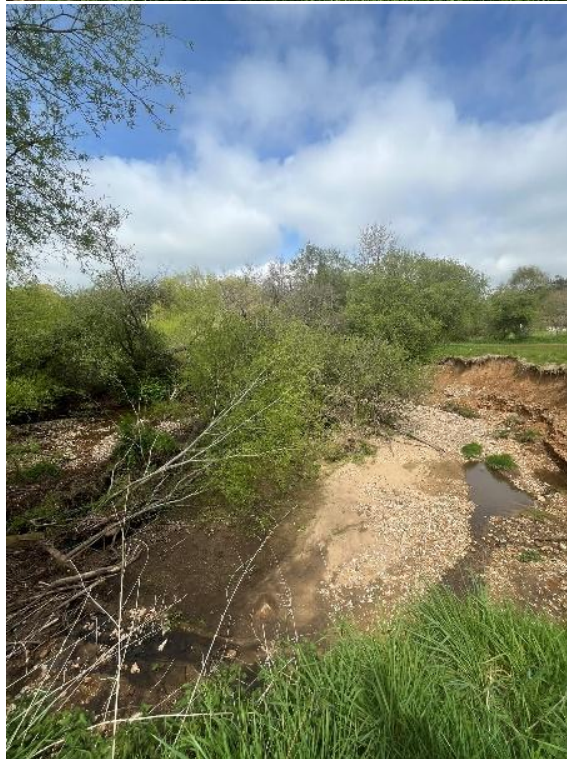
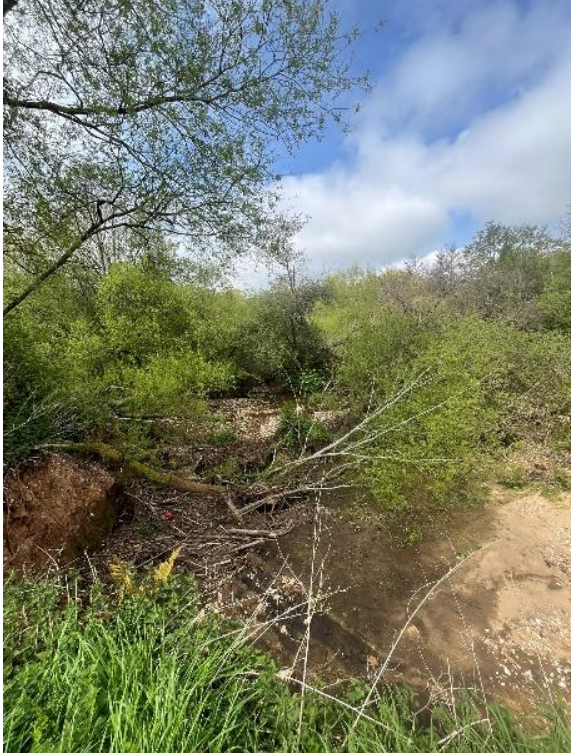
River Sid –  
SY 13572 89314

Large area of erosion on the River Sid, creating a 'cliff' of approximately 3m on the true left bank. There is no riparian buffer on the true left bank, and surface flow from the nearby road travels across the field to this point, increasing the impact of erosion. The large willow seen in photo 3 has likely fallen into the river as a result of the erosional processes. It is recommended that this is retained in place, as this large wood will likely help to trap sediment.

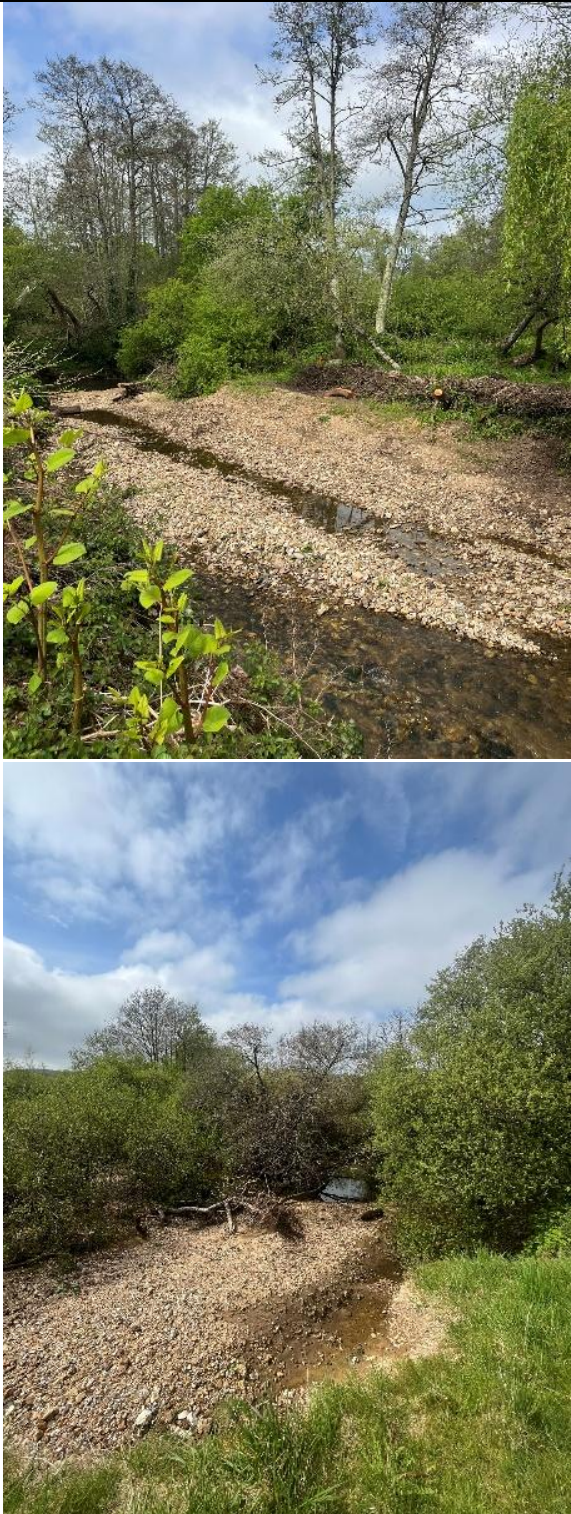
Description	Photograph
<p>River Sid – SY 13524 89392</p> <p>The channel has been allowed to move freely in this section of the River Sid, creating braided sections of channel with large gravel bars and coarse wood in the channel. However, there are still areas of bank erosion that warrant further investigation to enhance habitat.</p>

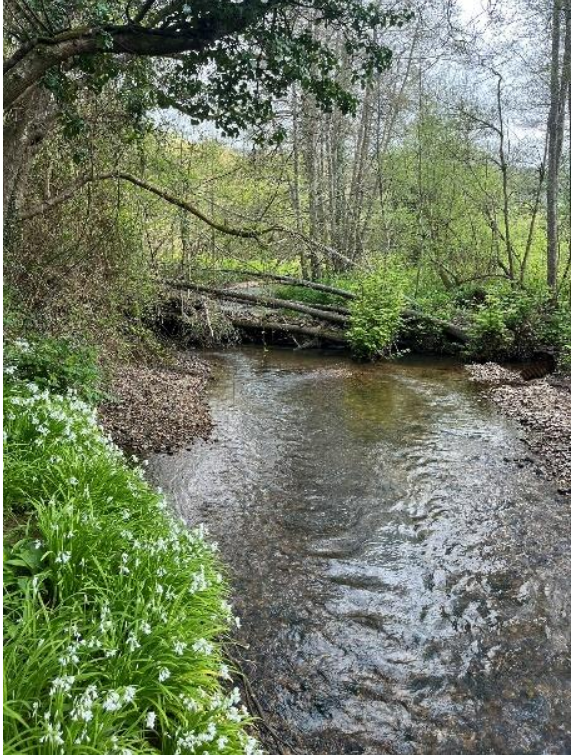
Description	Photograph
<p>River Sid – SY 13604 89584</p> <p>Large wood in channel on the River Sid, which is increasing channel and flow diversity. The structure is not an issue for fish migration as there is sufficient depth of flow beneath the large wood.</p>

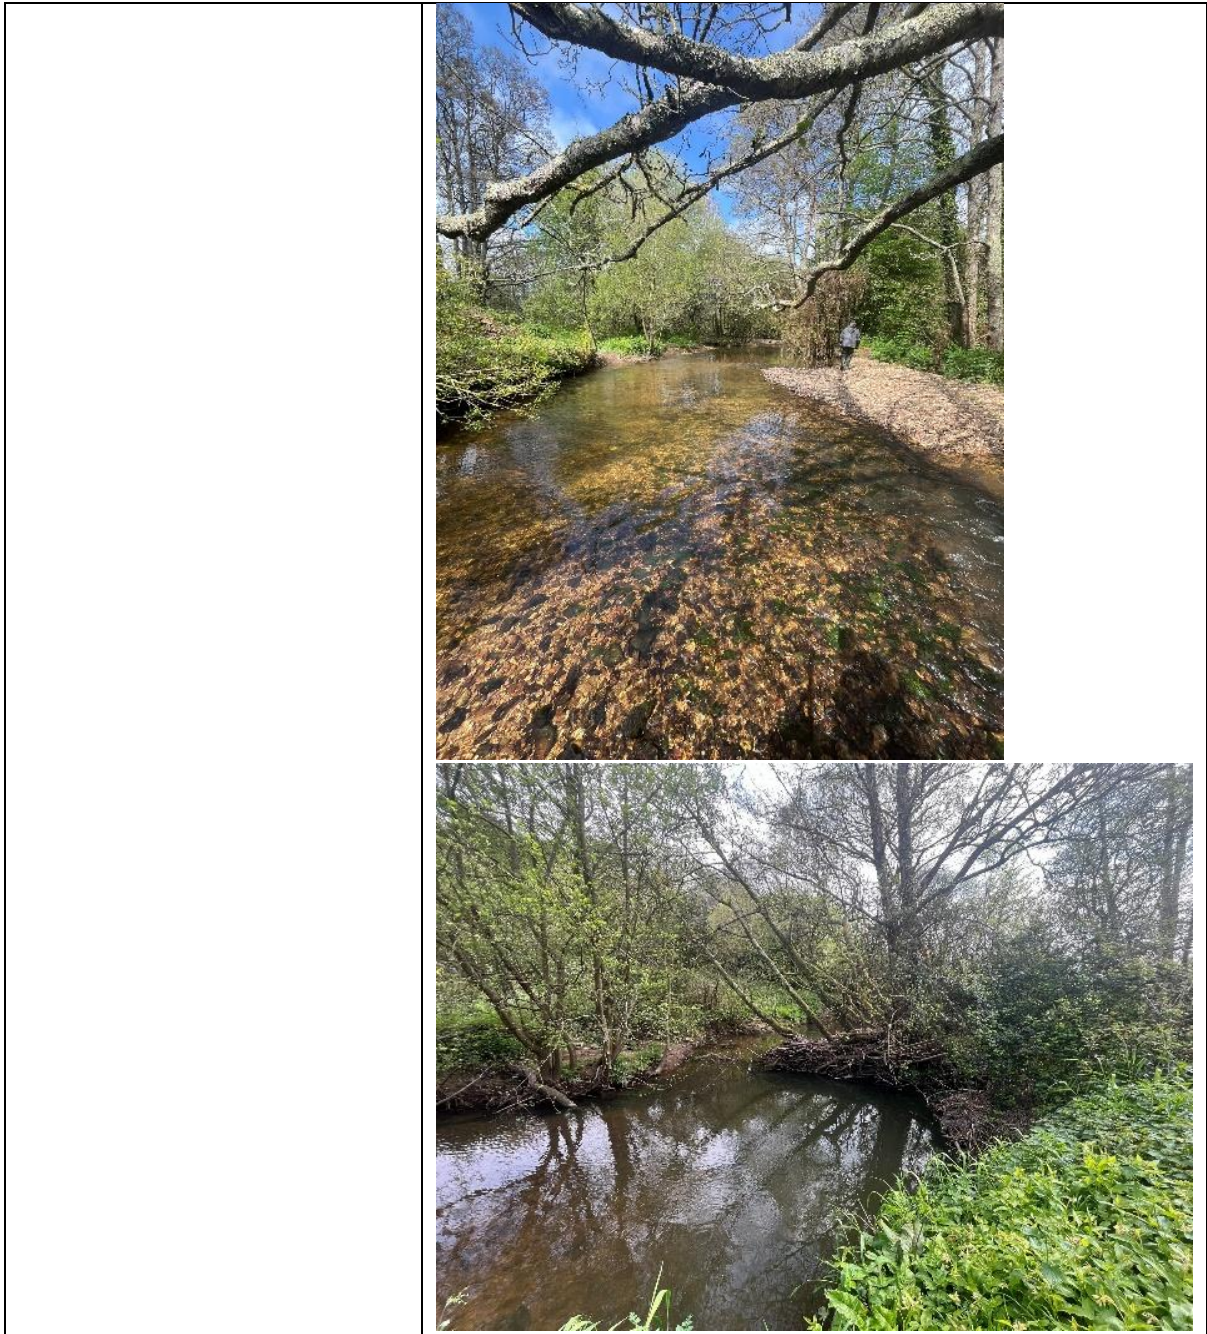
Description	Photograph
<p>River Sid – SY 13651 89551 to SY 13713 89614</p> <p>The River Sid throughout this reach is more natural, with space to move across the landscape with areas of connection to the floodplain resulting in sections of wet woodland. There is a high proportion of coarse wood in channel, leading to areas of channel braiding, accumulation of sediment bars and islands, overall creating a diverse mosaic of habitats.</p> <p>In areas of juvenile habitat, the gravel cobble matrix was of good spawning size, and due to the complexity of the reach, gravels appeared much cleaner than other areas of the catchment.</p> <p>A large proportion of Himalayan balsam and Japanese knotweed was noted throughout this reach.</p>

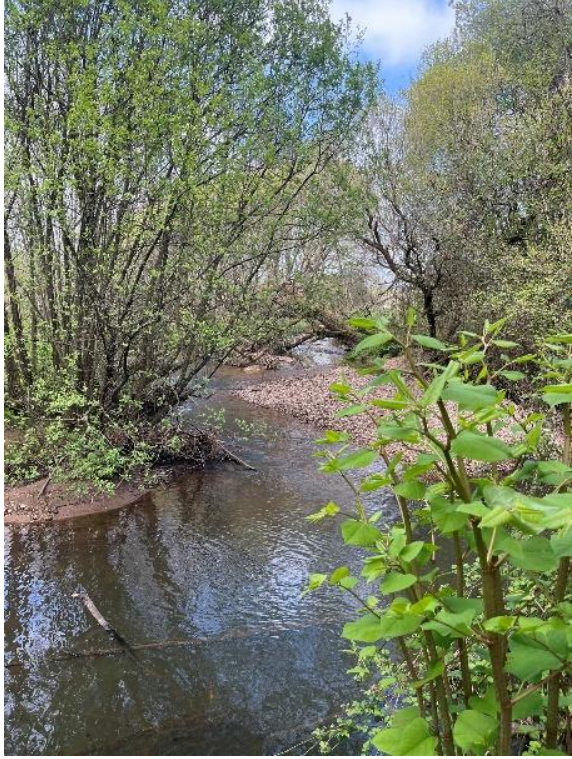
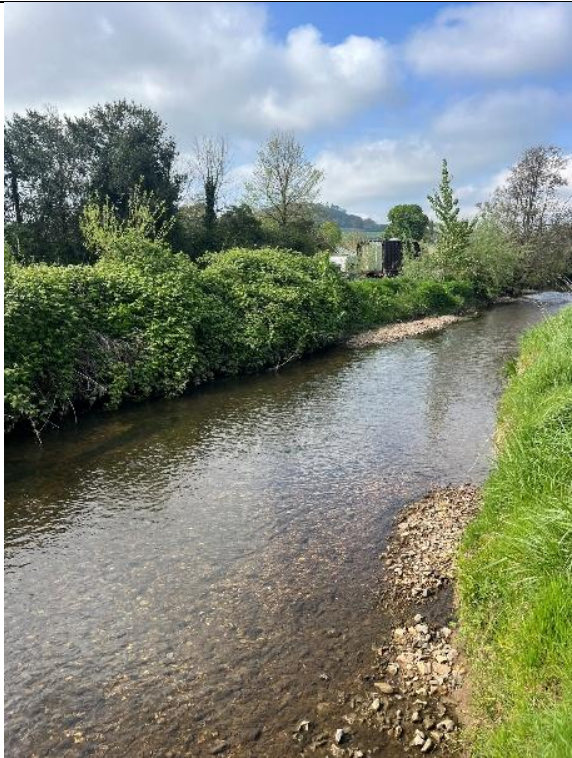
<p>River Sid – SY 13728 89732</p> <p>Straightened and homogenous section of the River Sid, with minimal tree cover and riparian buffer. This section would benefit from the addition of large woody flow deflectors to increase channel diversity and the creation of a more varied habitat. Selective tree planting and widening of riparian buffer would also add resilience to this section of the River Sid.</p>

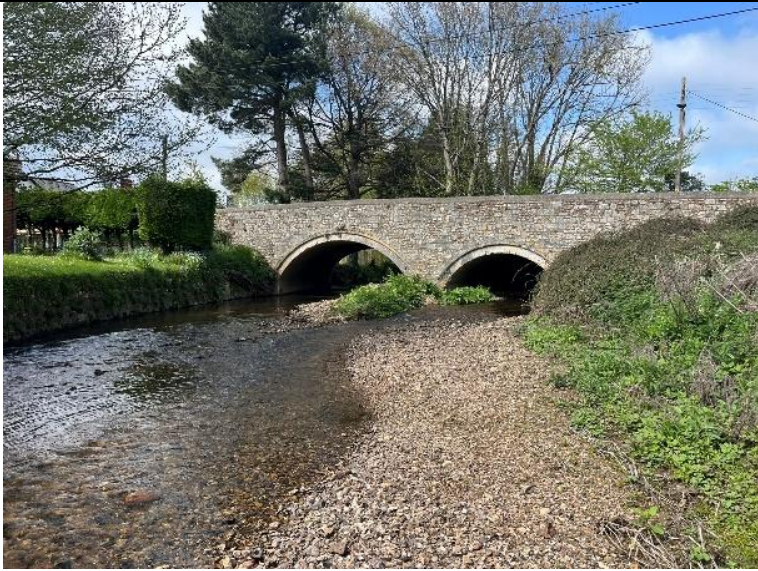
Description	Photograph
<p>River Sid – SY 13733 89965</p> <p>Sidford Bridge, where the Snod Brook joins the River Sid on the true left bank. The bridge does not pose an issue for fish migration. There is variability of habitat directly downstream of the bridge, with a mixture of fry and parr, however the area has minimal tree cover. At the time of surveying trout fry were seen on the tail of a riffle.</p>

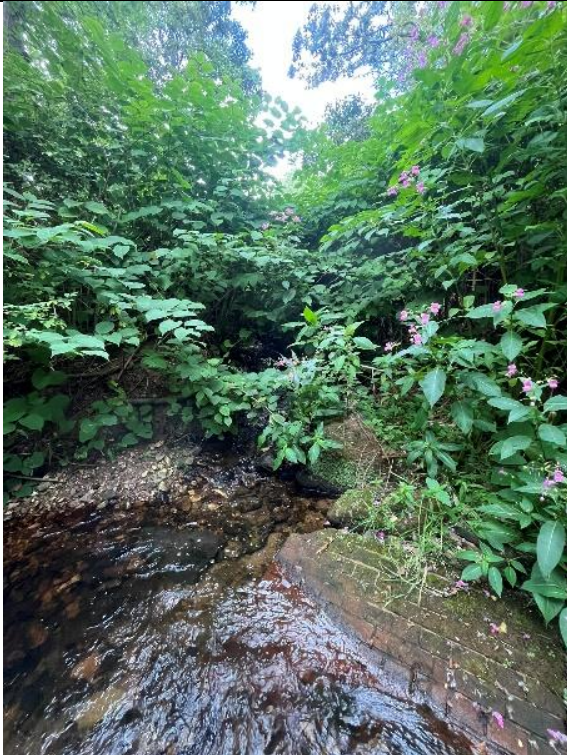
<p>River Sid – SY 13740 90155</p> <p>Confluence of the Burscombe Brook with the River Sid. This area has dense growth of Himalayan balsam.</p>

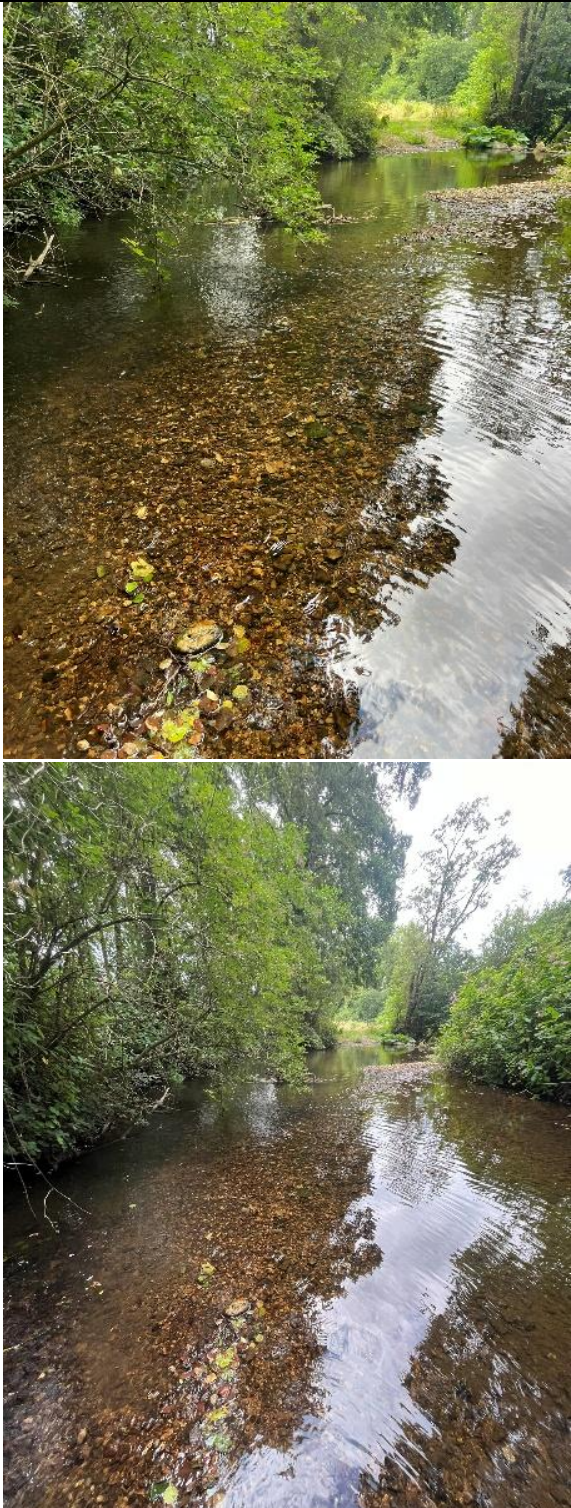
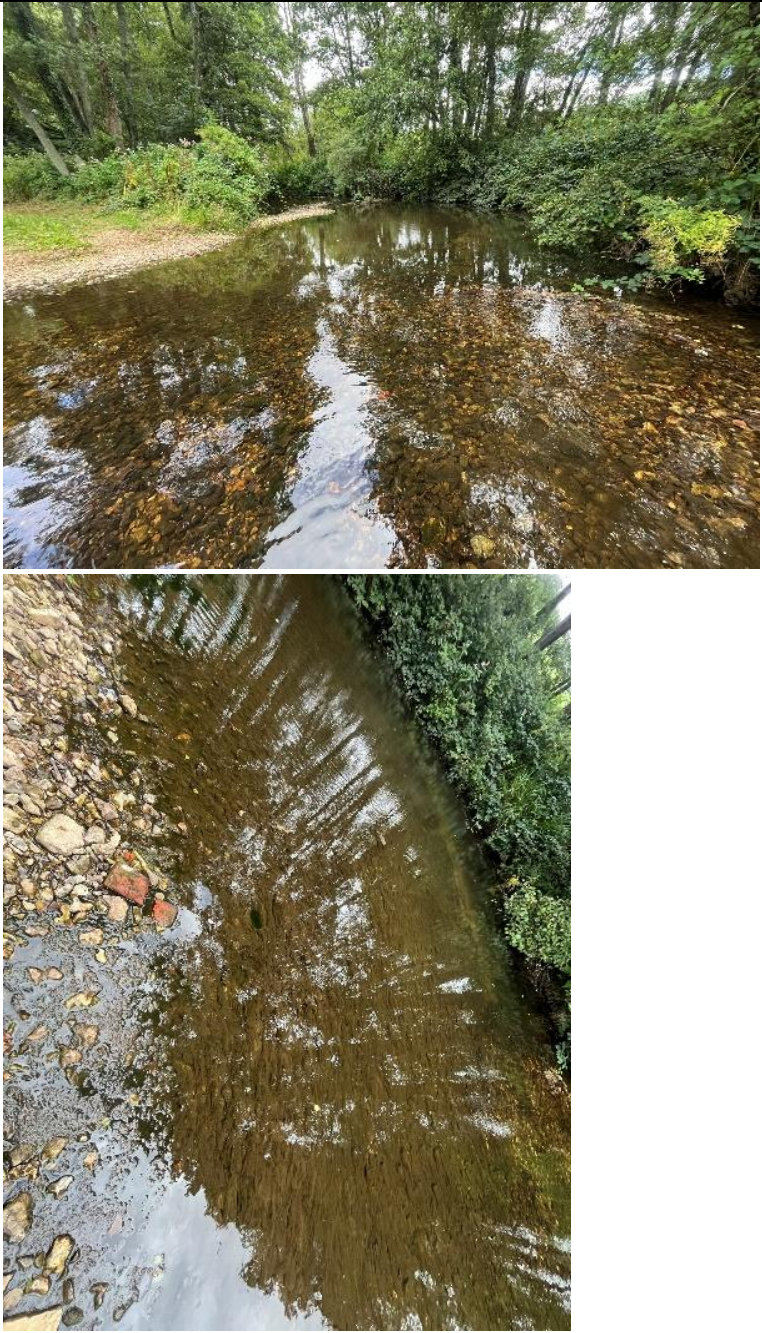
Description	Photograph
<p>River Sid – SY 13739 90570</p> <p>Impounded reach directly upstream of ford and two boulder weirs. Section has good spawning gravels present but, due to impoundment, the habitat is sub-optimal for spawning and fry. This impoundment reduces flow and oxygenation of interstitial space in the gravels. At the time of surveying, there was a high amount of algae growth on substrate present throughout the reach. This could be a result of nutrient enrichment, temperature and flow conditions or a combination thereof.</p>

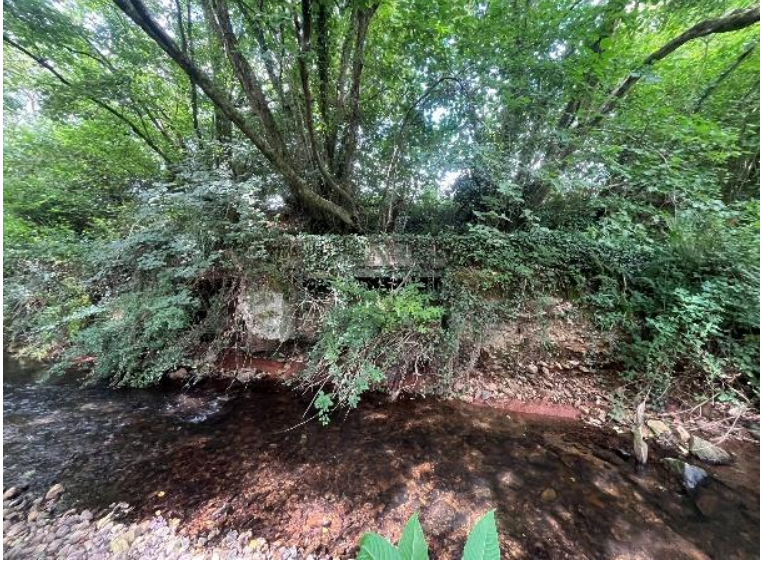
Description	Photograph
<p>River Sid – SY 13731 90671</p> <p>Historic structure on true right bank for River Sid. Not posing an issue to migration but may be constraining the river at this point and increasing erosion and incision of the bank.</p>

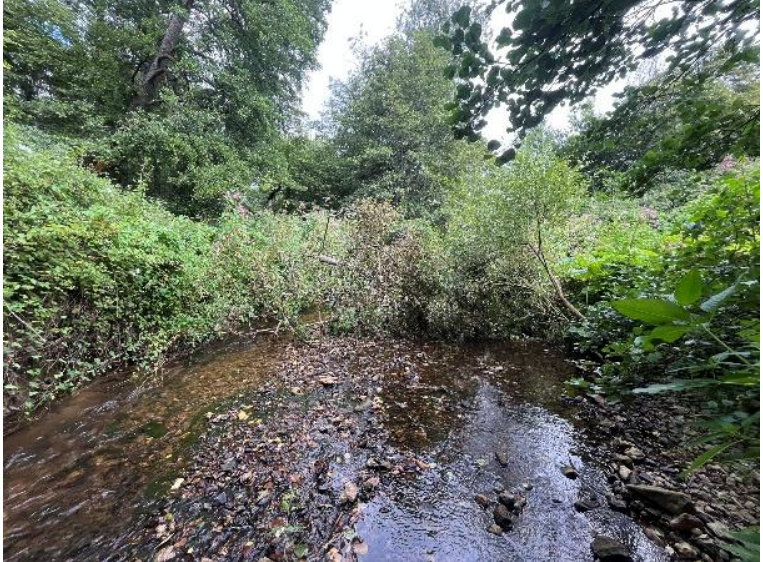
<p>River Sid – SY 13723 90668</p> <p>Large woody debris present in channel, not an issue for fish migration as clear route of passage along true right bank. The instream wood is already creating flow diversity, with a deeper parr channel along the true right banks and shallower fry habitat on the left.</p>

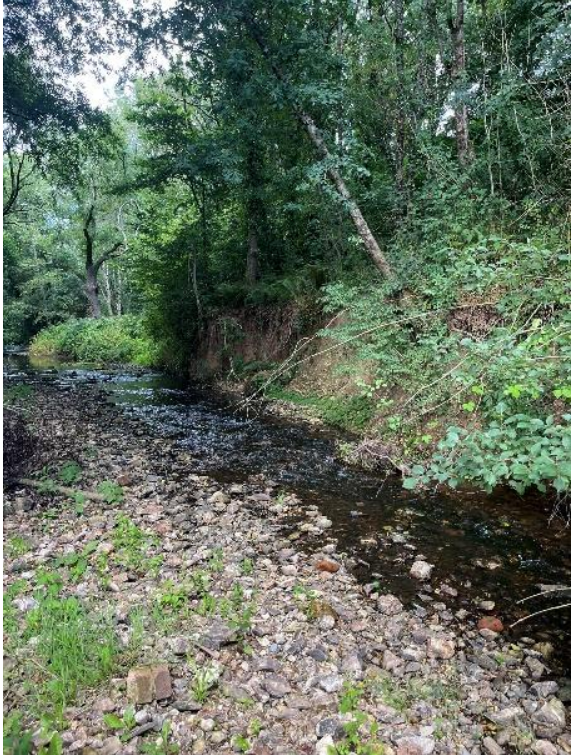
Description	Photograph
<p>River Sid – SY 13833 91211</p> <p>Heterogeneous habitat (mix of fry and parr in this section) with ample substrate, however the channel is straightened and constrained by incised banks that are also eroding.</p>

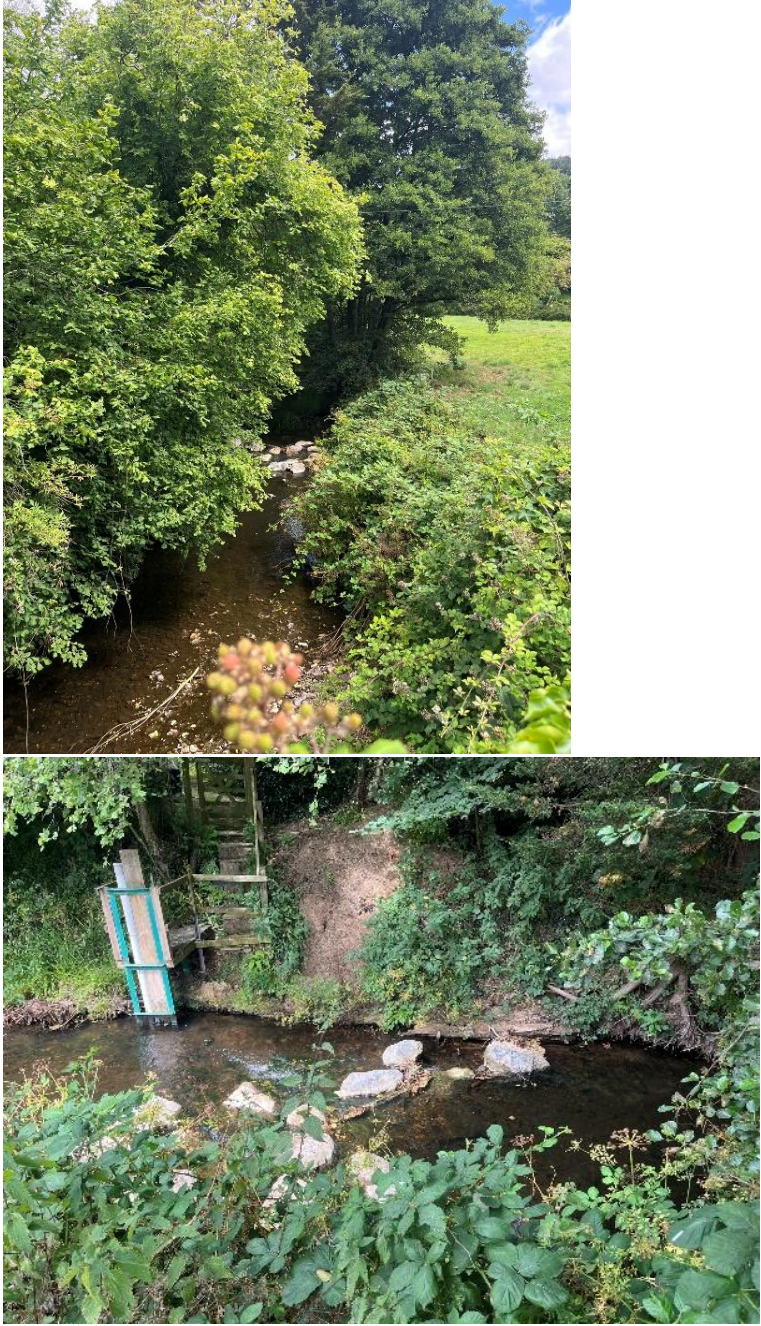
Description	Photograph
<p>River Sid – SY 13977 91616</p> <p>Instream boulders in an unnatural formation upstream of Sidbury EA level gauge, not likely related to gauge due to the placement upstream rather than downstream. Not likely to be a substantial issue.</p>

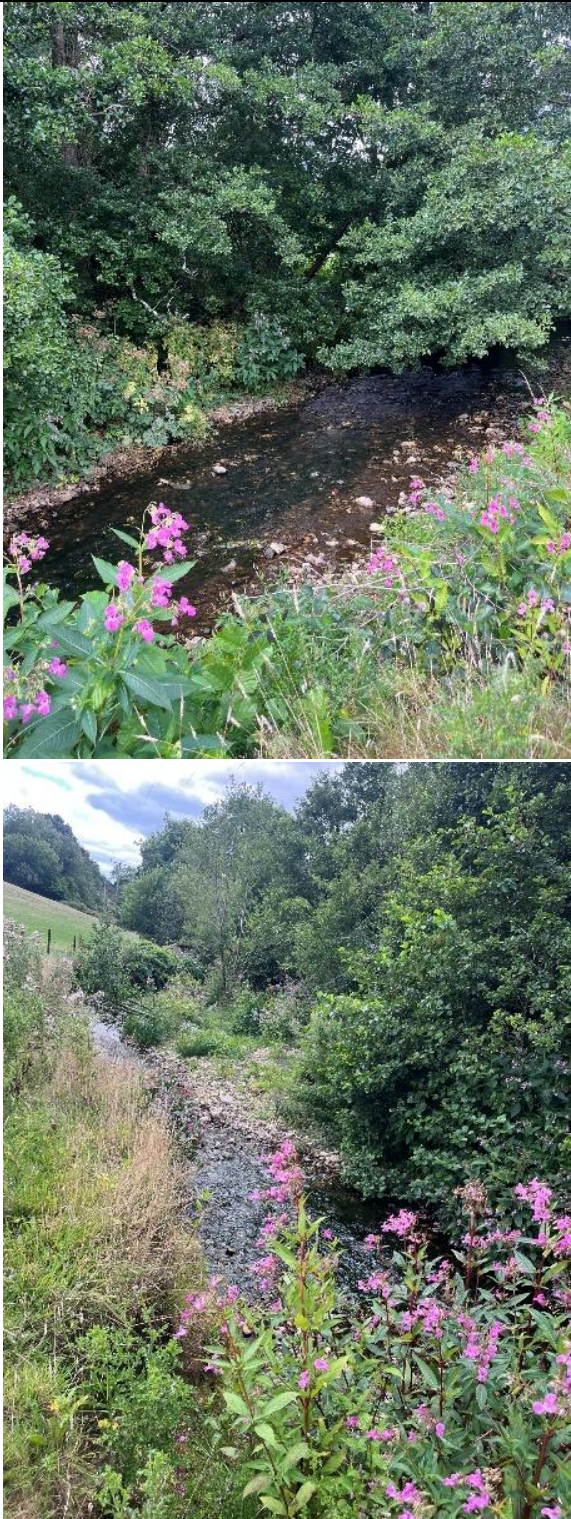
Description	Photograph
<p>River Sid – SY 14122 92070</p> <p>Location of new fry index survey site at 'US Church Street', in place of 'Sidbury' due to more suitable fry habitat for the survey methodology. Note, balsam present.</p>

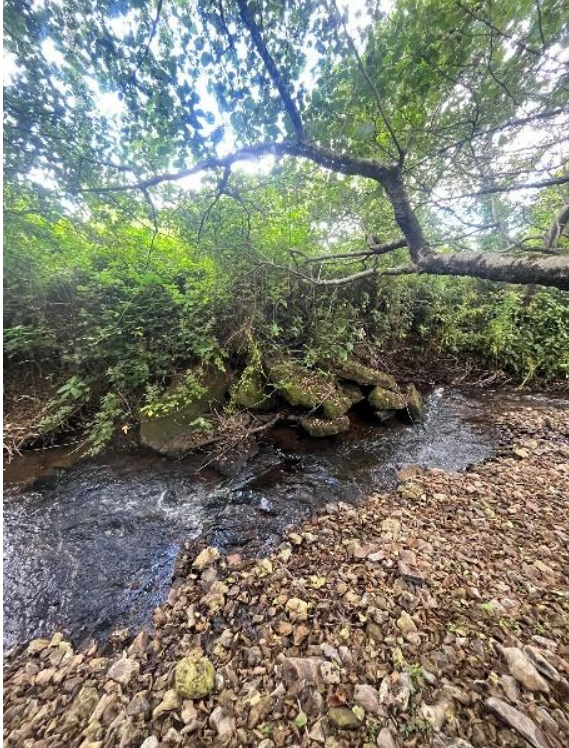
Description	Photograph
<p>River Sid – SY 14112 92161</p> <p>Tuer right bank undercutting and incised, appears to be reinforced with boulder or remnants of historic weir structure. Variety of habitat types in this reach, directly downstream of the Roncombe Stream confluence. Ample supply of gravel/cobble substrate.</p>

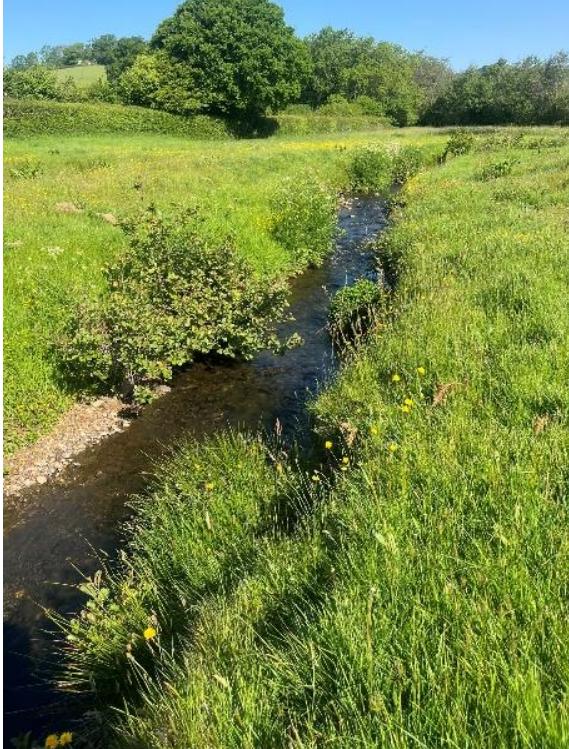
<p>River Sid – SY 14098 92293</p> <p>Moving into the upper reaches of the River Sid the channel becomes narrower. In this reach directly upstream of Cotford the reach is open with no riparian buffer or tree cover. Banks are incised, but not as severely as further downstream. This reach would benefit from selective tree planting and riparian buffer creation.</p>

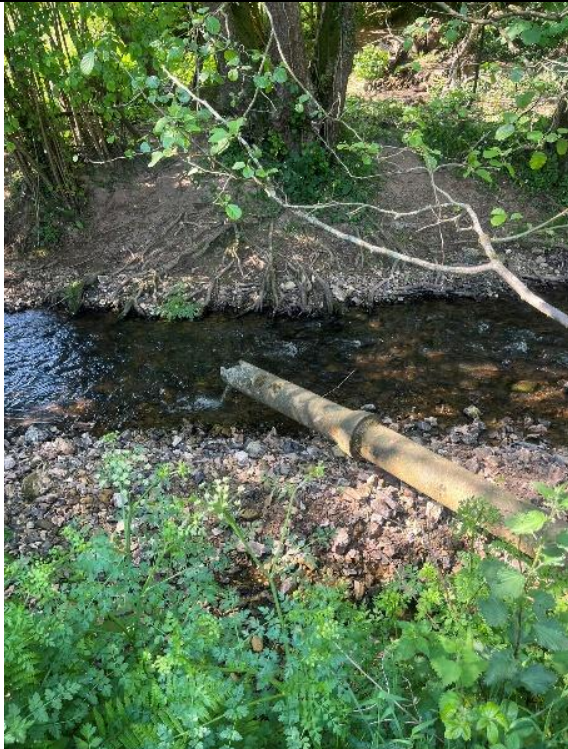
Description	Photograph
<p>River Sid – SY 14046 92424</p> <p>Pipe discharging into the River Sid. Origins and function unknown.</p>

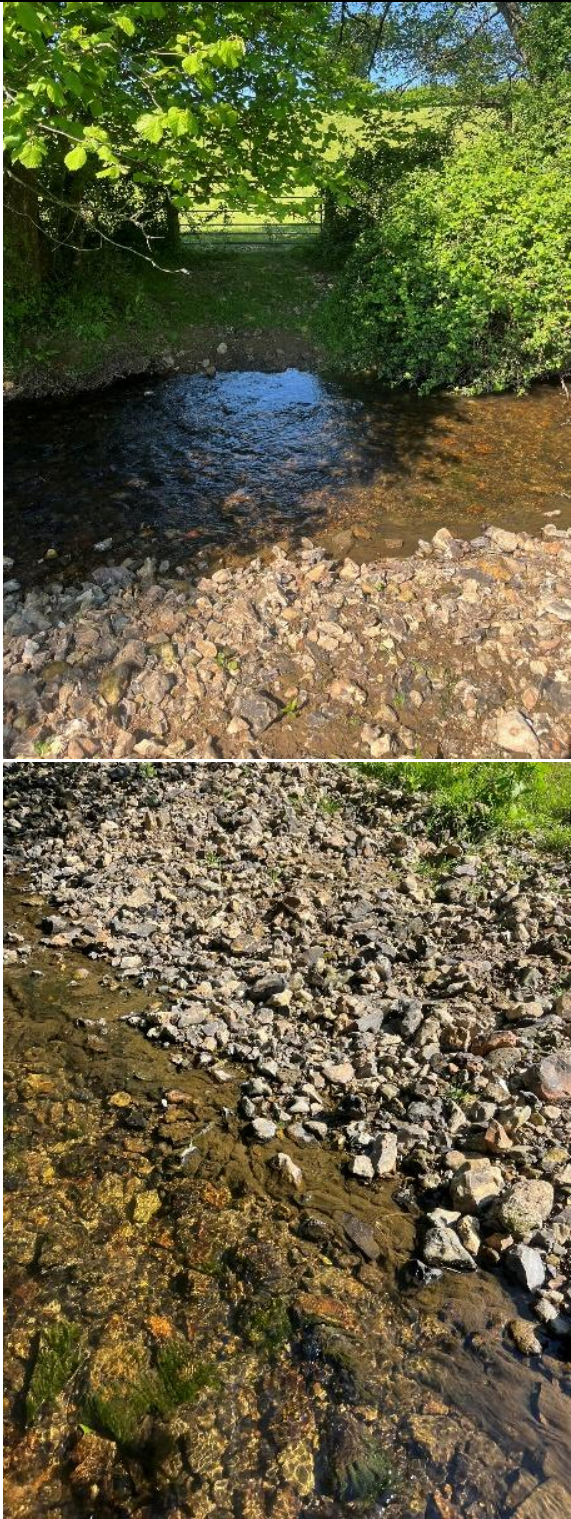
Description	Photograph
<p>River Sid – SY14000 95215</p> <p>Ford crossing for livestock movement on the River Sid. High levels of algae present at time of surveying.</p>

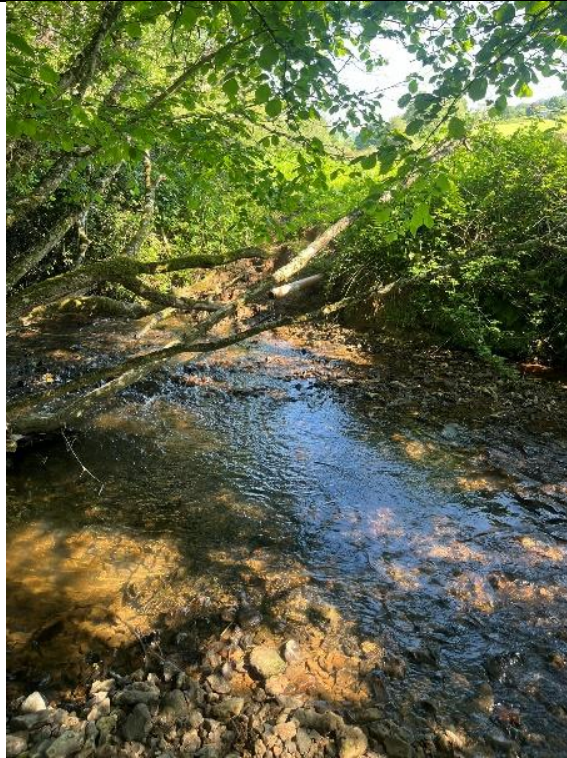
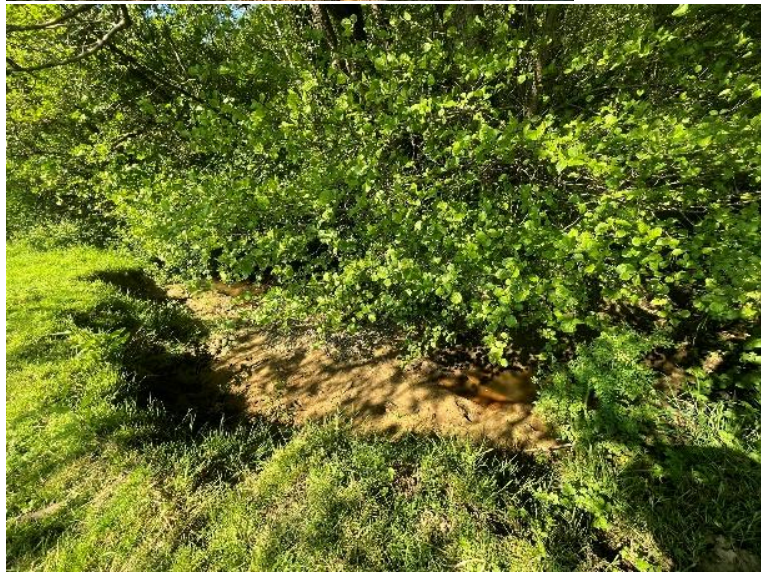
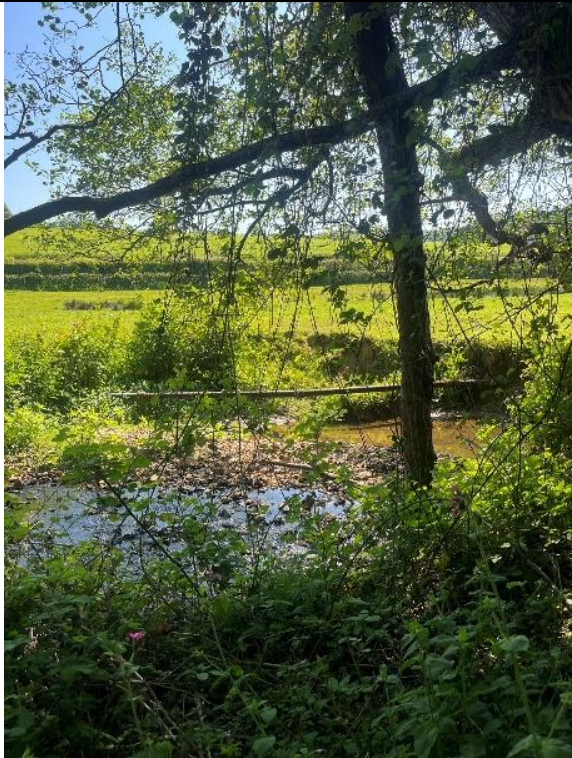
River Sid –  
SY 13994 92535 to SY 14009  
92757

Bank erosion present along reach, predominantly on true left bank where there is no fencing or riparian buffer for livestock pasture. Photo 3 shows a severe section of bank erosion of the true left bank whereby a pipe is now suspended. It is recommended to fence this reach to limit livestock access and willow stake areas of severe erosion to allow the bank to regenerate.

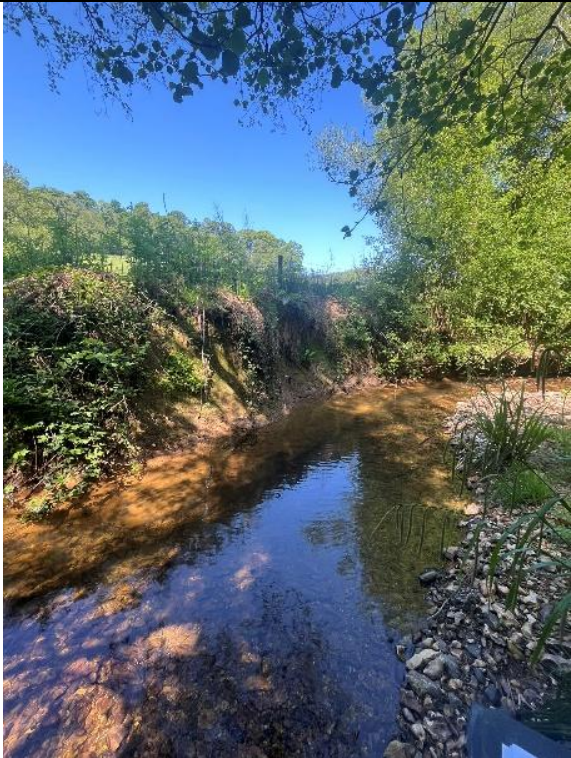
Description	Photograph
<p>River Sid – SY 14118 93356</p> <p>Incised eroding bank. From this point upstream of the catchment the gradient increases and banks are often steep valley sides. In some areas this resulted in unseen stretches of river due to inaccessibility.</p>

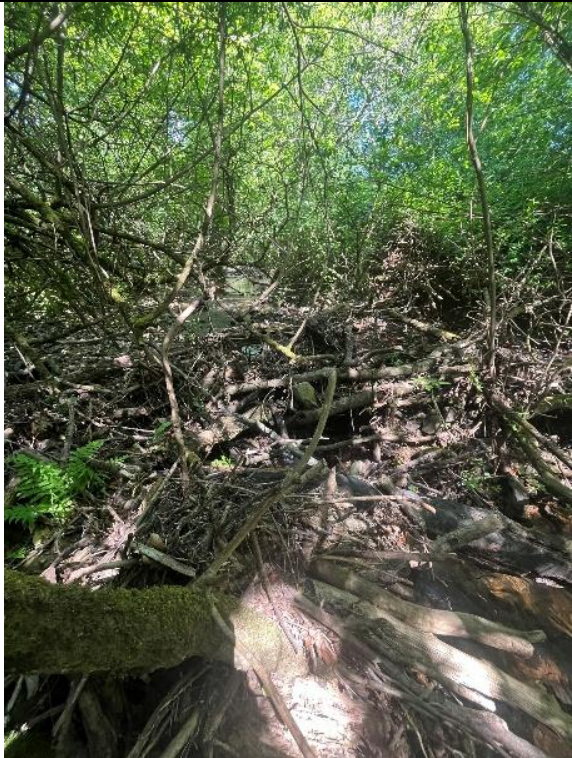
Description	Photograph
<p>River Sid – SY 14118 93646</p> <p>Large woody debris present instream of the River Sid. Although complex, it was not deemed to have an impact to fish passage as there were multiple routes through and around the woody structure for the free movement of fish.</p>
