# Appendix 3: Salmonid Habitat Walkover Maps – River Sid

## Appendix 4: Habitat walkover Photos – River Sid

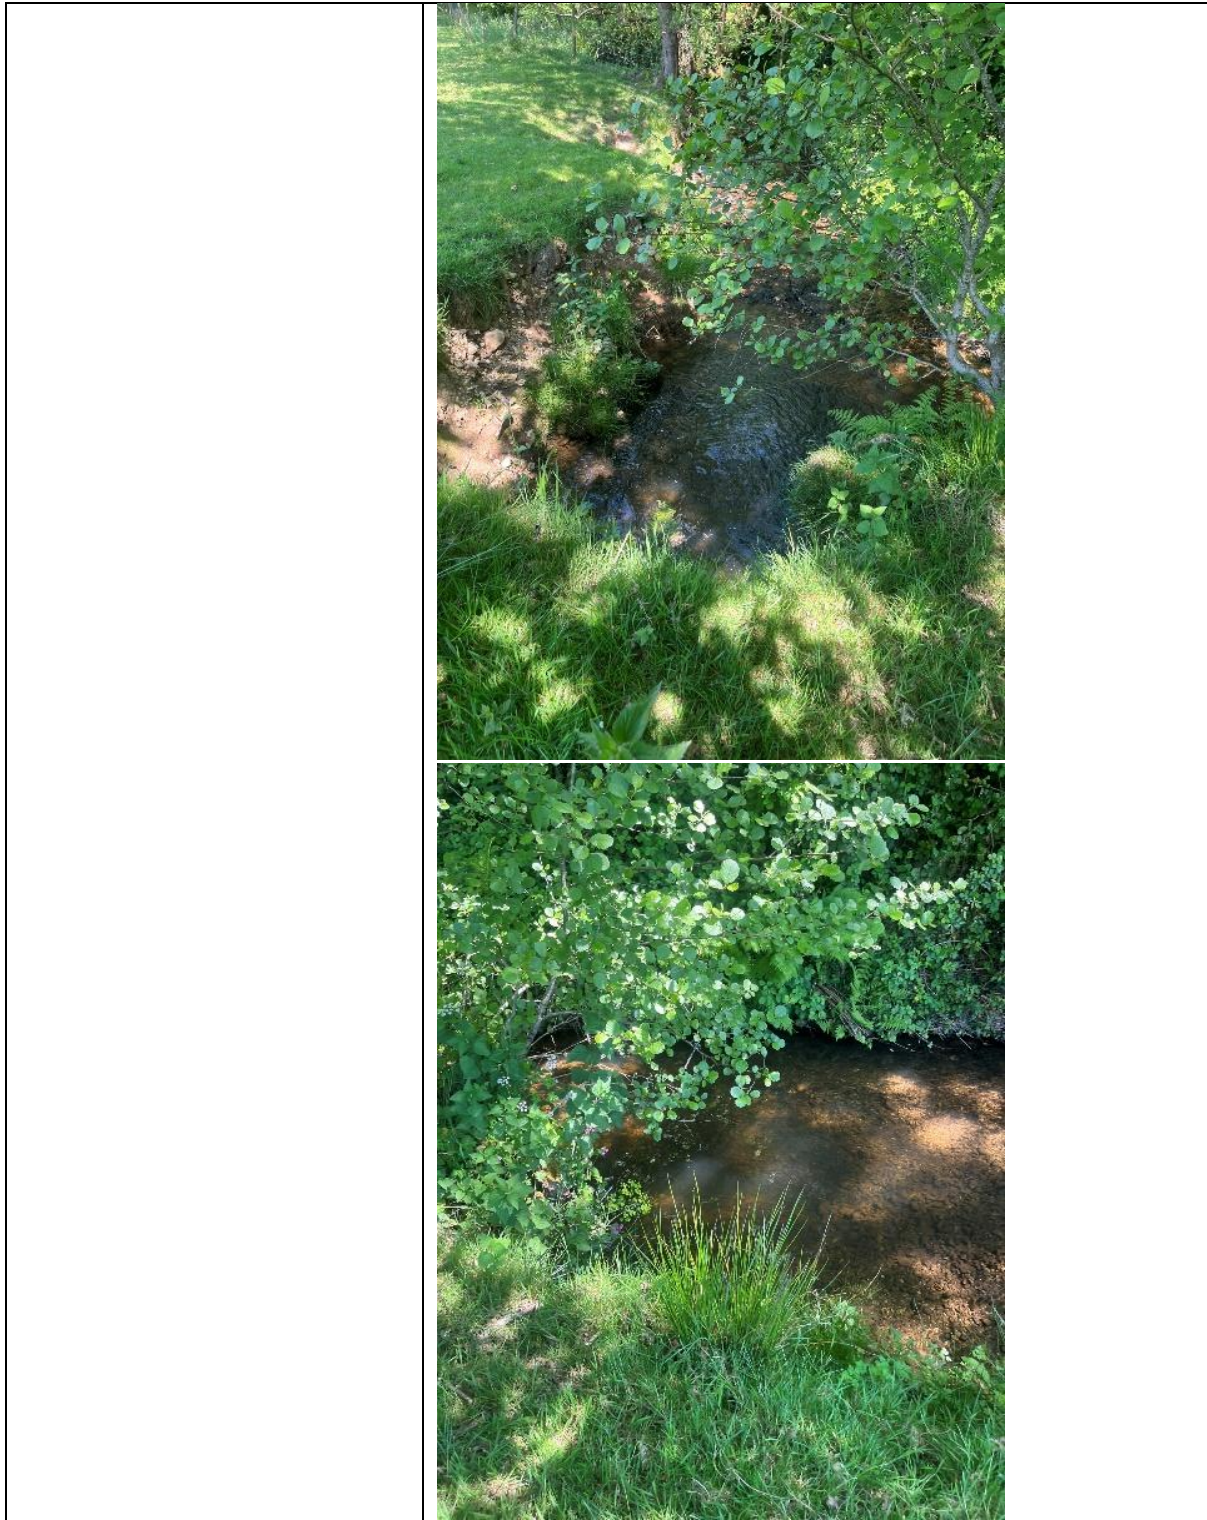
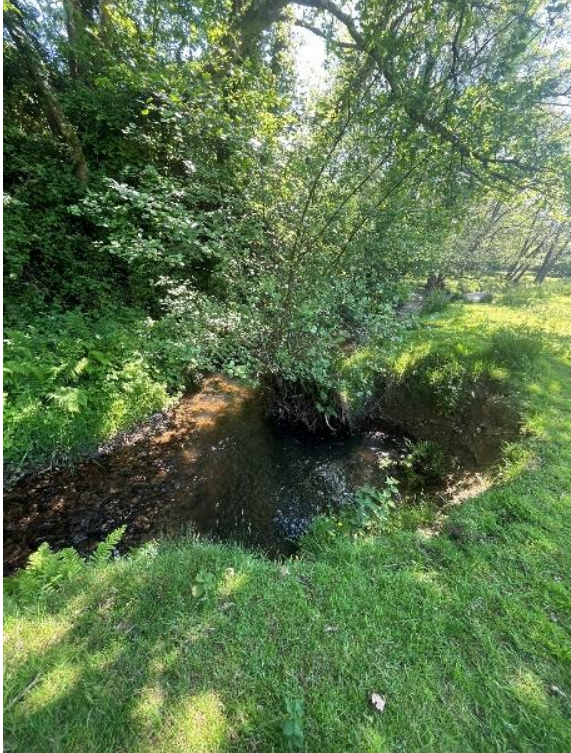
Description	Photograph
<p>River Sid – SY 14115 93753 to SY 14125 93781</p> <p>Section of good in-river habitat, mix of fry and parr with optimal sized spawning gravels that were relatively clean. However, this reach is unfenced with livestock present, resulting in poached and eroded banks. There was a favourable level of tree cover, however fencing of the banks to create a suitably sized riparian buffer is recommended, as well as installation of water troughs for livestock drinking access in place of access to the river.</p>

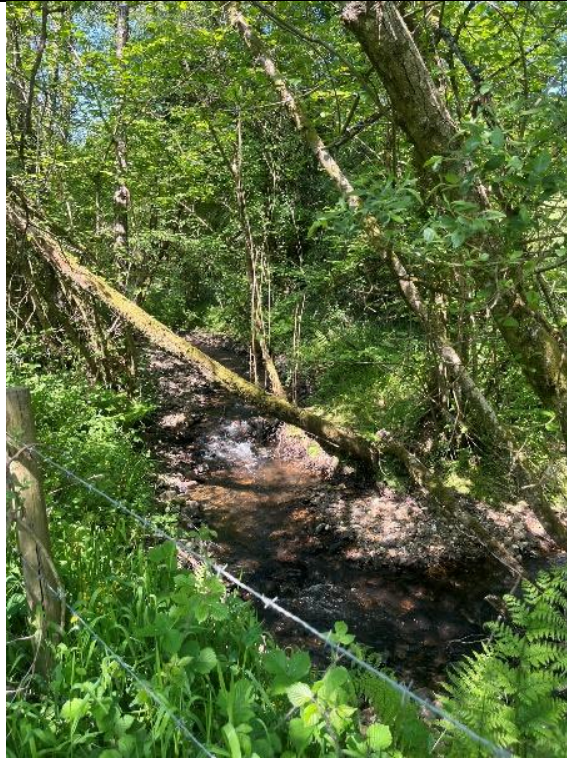
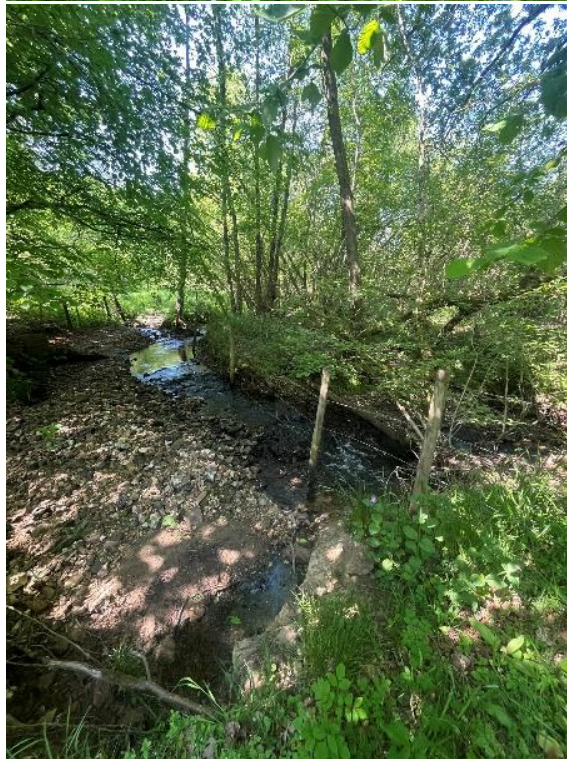
River Sid –  
SY 14107 94711 to SY 14091  
94741

Reach upstream of Plyford of the River Sid is much more natural, with the river able to move more freely across the landscape. Habitats in riparian buffer include species-rich grasslands. However, like many other areas of the catchment, banks are eroding and incised, although not as severely here.

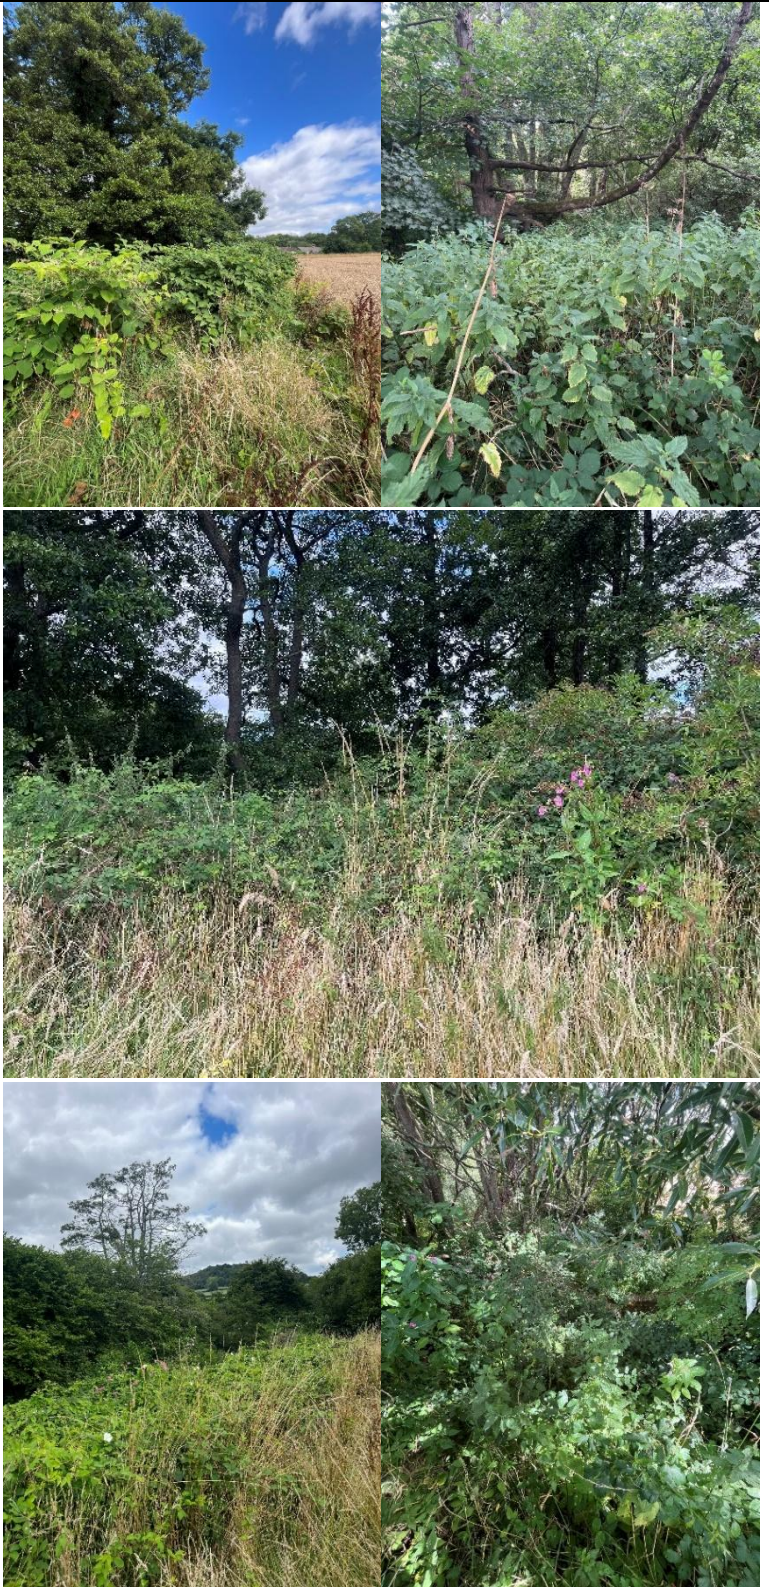
Description	Photograph
<p>River Sid –</p> <p>Examples of areas along the River Sid (SY 13745 90012, SY 13767 90123, SY 13784 90439, SY 13752 90535, SY 13698 90751, SY 13732 90780, SY 13698 90751, SY 13732 90780, SY 14095 91957) that were unseen during walkover surveys due to high densities of bank vegetation, as well as invasive species such as Japanese knotweed (present in photo 1) and Himalayan balsam (present in photo 3).</p>
