Westcountry Rivers Trust – Opening the Sid Catchment Assessment – River Sid - 2025

Barrier photos for **River Sid** MS1 – MS39

Extracted from Appendix 16

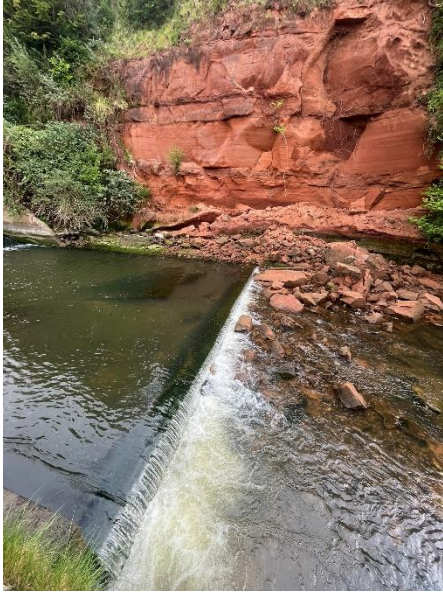
Barrier ID	Waterbody	NGR	Date Visited	Photo	Type of Obstruction	Flows	Possible Action	Notes
MS1	River Sid	SY 12859 87459	25/04/20 25

Concrete Weir	Non-adherent	Notch	Approx. 0.5m head, concrete weir, pool US and DS, attractive flow route on RHB, drowned in high tide?

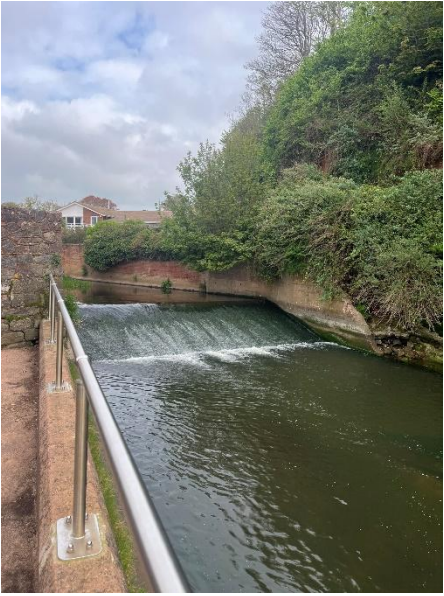
Barrier ID	Waterbody	NGR	Date Visited	Photo	Type of Obstruction	Flows	Possible Action	Notes
MS2 – Ham Weir	River Sid	SY12857 87466	25/04/20 25

Concrete Weir	Adherent		Tidal limit. 1-1.5m head, thin laminar flow. More passable in high tide? 1-1.5m concrete sill extending back from weir crest, thin film of water.

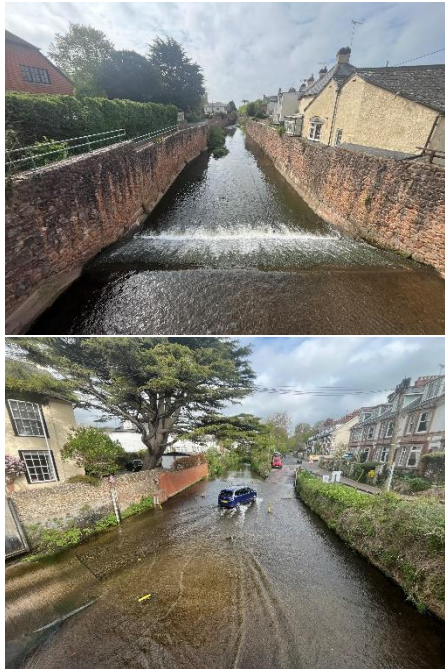
Barrier ID	Waterbody	NGR	Date Visited	Photo	Type of Obstruction	Flows	Possible Action	Notes
MS3 – Mill Ford Weir	River Sid	SY 12783 87669	25/04/20 25

Concrete Weir	Adherent		1-1.5m head, holding back ford crossing. Concrete with thin film of water. Spring high tide limit? Engineered trench DS.
MS4 - School Weir	River Sid	SY 12789 87866	25/04/20 25

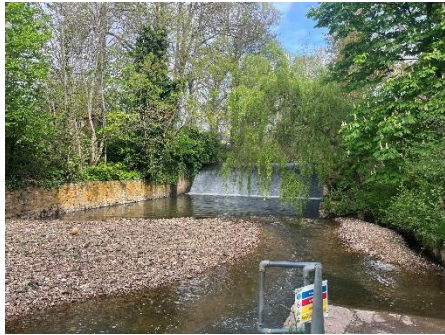
Concrete Weir	Adherent	Part remove and rock ramp	3m weir, near vertical. Progressing options

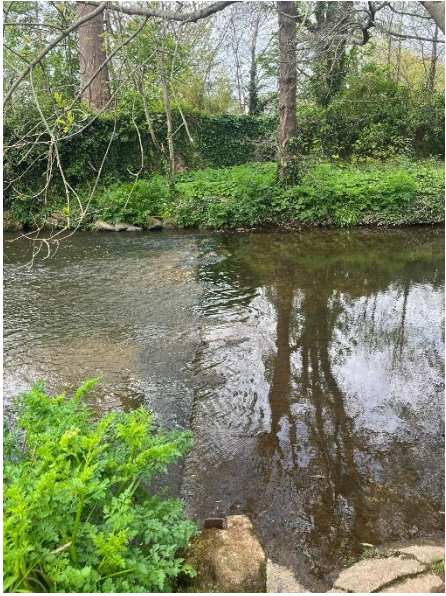
Barrier ID	Waterbody	NGR	Date Visited	Photo	Type of Obstruction	Flows	Possible Action	Notes
MS5 - Old School Weir	River Sid	SY 12790 87960	25/04/20 25

Concrete Weir	N/A		Approximately 10m Us of School Weir and submerged with sediment. Easement, progressing options.

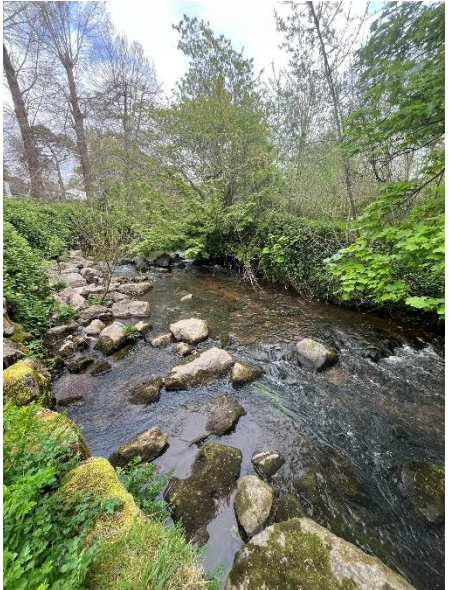
Barrier ID	Waterbody	NGR	Date Visited	Photo	Type of Obstruction	Flows	Possible Action	Notes
MS6	River Sid	SY 12824 88264	25/04/20 25

Boulder weir	Mixed - passable rotes		Boulder check weirs, passable routes, likely no action for these two
MS7	River Sid	SY 12824 88264	25/04/20 25

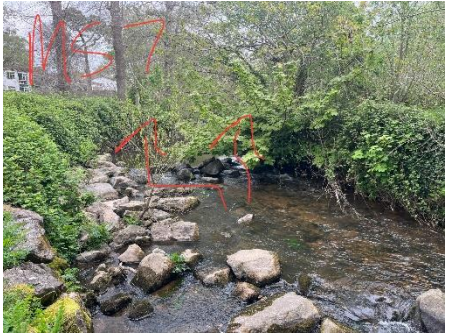
Boulder weir	Mixed - passable rotes		Boulder check weirs, passable routes, likely no action for these two

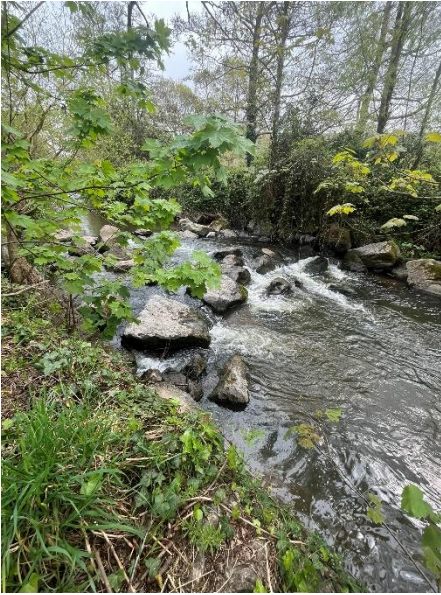
Barrier ID	Waterbody	NGR	Date Visited	Photo	Type of Obstruction	Flows	Possible Action	Notes
MS8	River Sid	SY 12838 88298	25/04/20 25

Boulder weir (2-step?)	Mixed (second has notched passable route)		Addition of material DS of MS8 will raise bed level and increase heterogeneity
MS9	River Sid	SY 12838 88298	25/04/20 25

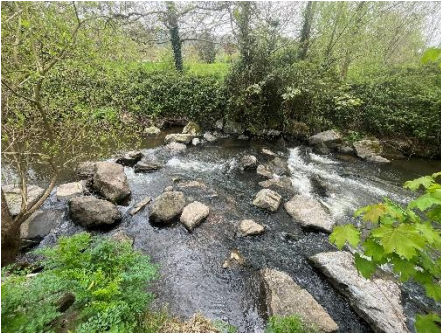
Boulder weir (2-step?)	Mixed (second has notched passable route)		Addition of material DS of MS8 will raise bed level and increase heterogeneity

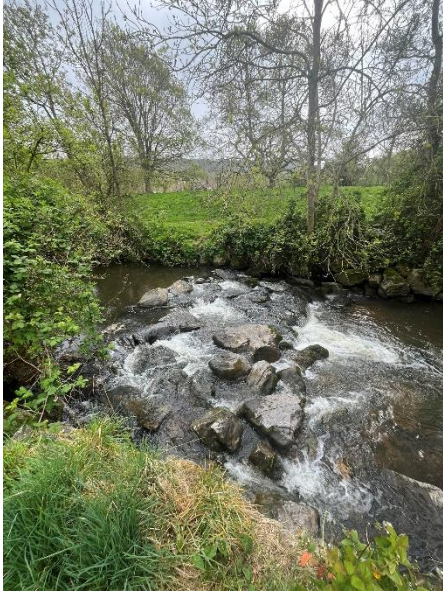
Barrier ID	Waterbody	NGR	Date Visited	Photo	Type of Obstruction	Flows	Possible Action	Notes
MS10	River Sid	SY 12858 88319	25/04/20 25

Boulder Weir	Mixed		1.5-2m DS to US span of weir. Addition of material to raise bed level.

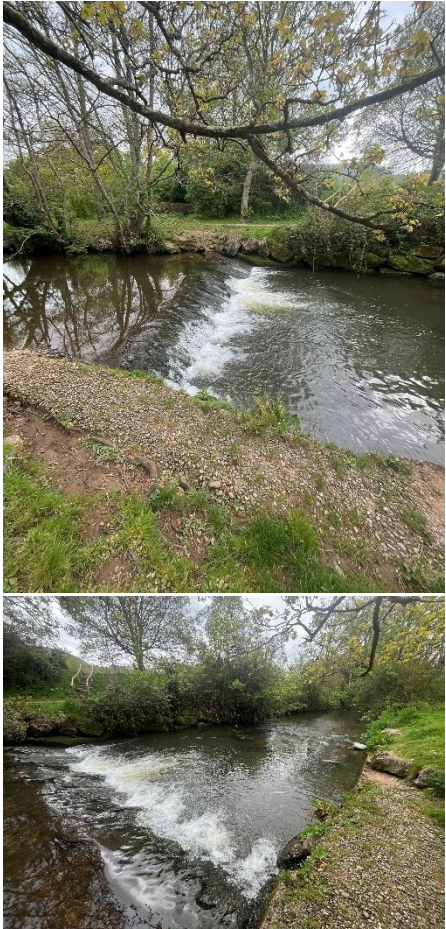
Barrier ID	Waterbody	NGR	Date Visited	Photo	Type of Obstruction	Flows	Possible Action	Notes
MS11 - Roly Poly Weir	River Sid	SY 12880 88342	25/04/2025

Concrete Weir	Mixed		Laminar flow at crest then non-adherent where concrete is deteriorating. Addition of bed material to raise bed level or notching.

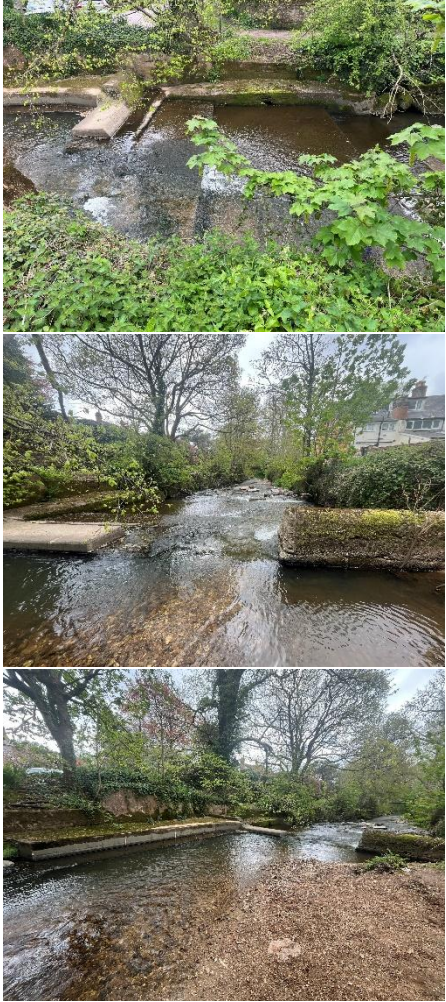
Barrier ID	Waterbody	NGR	Date Visited	Photo	Type of Obstruction	Flows	Possible Action	Notes
MS12	River Sid	SY 12965 88504	25/04/20 25

Concrete Weir	Laminar		<p>3-step concrete weir. Previously notched in top section? Flow directed to RHB. Decent depth on concrete flights but no pool/resting areas, energy intensive. Potentially boulders on entrance/exit route. Benefit to SNIFFER this weir. High priority, flood risk to property on RHB. Nice gravels US, no impoundment, parr and fry habitat.</p>

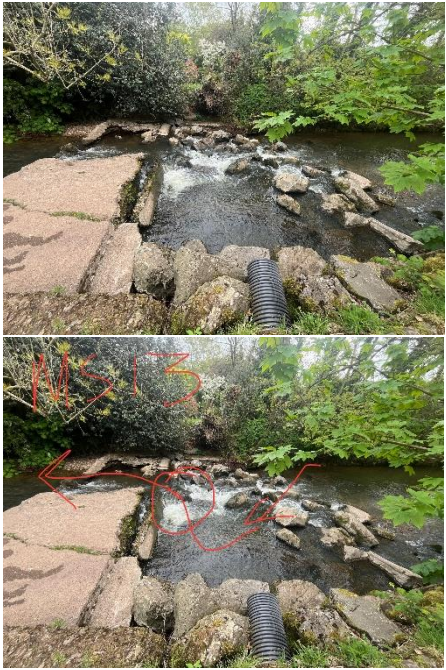
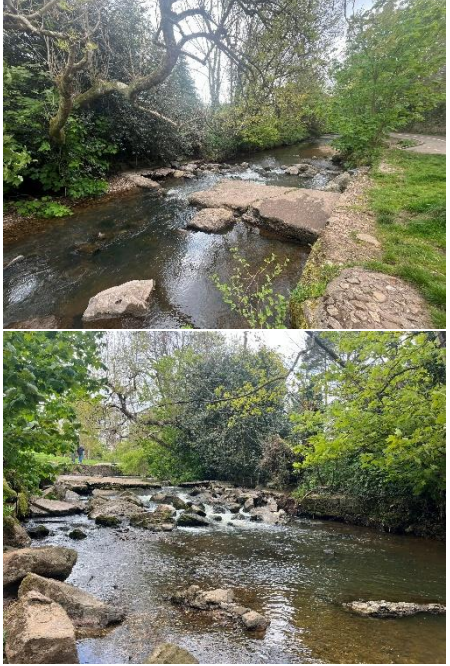
Barrier ID	Waterbody	NGR	Date Visited	Photo	Type of Obstruction	Flows	Possible Action	Notes
MS13	River Sid	SY 12966 88581	25/04/20 25

Boulder weir and deteriorating concrete weir	Mixed		<p>Boulders DS of weir reducing total head drop of weir. Multiple routes with mixed flows in this section (chute), pools and resting places. Concrete weir deteriorating, broken through in centre and LHB, good depth through section. Boulders on entrance with non-adherent flows, possibly not attractive and damaging.</p>

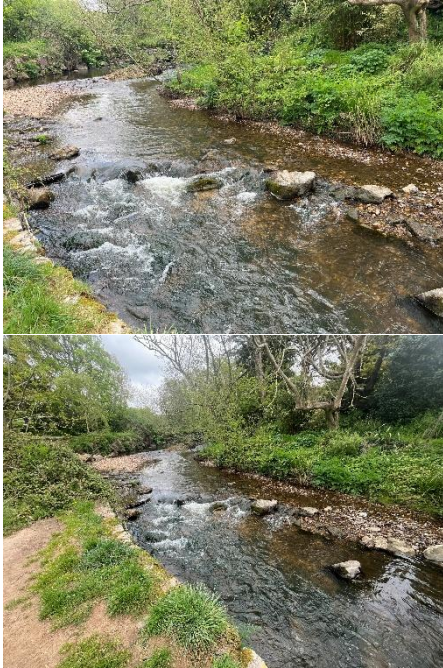
Barrier ID	Waterbody	NGR	Date Visited	Photo	Type of Obstruction	Flows	Possible Action	Notes
MS14	River Sid	SY 12972 88615	25/04/20 25

Boulder check weir	adherent		good route of passage, mostly drowned out. Best route RHB with laminar flow and notch

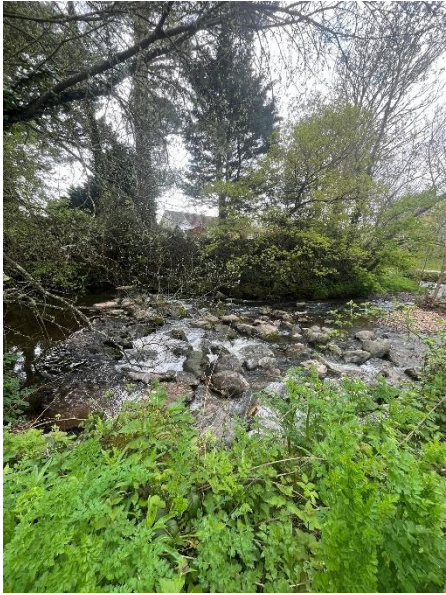
Barrier ID	Waterbody	NGR	Date Visited	Photo	Type of Obstruction	Flows	Possible Action	Notes
MS15	River Sid	SY 13007 88639	25/04/20 25

boulder weir	mixed		numerous potential routes. Approx 1m head. Pockets of resting pools (small and turbulent) limited laminar flow
MS16	River Sid	SY 13092 88615	25/04/20 25

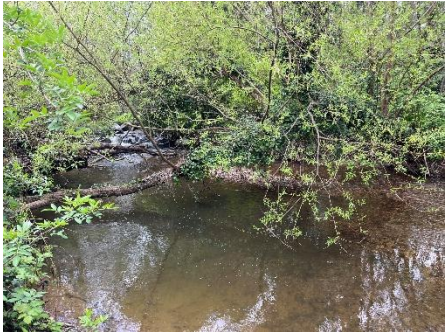
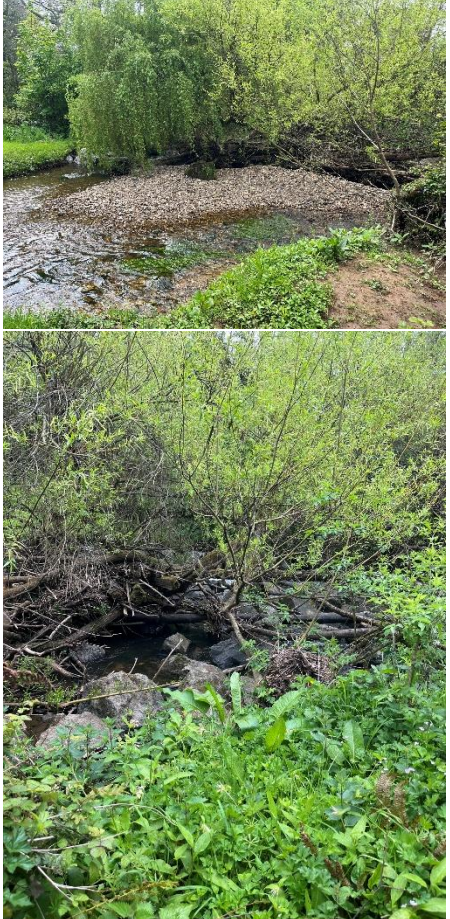
boulder weir	mixed		similar to MS15, LWD accumulation on RHB to centre of weir crest. Willow growing in middle with gravel bar behind willow, some fry habitat and ranunculous present

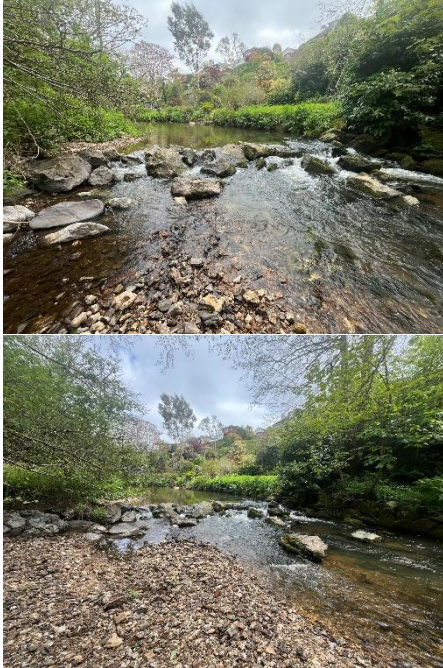
Barrier ID	Waterbody	NGR	Date Visited	Photo	Type of Obstruction	Flows	Possible Action	Notes
MS17	River Sid	SY 13188 88699	25/04/20 25

boulder weir	mixed		three to four routes, possible notch for section of laminar flow. Approx 0.5m head

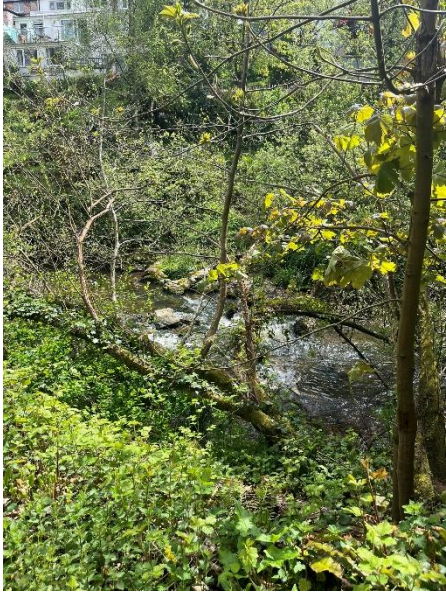
Barrier ID	Waterbody	NGR	Date Visited	Photo	Type of Obstruction	Flows	Possible Action	Notes
MS18	River Sid	SY 13260 88804	25/04/20 25

boulder weir	mixed		not likely an issue as lots of gaps with laminar flow, good depth US and DS

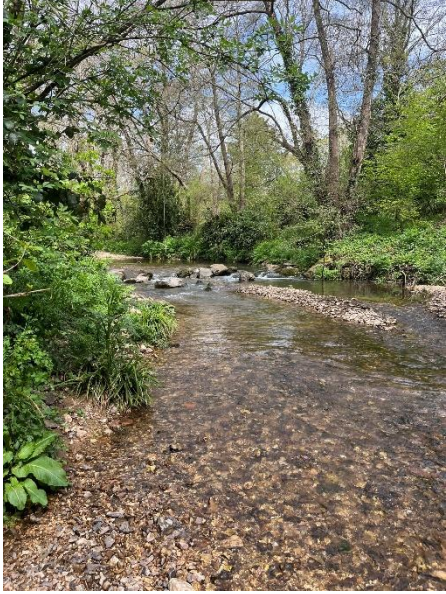
Barrier ID	Waterbody	NGR	Date Visited	Photo	Type of Obstruction	Flows	Possible Action	Notes
MS19	River Sid	SY 13292 88825	25/04/20 25

boulder weir	mixed		not likely an issue as lots of gaps with laminar flow, shallow US, good gravels

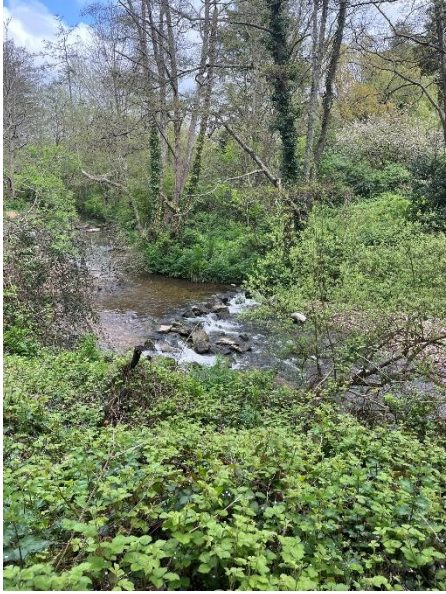
Barrier ID	Waterbody	NGR	Date Visited	Photo	Type of Obstruction	Flows	Possible Action	Notes
MS20	River Sid	SY 13275 88880	25/04/20 25

boulder weir	mixed		boulder weir DS of Gilchrist EF site. Multiple routes, could move boulders for more effective route

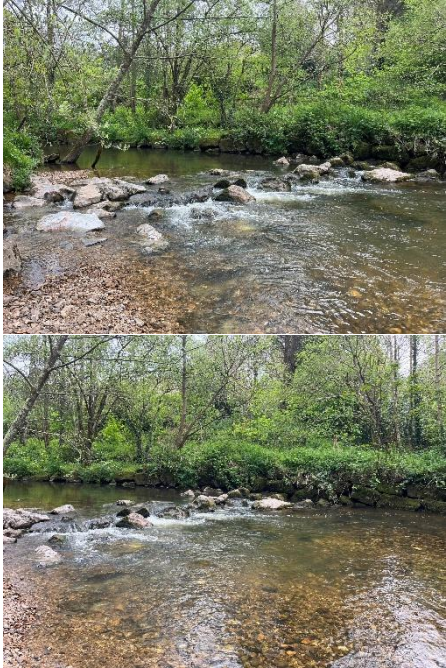
Barrier ID	Waterbody	NGR	Date Visited	Photo	Type of Obstruction	Flows	Possible Action	Notes
MS21	River Sid	SY 13298 88911	25/04/20 25

boulder weir	mixed		boulder weir US of Gilchrist EF site. 0.3m head, multiple routes, shallow depth US

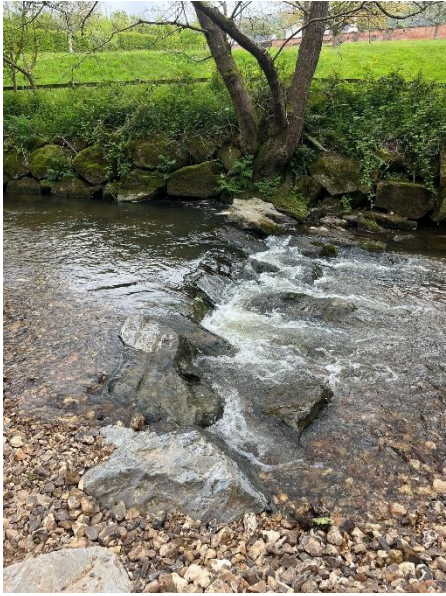
Barrier ID	Waterbody	NGR	Date Visited	Photo	Type of Obstruction	Flows	Possible Action	Notes
MS22	River Sid	SY 13320 88947	25/04/20 25

boulder weir	mixed		boulder weir, good pool depth US and DS, laminar flow but boulders in way
MS23	River Sid	SY 13314 88959	25/04/20 25

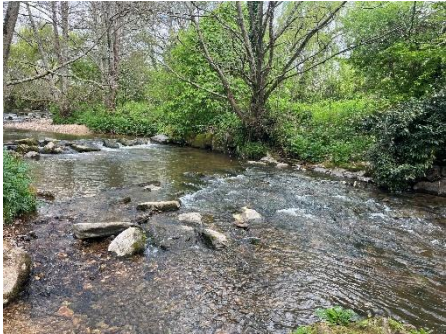
submerged boulder check weir	drowned	None	boulder check weir now submerged, free route of passage

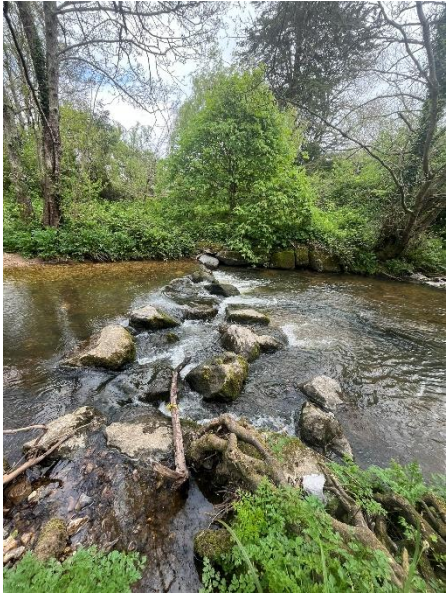
Barrier ID	Waterbody	NGR	Date Visited	Photo	Type of Obstruction	Flows	Possible Action	Notes
MS24	River Sid	SY 13313 88974	25/04/20 25

boulder weir	mixed		good pool depth US/DS, multiple routes
MS25	River Sid	SY 13305 88996	25/04/20 25

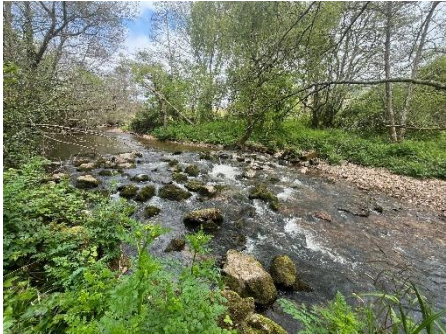
boulder weir	mixed		large structure with multiple routes and resting areas, approx. 0.6m head

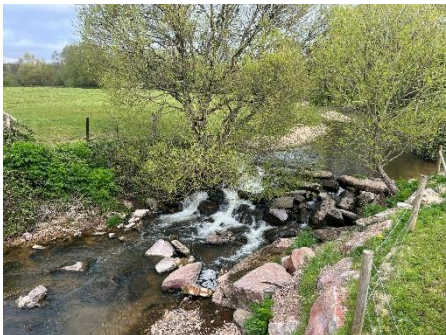
boulder weir and ford	mixed cascade		2m boulder weir holding up ford at Fortescue. Farmer has moved concrete block on RHB and reinforced DS LHB with boulders, farmer keen to have more reinforcement DS
MS28	River Sid	SY 14120 93669	14.05.25

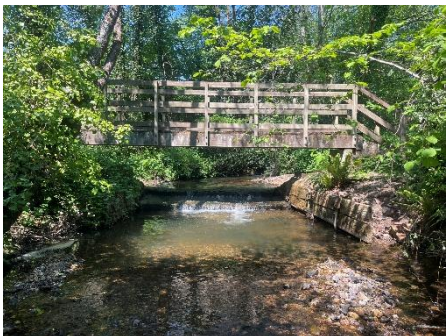
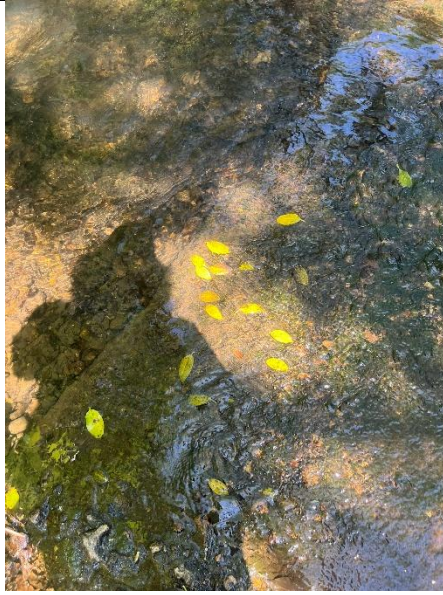
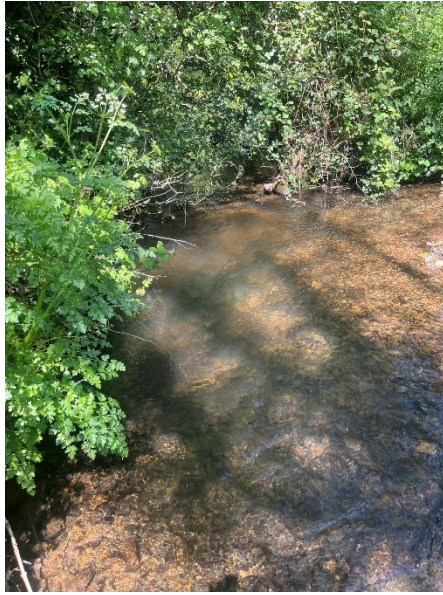
concrete block weir for ford	two step mixed	remove	two step weir holding ford. Deep plunge pool but no depth US, clear span footbridge

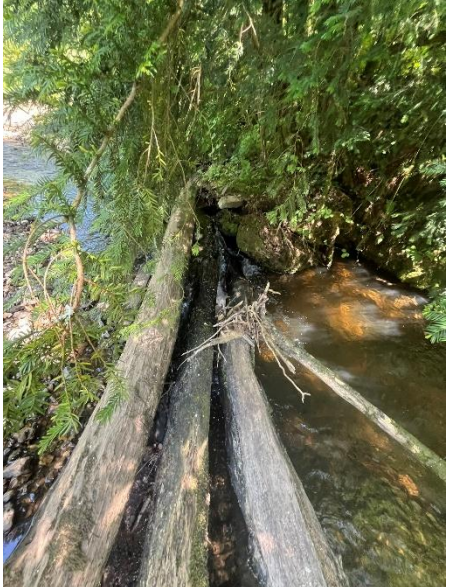
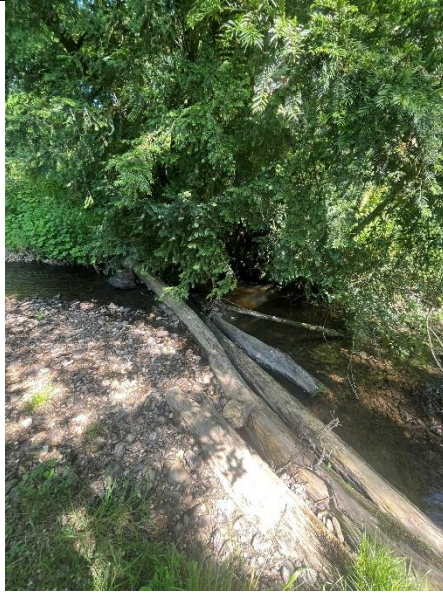
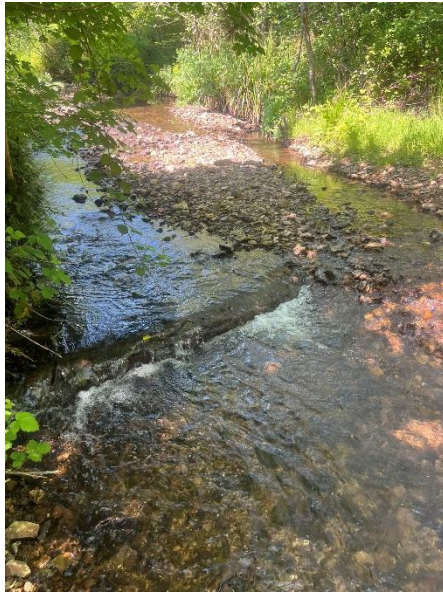
Barrier ID	Waterbody	NGR	Date Visited	Photo	Type of Obstruction	Flows	Possible Action	Notes
MS29 – Plyford Ford	River Sid	SY 14218 94510	14.05.25

ford held back with large wood	Non-adherent		good pool depth DS, three large trunks holding back ford, water flowing through and over wood

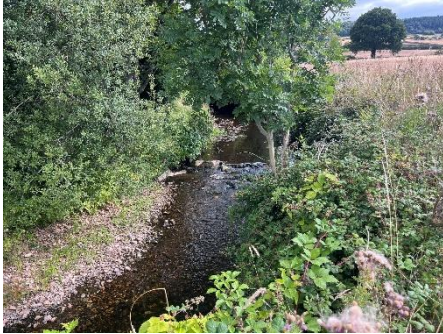
Barrier ID	Waterbody	NGR	Date Visited	Photo	Type of Obstruction	Flows	Possible Action	Notes
MS30	River Sid	SY 13748 90082	01/08/20 25

boulder check weir	Adherent	remove	low boulder check weir, no issue in higher flows, routes of passage through
MS31	River Sid	SY 13767 90123	01/08/20 25

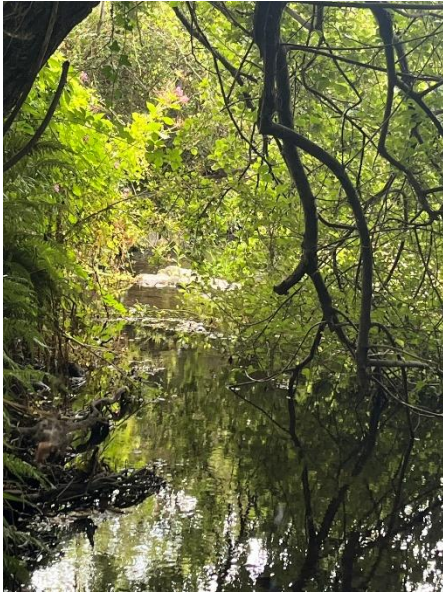
Boulder check weir		remove	boulder weir, couldn't properly see. See notes on map

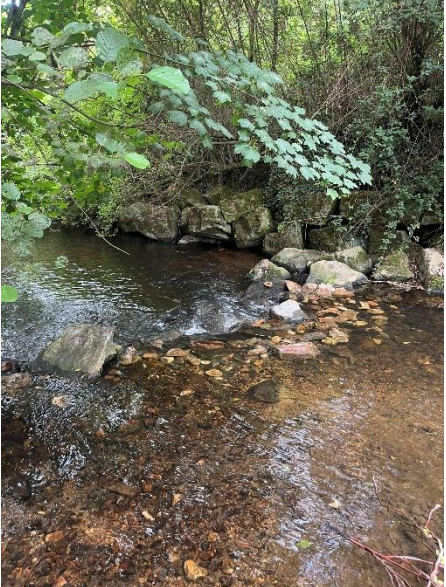
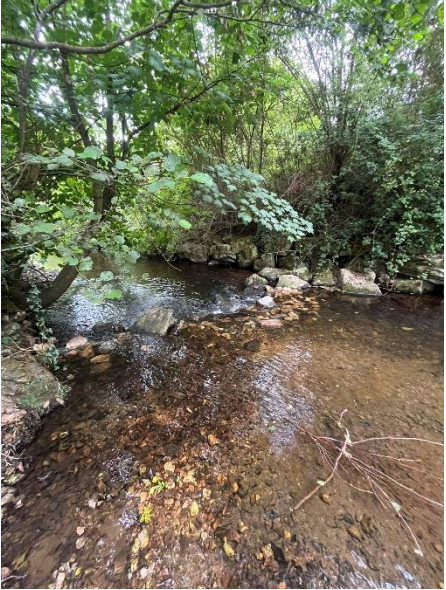
MS32	River Sid	SY 13739 90590	01/08/20 25

Boulder check weir	mixed	remove	boulder check weir approx. 5-10m DS of ford, impounding nice gravels
------	-----------	----------------------	----------------	--	-----------------------	-------	--------	---

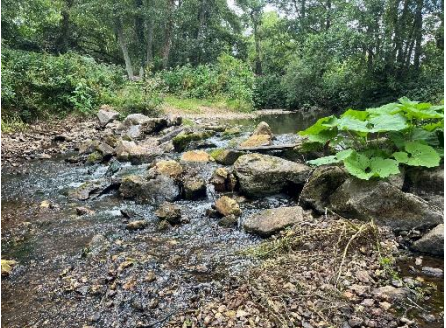
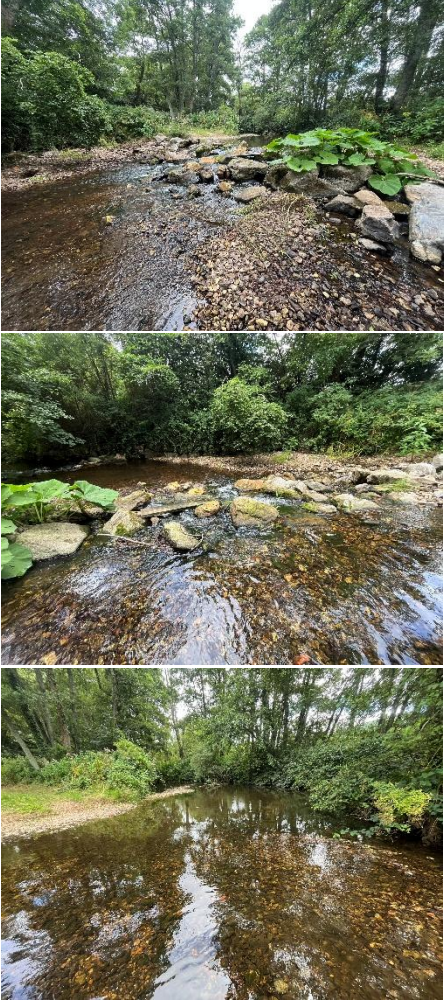
MS33	River Sid	SY 13739 90570	01/08/20 25

boulder weir for ford	mixed		boulder weir 0.5-1m head for ford crossing, no resting places, impounding nice gravels, lots of algae

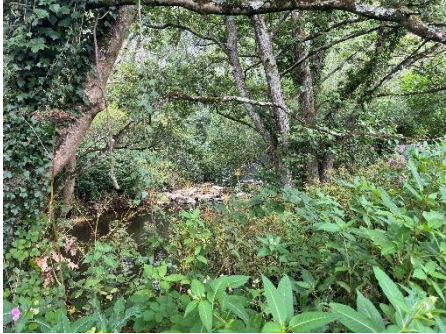
Barrier ID	Waterbody	NGR	Date Visited	Photo	Type of Obstruction	Flows	Possible Action	Notes
MS34 – Sidford Mill Weir	River Sid	SY 13732 90780	01/08/2025

large weir	Non-adherent		similar to school weir in size and look, no decent access at time of survey for RB or LB
MS35	River Sid	SY 14057 91817	01/08/2025

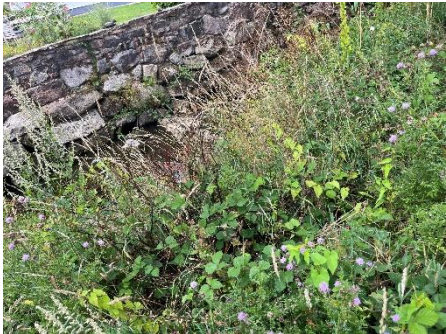
boulder check weir		remove	three to four boulders across stream, RB reveted

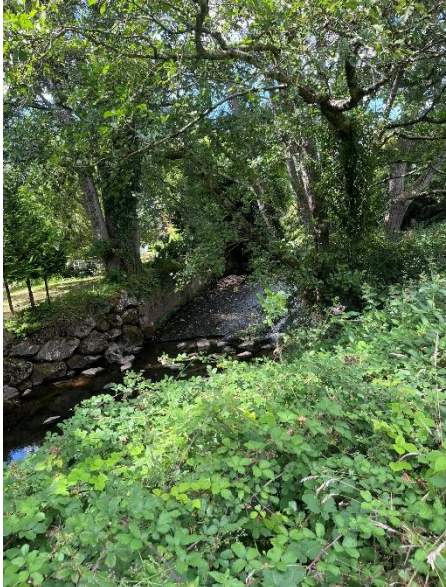
Barrier ID	Waterbody	NGR	Date Visited	Photo	Type of Obstruction	Flows	Possible Action	Notes
MS36 – Sidbury Mill Weir	River Sid	SY 14075 91733	01/08/20 25

concrete sloping weir	Adherent		2m head concrete sloping weir, very shallow flow over face. Feeds leat for Sidbury Mill

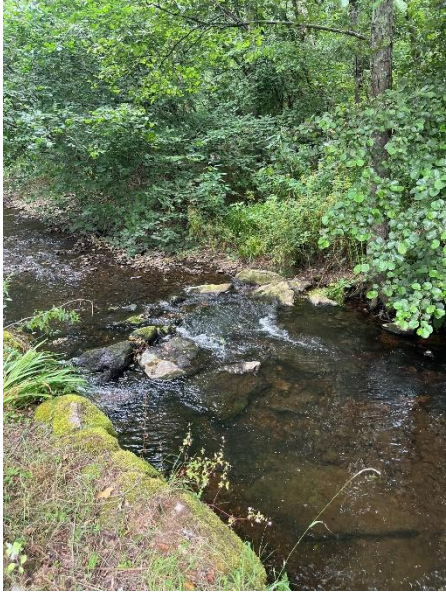
Barrier ID	Waterbody	NGR	Date Visited	Photo	Type of Obstruction	Flows	Possible Action	Notes
MS37	River Sid	SY 13844 91278	01/08/20 25

boulder check weir	Adherent	move boulders	passable boulder check weir, movement of boulders for better habitat heterogeneity

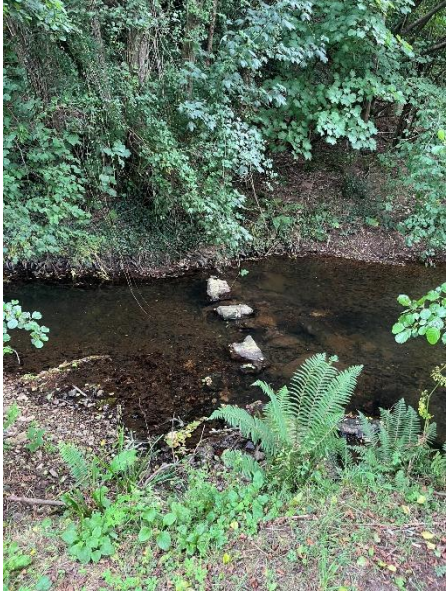
Barrier ID	Waterbody	NGR	Date Visited	Photo	Type of Obstruction	Flows	Possible Action	Notes
MS38	River Sid	SY 13807 91306	01/08/20 25

Boulder check weir	Adherent	move boulders	passable boulder check weir, movement of boulders for better habitat heterogeneity
