# Appendix 5: Salmonid Habitat Walkover Maps – Snod Brook

## Appendix 6: Habitat walkover Photos – Snod Brook

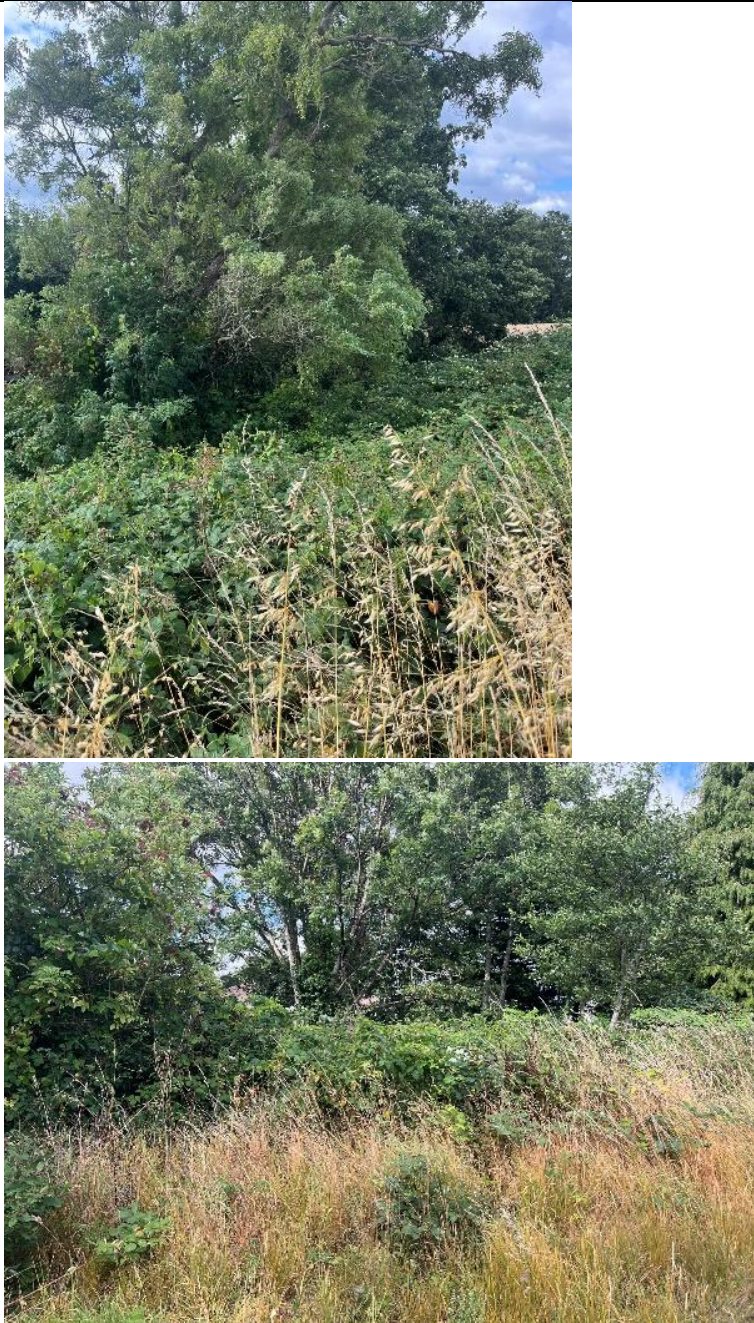
Description	Photograph
<p data-bbox="204 309 432 427">Snod Brook – SY 13850 90074, SY 13762 89987</p> <p data-bbox="204 483 576 645">Example of sections of the Snod Brook where overgrown banks resulted in unseen sections of river.</p>

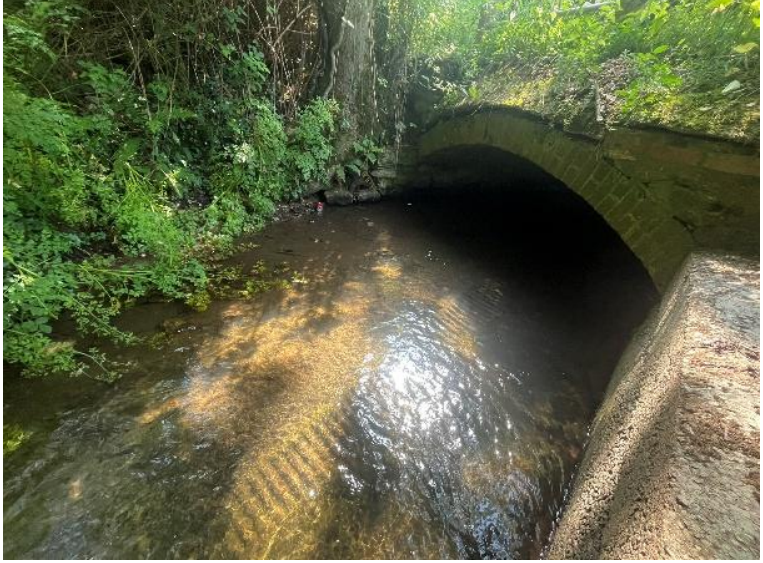
Description	Photograph
<p>Snod Brook – SY 14089 90061</p> <p>Road bridge across the Snod Brook at Harcombe Lane East. Bridge not an issue for fish passage, however if sediment accumulated this could limit passage opportunity.</p>

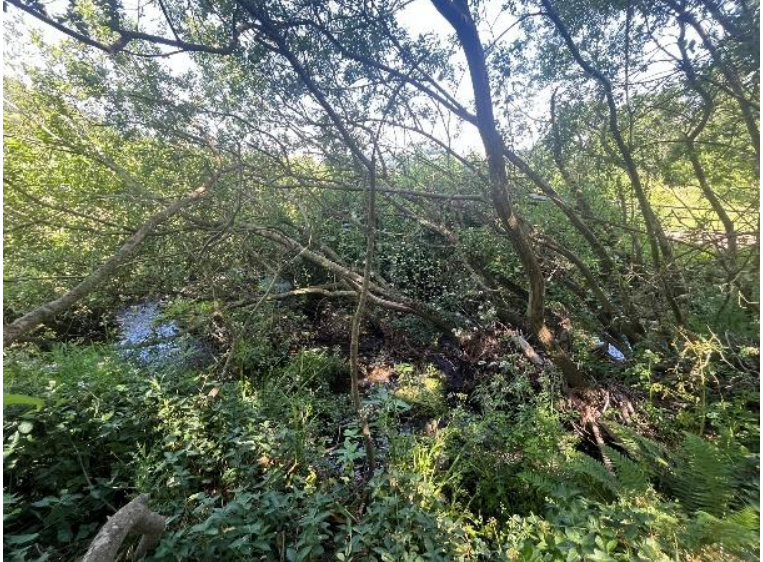
<p>Snod Brook – SY 15072 90128</p> <p>Section of Snod Brook with island and coarse wood in channel providing good habitat heterogeneity.</p>

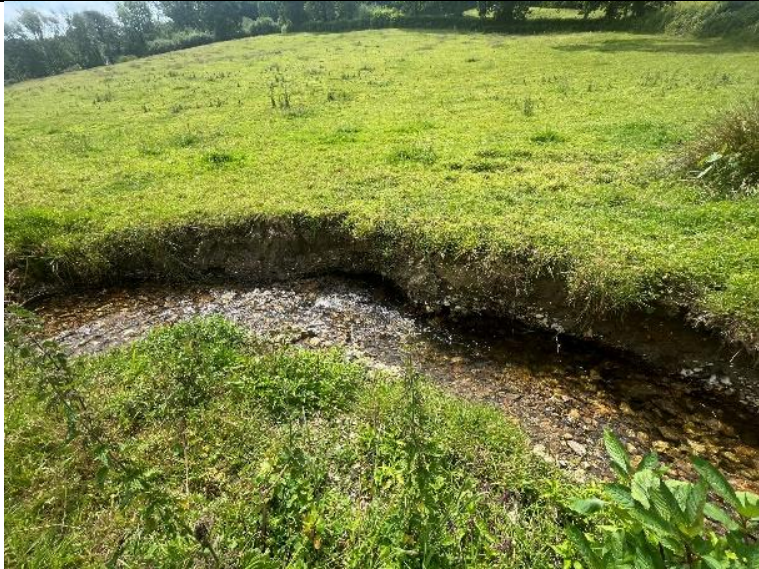
Description	Photograph
<p>Snod Brook – SY 15491 90392</p> <p>Incised eroding banks on the Snod Brook</p>	 
<p>Snod Brook – SY 15558 90393</p> <p>Eroding bank with no riparian buffer or tree cover on both banks of the Snod Brook. Gravel coble layer visible in true left bank. Section would benefit from wide fenced riparian buffer as well as selective tree planting to minimise temperature increase in low summer flows.</p>

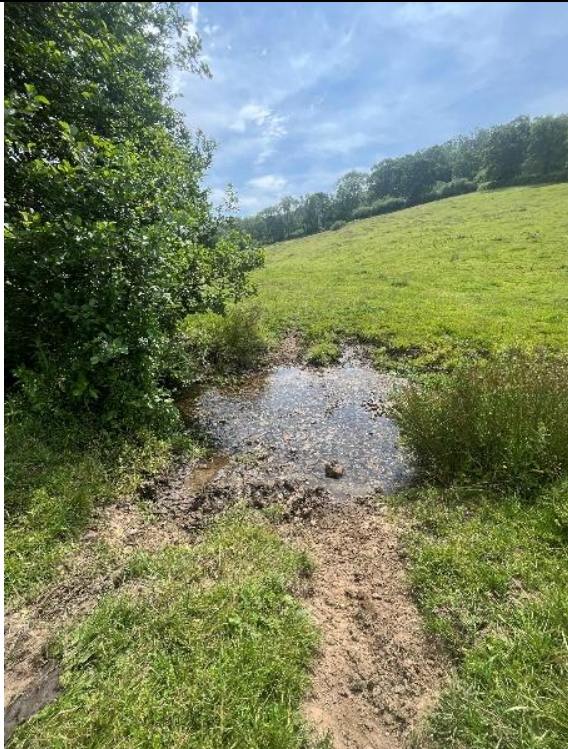
Description	Photograph
<p data-bbox="204 241 427 315">Snod Brook – SY 15566 90404</p> <p data-bbox="204 371 592 495">Poaching on both banks due to animal access across the Snod Brook.</p>

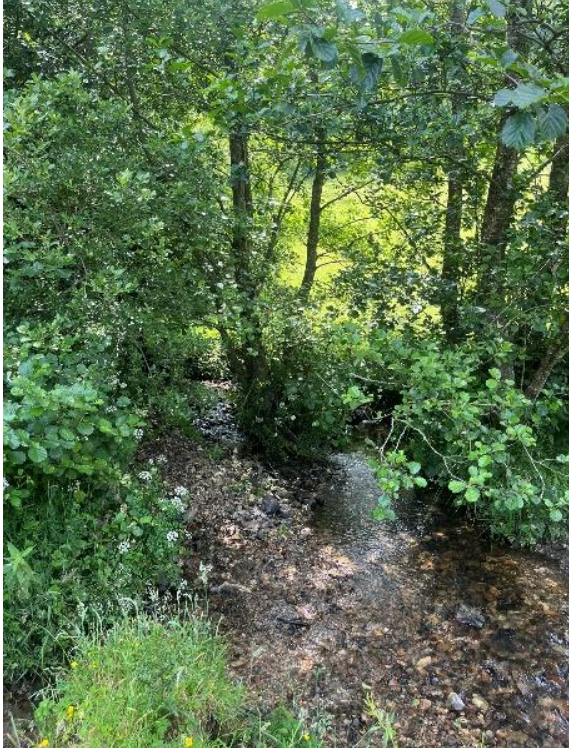
Description	Photograph
<p>Snod Brook – SY 15719 90385</p> <p>Shaded section of the Snod Brook with mixture of fry and parr habitats. Although shaded, it is not recommended to coppice this section as much of the reach downstream of this point is open with no tree cover, therefore limited resilience to warming river temperature in summer.</p>

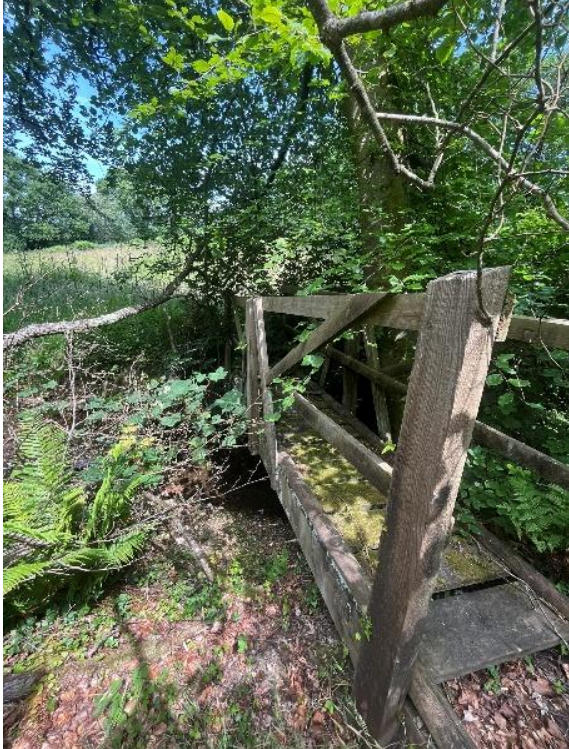
<p>Snod Brook – SY 15794 90358</p> <p>Old wooden bridge across Snod Brook, in disrepair. Not currently an issue, but if unchecked and deteriorating further, could cause fish passage issues if it collapses and blocks the brook.</p>

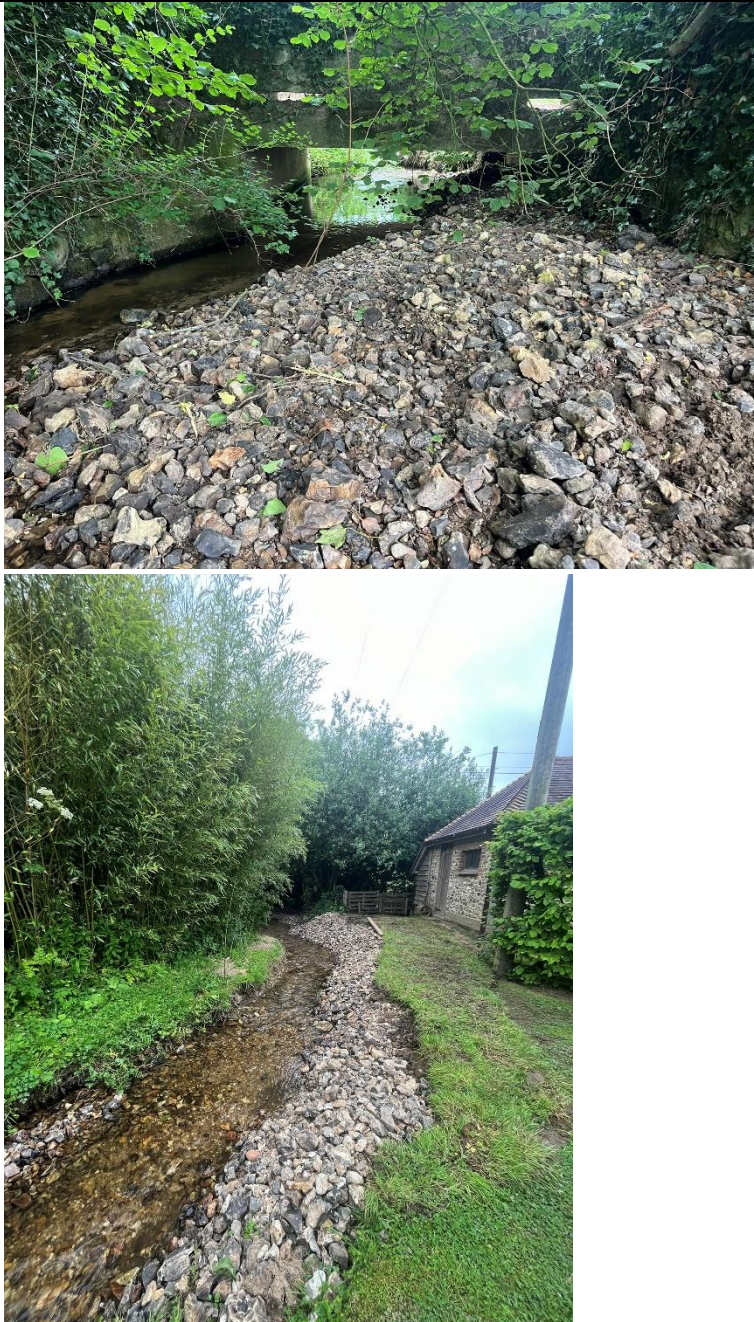
Description	Photograph
<p data-bbox="204 239 424 315">Snod Brook – SY 15440 90473</p> <p data-bbox="204 371 596 797">Good section of juvenile habitat, however minimal shade cover. Accumulation of substrate may cause an issue for fish passage and bridge if unchecked. New Fry Index Survey site carried out at this location, resulting in fair classification for trout fry.</p>

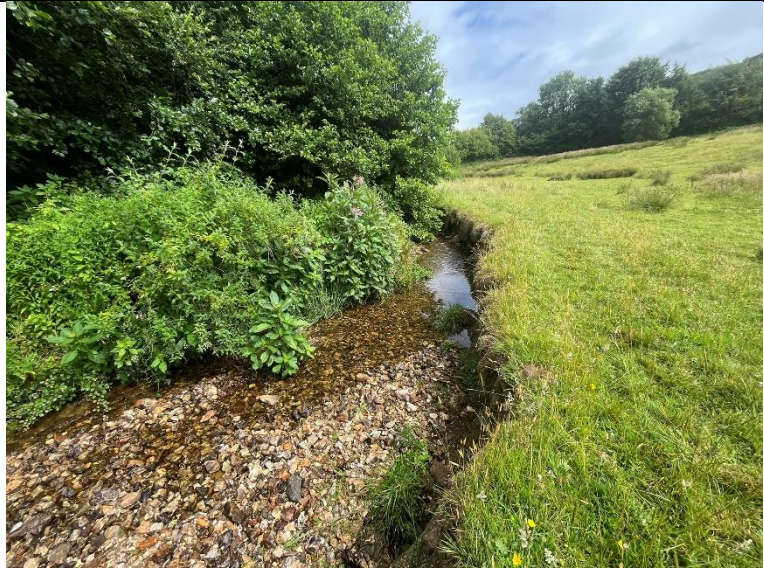
Snod Brook -  
SY 15313 90805

Favourable gravel cobble mix providing good conditions for spawning. Both banks are incised and eroding, and there is no riparian buffer on true left bank resulting in animal access to Snod Brook.

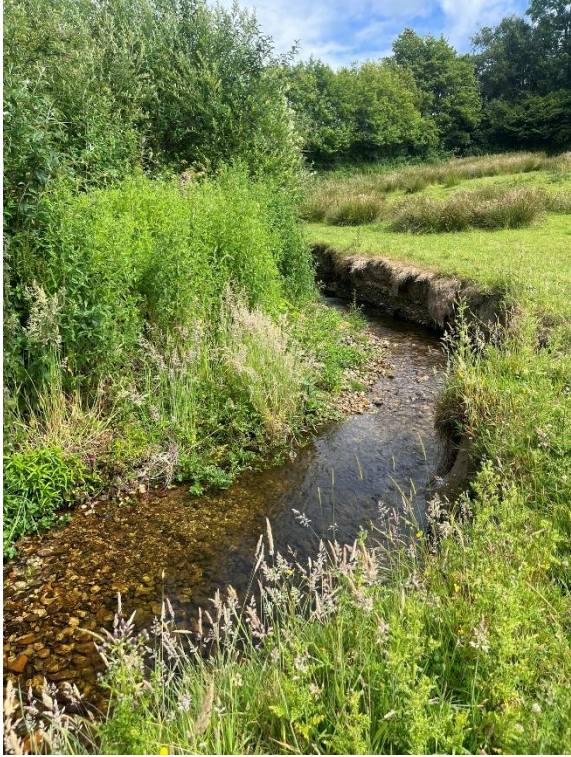
<p>Snod Brook – SY 15533 91547</p> <p>Bank eroding and undercutting on Snod Brook, with tree roots exposed.</p>
