Barrier photos for **Snod Brook SN1 – SN11**

Extracted from Appendix 16

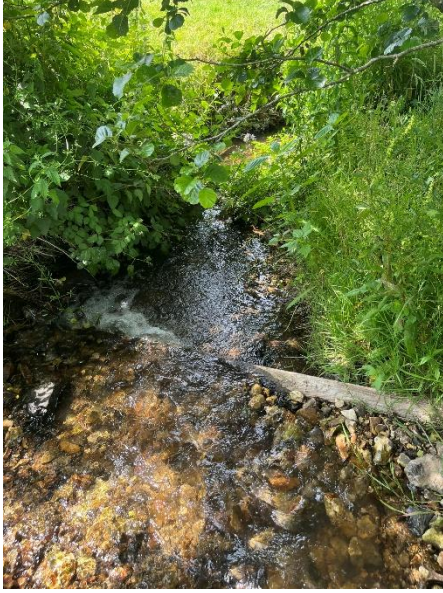
Barrier ID	Waterbody	NGR	Date Visited	Photo	Type of Obstruction	Flows	Possible Action	Notes
SN1	Snod Brook	SY 15668 90391	20.06.25

Fence post/Log jam	non-adherent	remove/notch	post/log across river, minor barrier and likely passable. Pool DS, gravels being held behind US

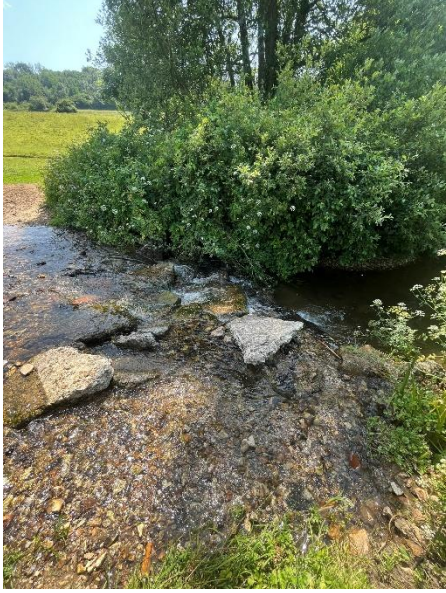
Barrier ID	Waterbody	NGR	Date Visited	Photo	Type of Obstruction	Flows	Possible Action	Notes
SN2	Snod Brook	SY 15080 90139	20.06.25

Boulder reinforced ford	mixed flows	pre-barrage	mix of flows, no resting areas across the structure and shallow flows. Deep pool DS, multiple potential routes

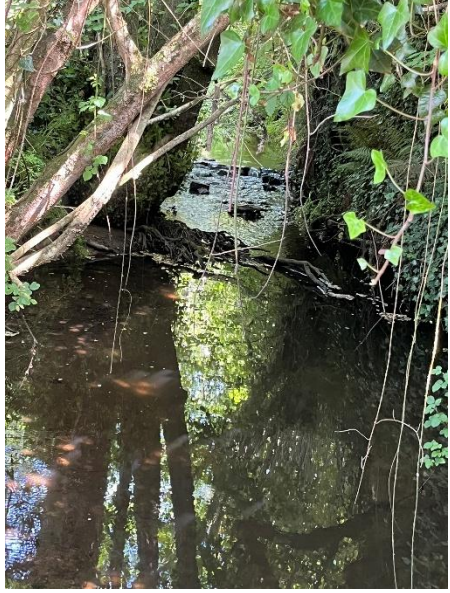
Barrier ID	Waterbody	NGR	Date Visited	Photo	Type of Obstruction	Flows	Possible Action	Notes
SN3	Snod Brook	SY 14501 90015	20.06.25

check weir	mixed flows	remove/notch	small boulder cheek weir. No issue in high flows, potential easy win

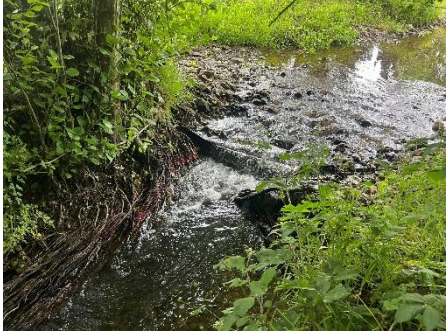
Barrier ID	Waterbody	NGR	Date Visited	Photo	Type of Obstruction	Flows	Possible Action	Notes
SN6	Snod Brook	SY 15389 90593	24.06.25

log jam	non-adherent	remove/notch	log/post across river, minimal barrier, notch or remove

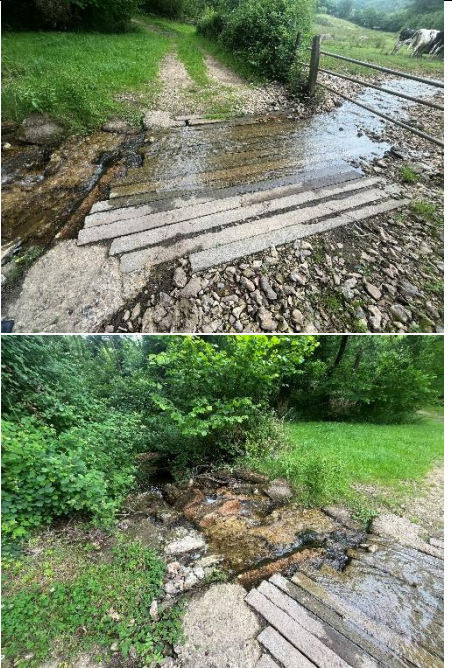
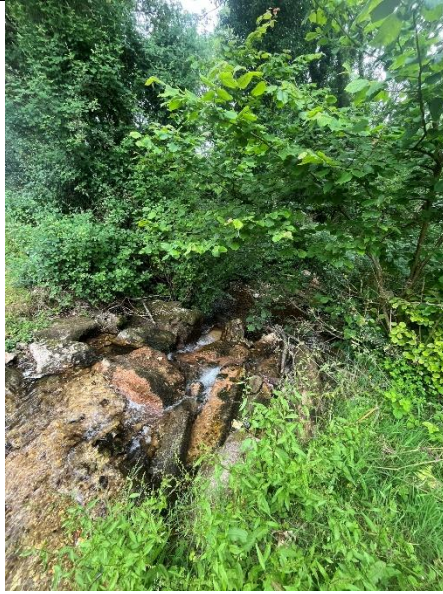
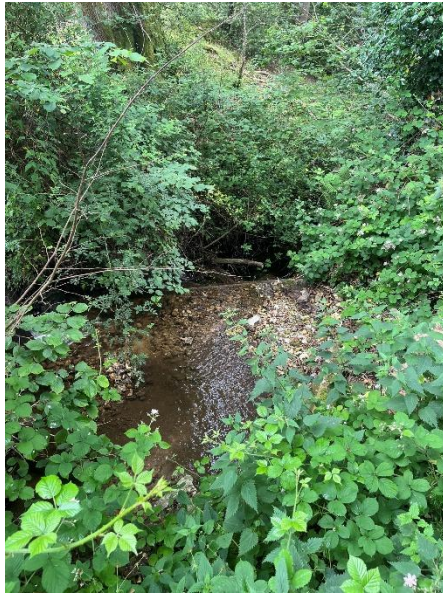
<p>SN7</p>	<p>Snod Brook</p>	<p>SY 15607 91573</p>	<p>24.06.25</p>	 	<p>ford and step weir</p>	<p>mixed flows</p>	<p>Clear span bridge</p>	<p>3 step pool weirs up to ford crossing. Rubble throughout structure making the ford likely impassable.</p>
------------	-------------------	-------------------------------	-----------------	---	-------------------------------	------------------------	------------------------------	--

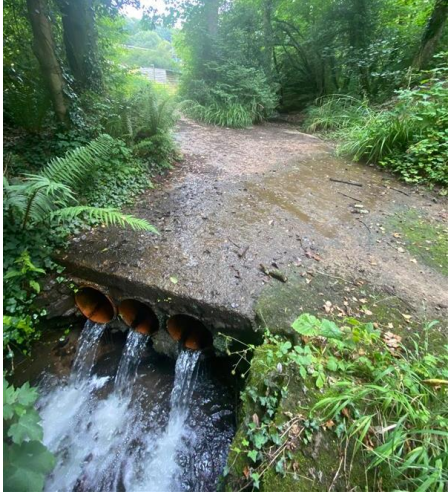
Barrier ID	Waterbody	NGR	Date Visited	Photo	Type of Obstruction	Flows	Possible Action	Notes
SN8	Snod Brook	SY 16108 90284

pipe culvert ford and concrete debris	non-adherent		converted ford crossing that has been concreted over with 3 pipe culverts (5-6m long) that flow into raised plunge pool created by large bits of concrete debris. Drop from pipes into pools non adherant, approx 20cm drop. North bank very incised and undercutting due to debris altering flows.

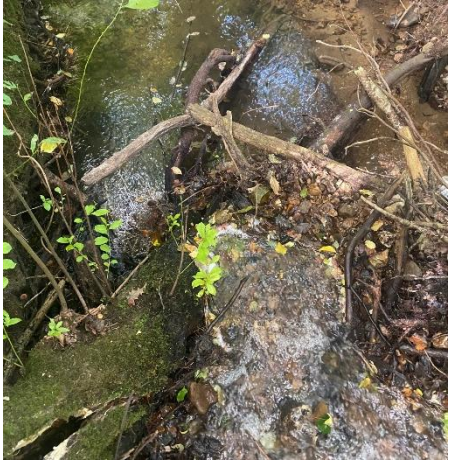
Barrier ID	Waterbody	NGR	Date Visited	Photo	Type of Obstruction	Flows	Possible Action	Notes
SN9	Snod Brook	SY 16070 91844

woody dam	mixed	notch/remove	woody dam that has filled with organic debris creating impassable lip

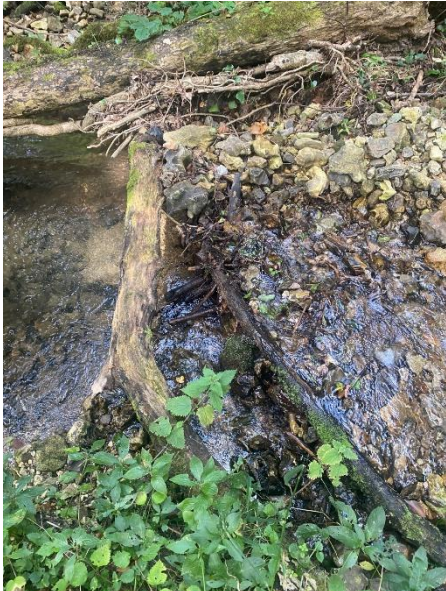
Barrier ID	Waterbody	NGR	Date Visited	Photo	Type of Obstruction	Flows	Possible Action	Notes
SN10	Snod Brook	SY 16247 92251

woody dam	non-adherent	notch/remove	woody dam filled with organic debris, creating impassable lip that drops into small pool
