Westcountry Rivers Trust – Opening the Sid Catchment Assessment – River Sid - 2025

Barrier photos for **Woolbrook** WB1 – Wb31

Extracted from Appendix 16

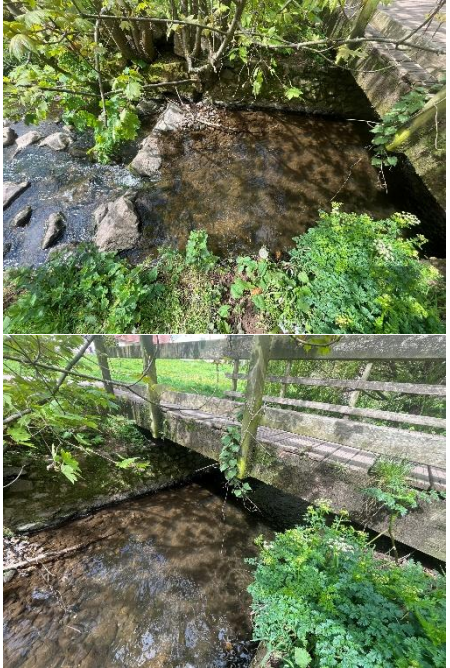
Barrier ID	Waterbody	NGR	Date Visited	Photo	Type of Obstruction	Flows	Possible Action	Notes
WB1	Woolbrook	SY 12976 88628	09.10.25

Boulder weir with broken concrete sill	adherent		three large boulders with gap in-between, possibly passable. Concrete and revetment under footbridge

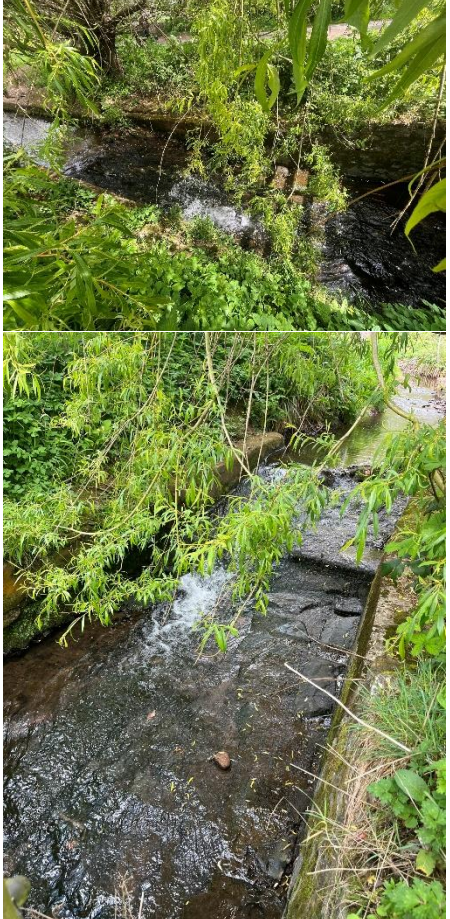
Barrier ID	Waterbody	NGR	Date Visited	Photo	Type of Obstruction	Flows	Possible Action	Notes
WB2	Woolbrook	SY 12971 88638	09.10.25

concrete chute	adherent		boulder concrete chute extending under footbridge and US. Lip with non-adherent flows

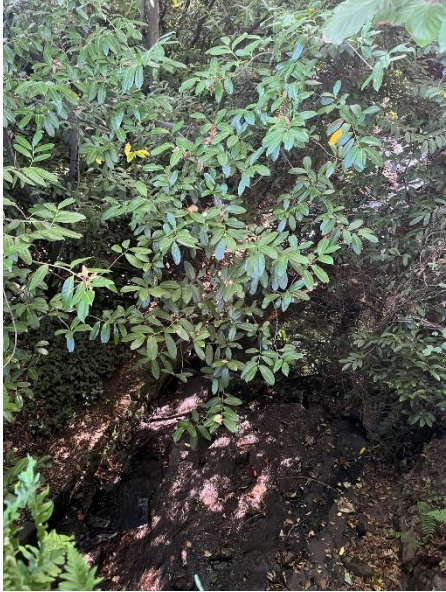
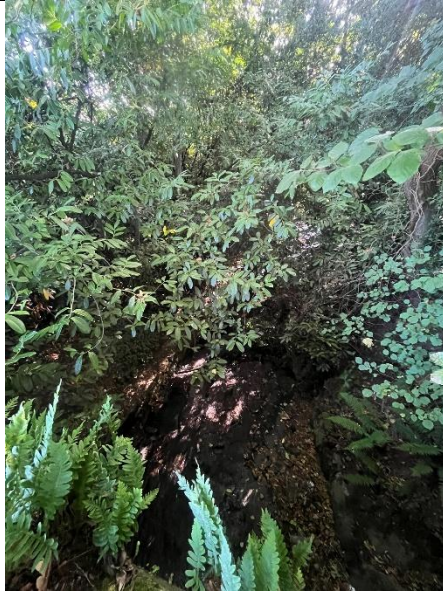
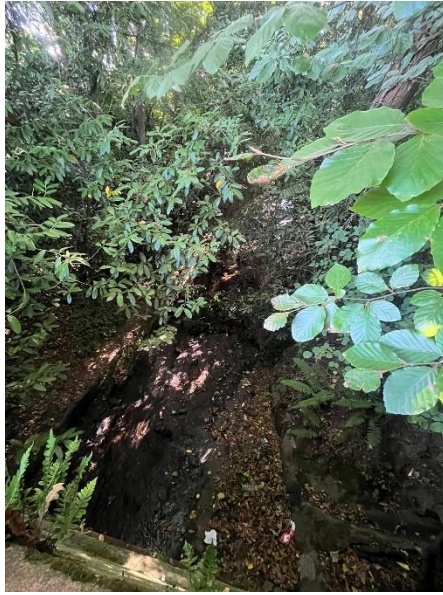
Barrier ID	Waterbody	NGR	Date Visited	Photo	Type of Obstruction	Flows	Possible Action	Notes
WB3	Woolbrook	SY 12736 88862	09.10.25

Bridge footing/apron	adherent	pre-barrage and baffle	extensive bridge footing, apron with sloping weir at foot on DS. Concrete extends under road bridge.

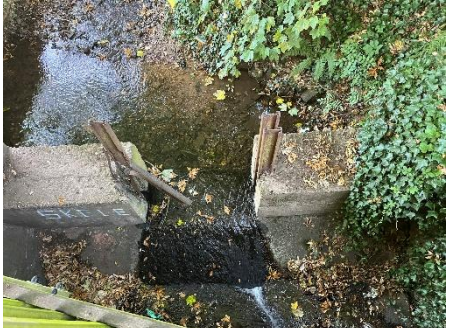
WB4	Woolbrook	SY 12732 88877	09.10.25

sloping weir/slucice at top of bridge apron	adherent		steep slope on weir, directly US of bridge apron. Slucice gate not active

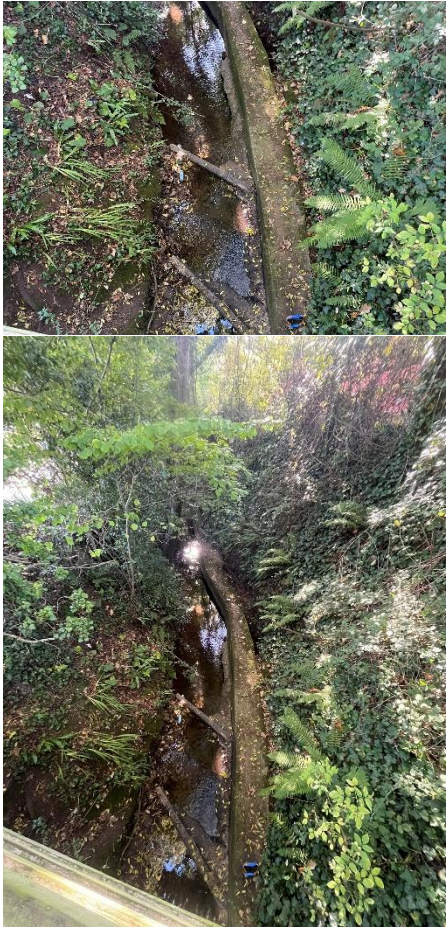
Barrier ID	Waterbody	NGR	Date Visited	Photo	Type of Obstruction	Flows	Possible Action	Notes
WB5	Woolbrook	SY 12580 89015	09.10.25

series of stepped weirs	going through structure		four step weirs with pools under footbridge. Revetted right bank eroding behind. Flow going through concrete structures rather than over lip

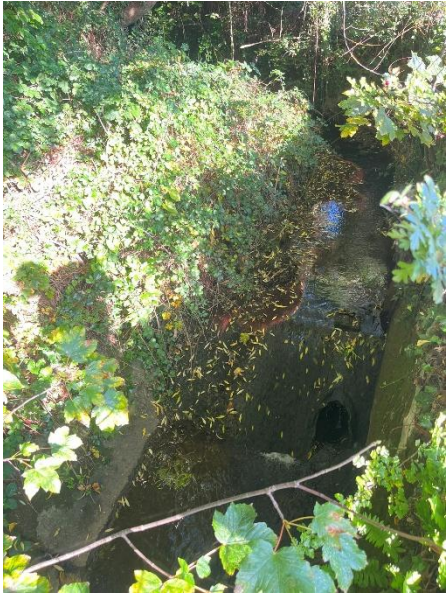
Barrier ID	Waterbody	NGR	Date Visited	Photo	Type of Obstruction	Flows	Possible Action	Notes
WB6	Woolbrook	SY 12586 89031	09.10.25

sloped weir with concrete extending US	adherent		steep sloping weir with concrete extending US 5-10m
WB7	Woolbrook	SY 12388 89097	09.10.25

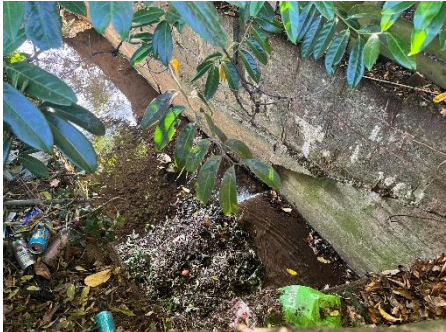
weir at toe of bridge apron	non-adherent, adherent at apron		30cm weir toe on apron of bridge. Concrete apron extends under bridge

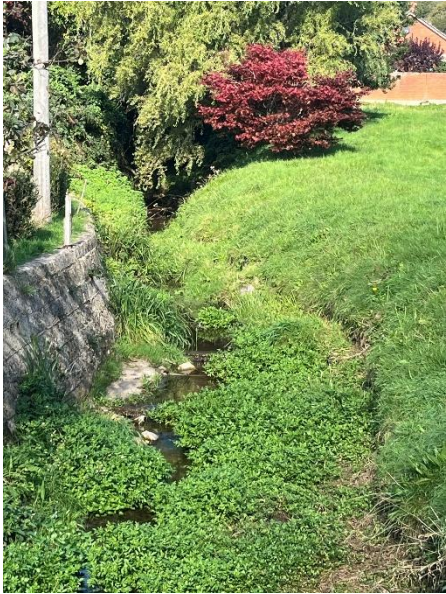
Barrier ID	Waterbody	NGR	Date Visited	Photo	Type of Obstruction	Flows	Possible Action	Notes
WB9	Woolbrook	SY 12378 89101	09.10.25

check weir	adherent	remove	check weir, approx. 20cm drop, no pool depth
WB10	Woolbrook	SY 12172 89155	09.10.25					unable to see properly. Approx 15m DS of WB11, think it is concrete construction with approx. 1m head

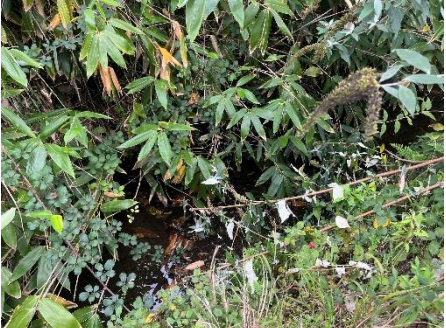
WB12	Woolbrook	SY 12156 89158	09.10.25

concrete slope	adherent		shallow sloping concrete weir

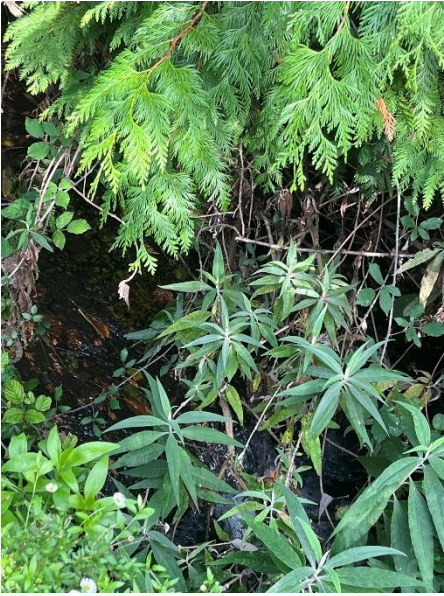
Barrier ID	Waterbody	NGR	Date Visited	Photo	Type of Obstruction	Flows	Possible Action	Notes
WB13	Woolbrook	SY 12164 89146	09.10.25

concrete slope	non-adherent		shallow sloping concrete weir with lip, approx. 40cm head
WB14	Woolbrook	SY12150 89171	09.10.25

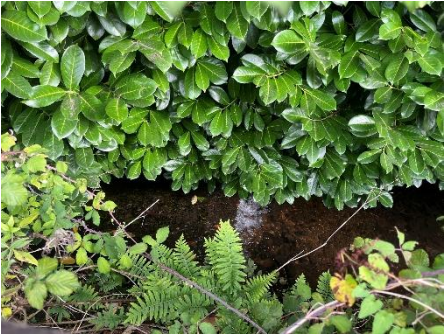
concrete weir	non-adherent		approx. 30cm head, non-adherent flows and concrete extends US 1m

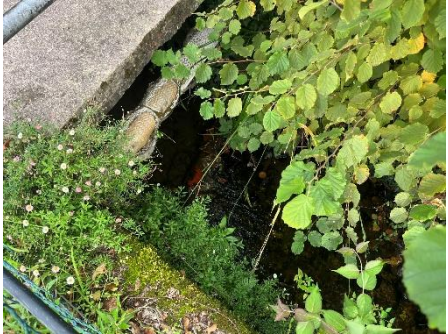
Barrier ID	Waterbody	NGR	Date Visited	Photo	Type of Obstruction	Flows	Possible Action	Notes
WB15	Woolbrook	SY 12112 89207	09.10.25

pipe	non-adherent		pipe on riverbed causing non-adherent flows (no issue in higher flows), resulting in impoundment US

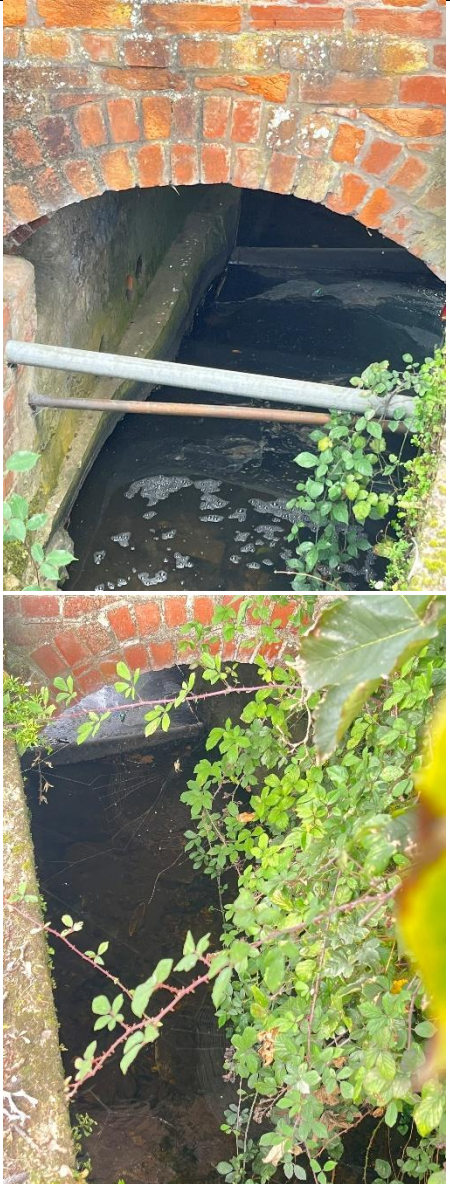
<p>WB16</p>	<p>Woolbrook</p>	<p>SY 12095 89218</p>	<p>09.10.25</p>

<p>pipe</p>	<p>flow under pipe</p>	<p>pipe on riverbed causing impoundment and stagnant water</p>
-------------	------------------	-------------------------------	-----------------	---	-------------	----------------------------	--

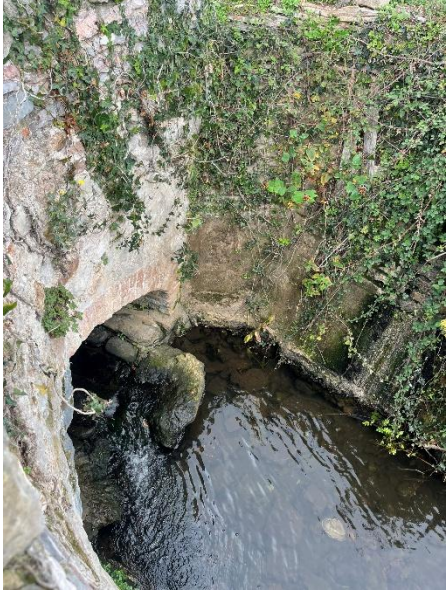
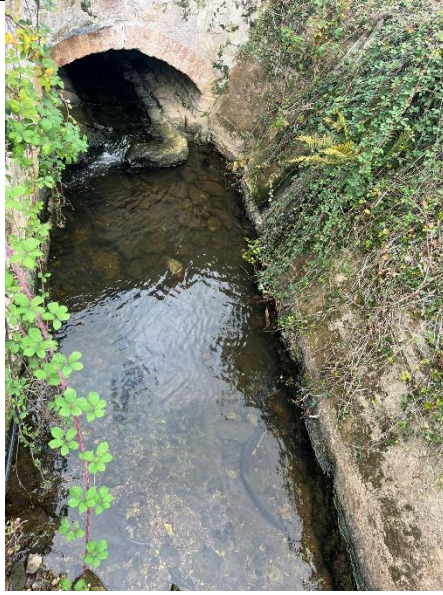
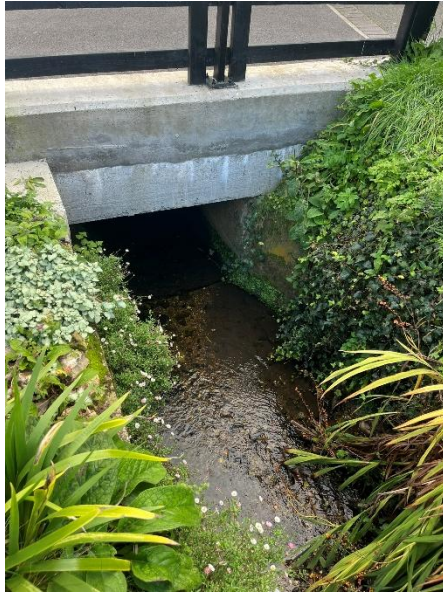
Barrier ID	Waterbody	NGR	Date Visited	Photo	Type of Obstruction	Flows	Possible Action	Notes
WB17	Woolbrook	SY 12075 89237	09.10.25

culvert (perched lip)	adherent		<p>toe of road culvert, old stone construction. Eroding and perched, but erosion has made adherent flow. Concrete lip on culvert at US end (SY 12198 )</p>

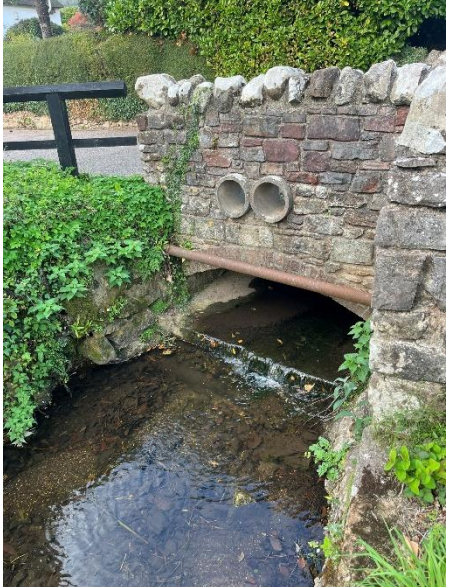
Barrier ID	Waterbody	NGR	Date Visited	Photo	Type of Obstruction	Flows	Possible Action	Notes
WB18	Woolbrook	SY 12003 89265	09.10.25

bridge apron	non-adherent		concrete lip approx. 30cm, thin adherent flow over concrete apron

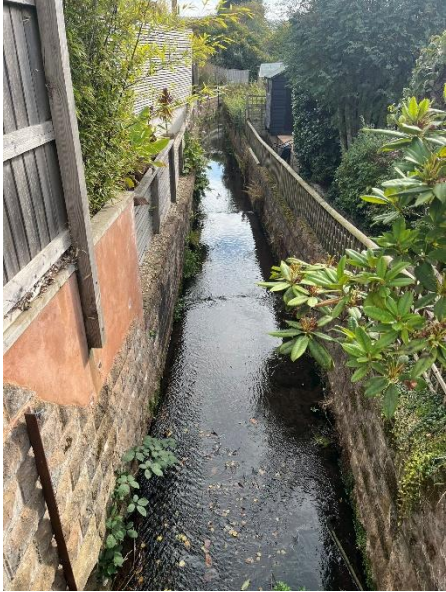
Barrier ID	Waterbody	NGR	Date Visited	Photo	Type of Obstruction	Flows	Possible Action	Notes
WB19	Woolbrook	SY 11795 89351	09.10.25

4 check weirs DS of bridge	non-adherent		low flow throughout each check weir. Approx 30cm head on each check weir (from view of road bridge). Very homogenous habitat, concrete bed throughout

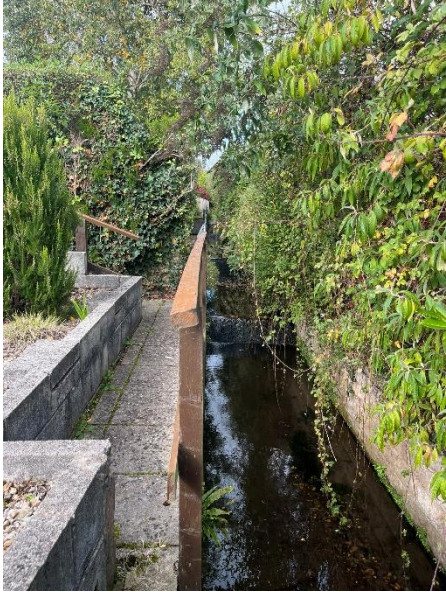
Barrier ID	Waterbody	NGR	Date Visited	Photo	Type of Obstruction	Flows	Possible Action	Notes
WB20	Woolbrook	SY 11787 89358	09.10.25

6 check weirs Us of bridge	adherent		similar to DS. Closest check weir to bridge 1m head, next two upstream approx. 0.5m head. Homogenous habitat and concrete bed.

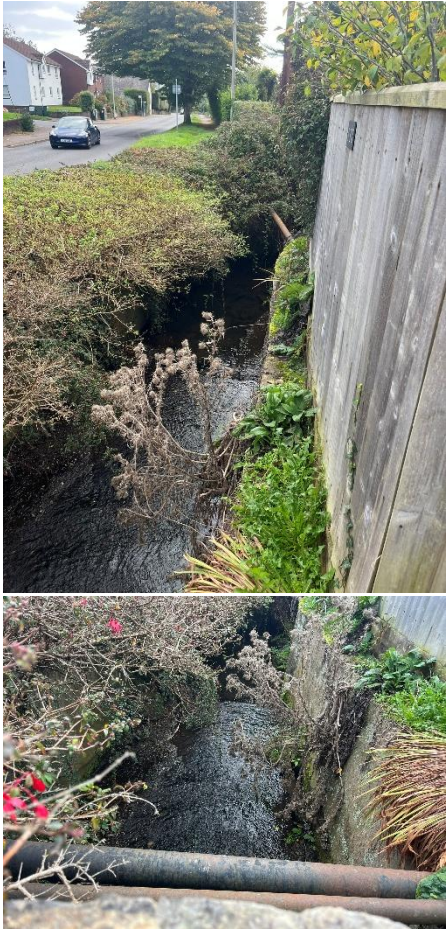
Barrier ID	Waterbody	NGR	Date Visited	Photo	Type of Obstruction	Flows	Possible Action	Notes
WB21	Woolbrook	SY 11696 89478	09.10.25

bridge apron and lip	non-adherent at lip, adherent on apron		concrete apron extends 2m Ds of bridge. Thin film of water, ends with approx. 30cm toe with non-adherent flow

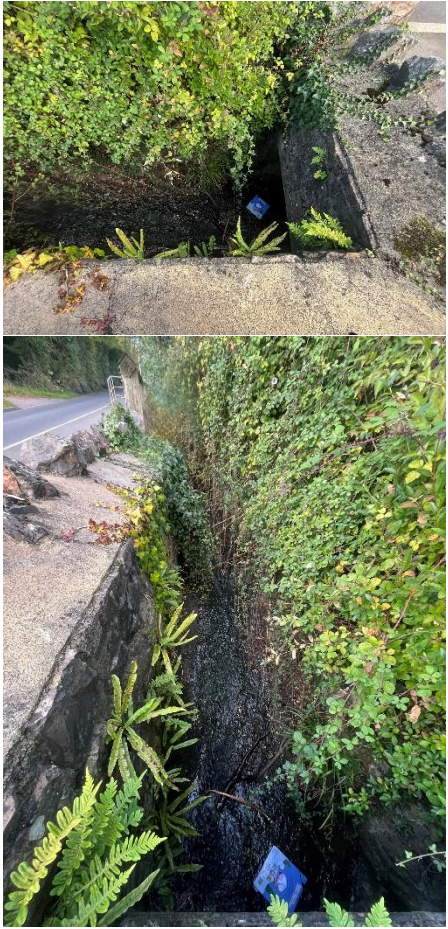
Barrier ID	Waterbody	NGR	Date Visited	Photo	Type of Obstruction	Flows	Possible Action	Notes
WB22	Woolbrook	SY 11664 89508	09.10.25

top of culvert, concrete slope	adherent		1.5m sloped concrete bed into culvert.

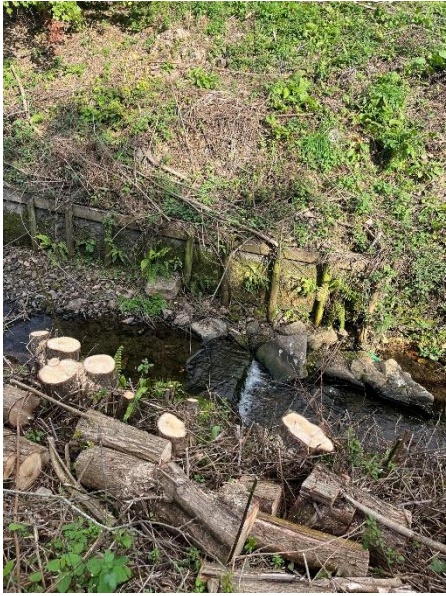
Barrier ID	Waterbody	NGR	Date Visited	Photo	Type of Obstruction	Flows	Possible Action	Notes
WB23	Woolbrook	SY 11598 89611	09.10.25

concrete and boulder	non-adherent		concrete boulder check weir
WB24	Woolbrook	SY 11566 89577	09.10.25

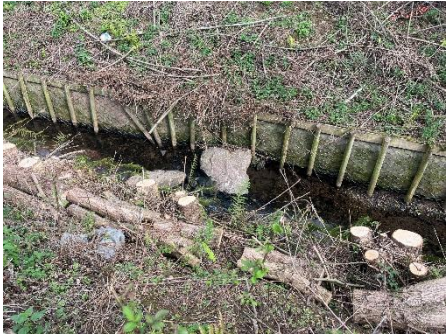
boulder weir	non-adherent		large boulder check weir in channel

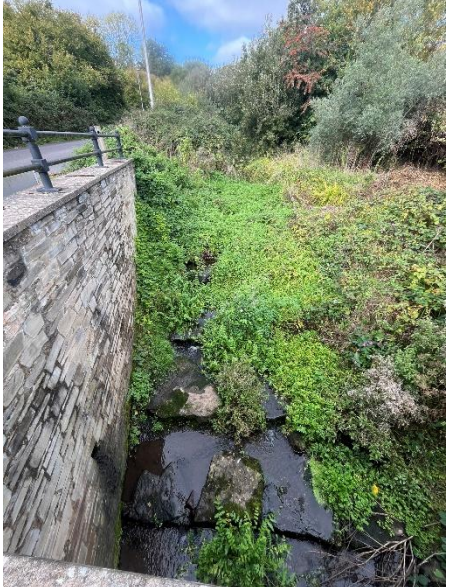
Barrier ID	Waterbody	NGR	Date Visited	Photo	Type of Obstruction	Flows	Possible Action	Notes
WB25	Woolbrook	SY 11535 89652	09.10.25

check weir	non-adherent		boulder check weir

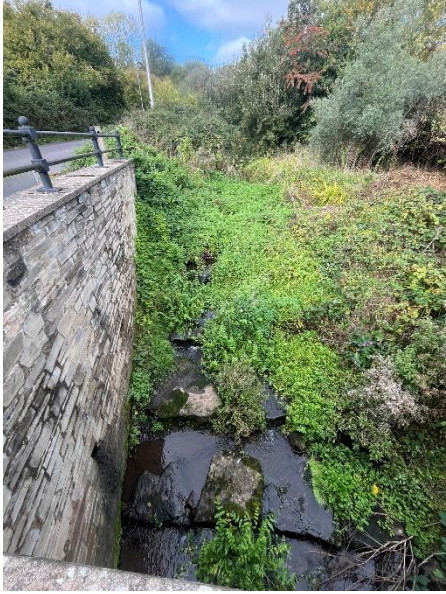
Barrier ID	Waterbody	NGR	Date Visited	Photo	Type of Obstruction	Flows	Possible Action	Notes
WB27	Woolbrook	SY 11535 89652	09.10.25

check weir	non-adherent		boulder check weir

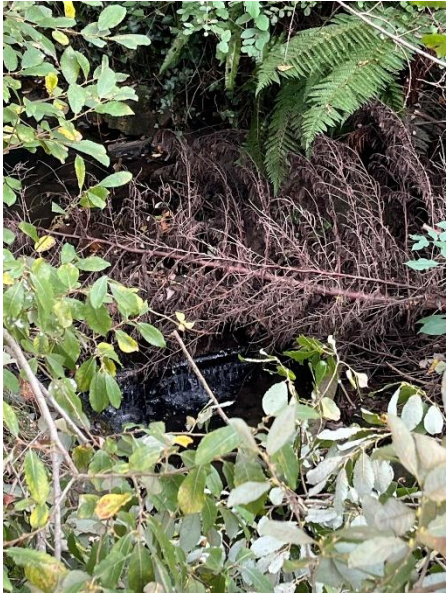
Barrier ID	Waterbody	NGR	Date Visited	Photo	Type of Obstruction	Flows	Possible Action	Notes
WB28	Woolbrook	SY 11465 89726	09.10.25

weir	non-adherent		deteriorating weir structure, difficult to see clearly

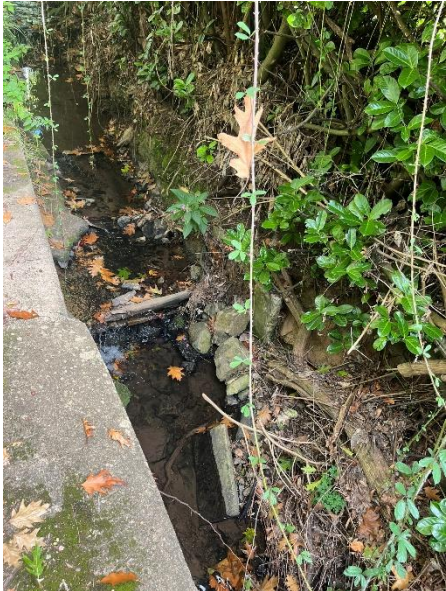
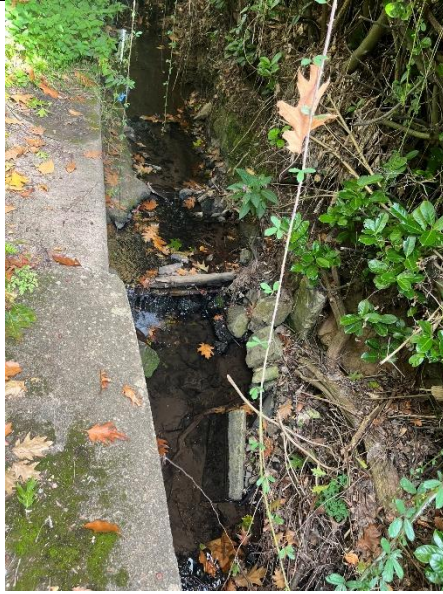
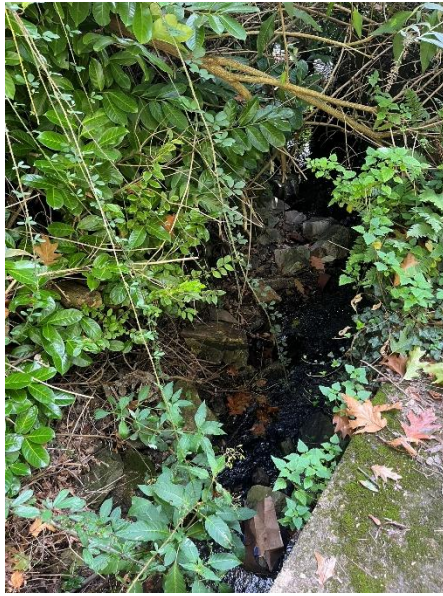
Barrier ID	Waterbody	NGR	Date Visited	Photo	Type of Obstruction	Flows	Possible Action	Notes
WB29	Woolbrook	SY 11465 89745	09.10.25

weir			<p>deteriorating boulder concrete check weir. Looks as if one DS has blown out and no longer a check weir</p>

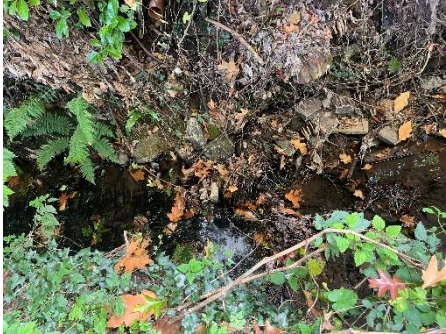
Barrier ID	Waterbody	NGR	Date Visited	Photo	Type of Obstruction	Flows	Possible Action	Notes
WB30	Woolbrook	SY 11462 89750	09.10.25

weir			deteriorating boulder concrete check weir.
