# Appendix 11: Salmonid Habitat Walkover Maps – Burscombe Brook

## Appendix 12: Habitat walkover Photos – Burscombe Brook

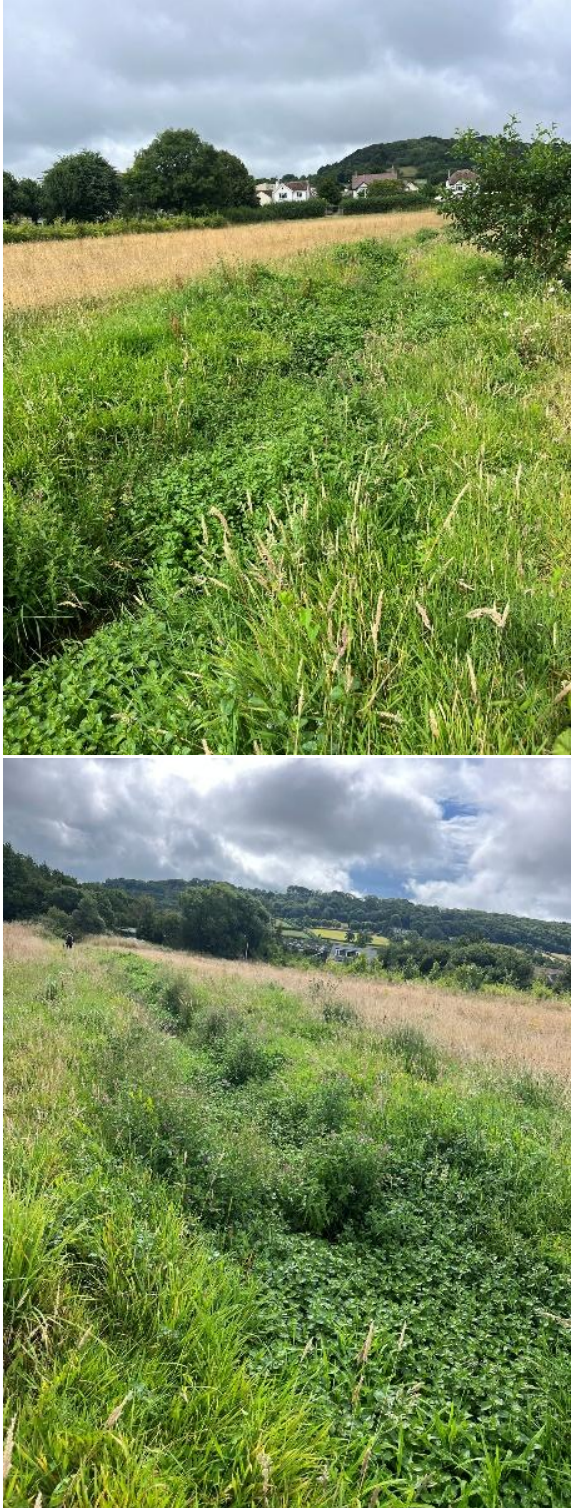
Description	Photograph
<p>Burscombe Brook – SY 13527 90242</p> <p>Lower section of Burscombe Brook below A375. Channel straightened and disconnected from floodplain, constrained by bunds. Reach heavily vegetated instream, bankside open with no tree cover. Reach would benefit from woody debris additions to reconnect floodplain and increase habitat heterogeneity. Tree planting would be beneficial to slow water flows and increase habitat resilience.</p>

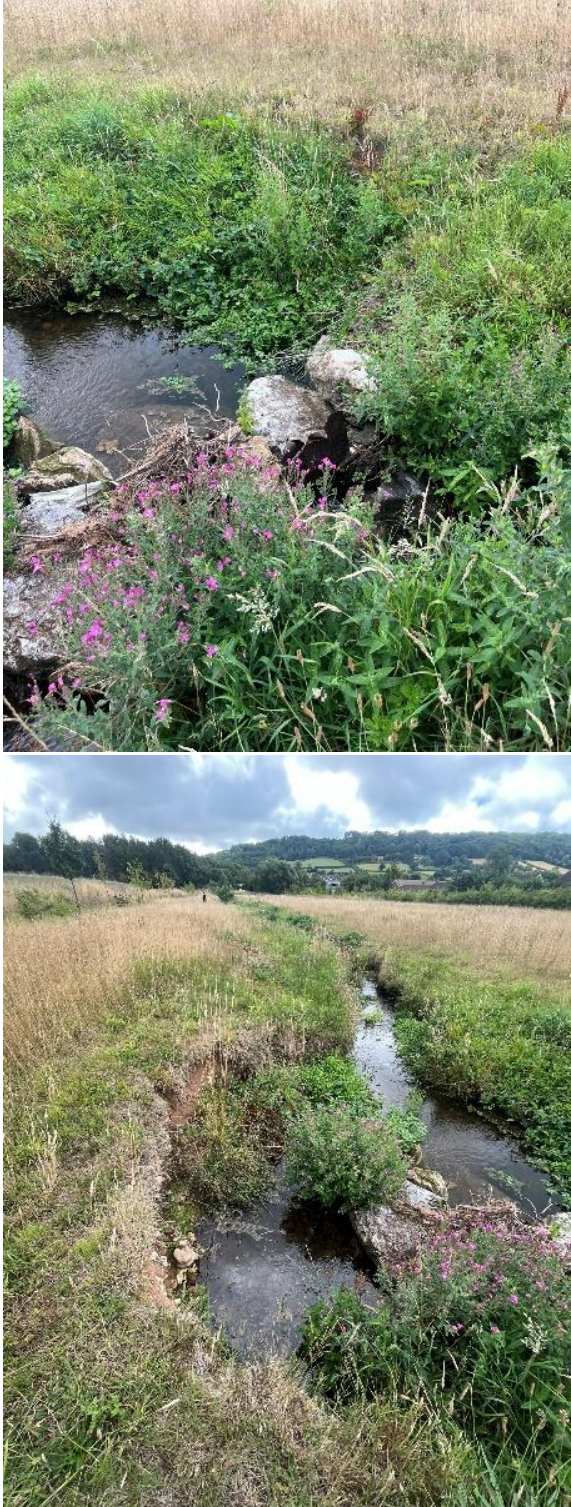
Description	Photograph
<p data-bbox="204 239 478 315">Burscombe Brook – SY 13473 90254</p> <p data-bbox="204 371 561 582">Boulder check weir within reach below A375. Brook has eroded on true left bank to create natural bypass channel.</p>

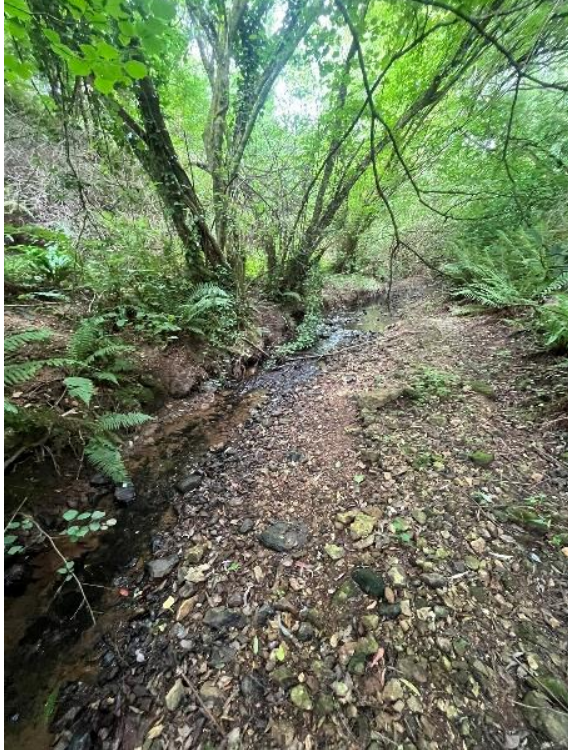
Description	Photograph
<p>Burscombe Brook – SY 12695 90682</p> <p>Full channel width shown in photo with narrow low flow channel down true right bank. Section shaded, banks appear prone to erosion in higher spate flows.</p>

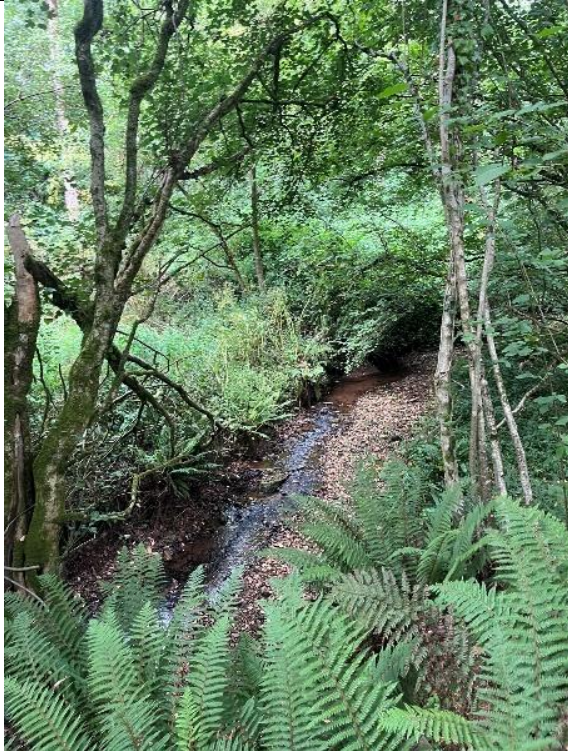
<p>Burscombe Brook – SY 12689 90697</p> <p>Shaded section of Burscombe Brook. Low water flows, but ample gravel cobble substrate mix for salmonid spawning.</p>

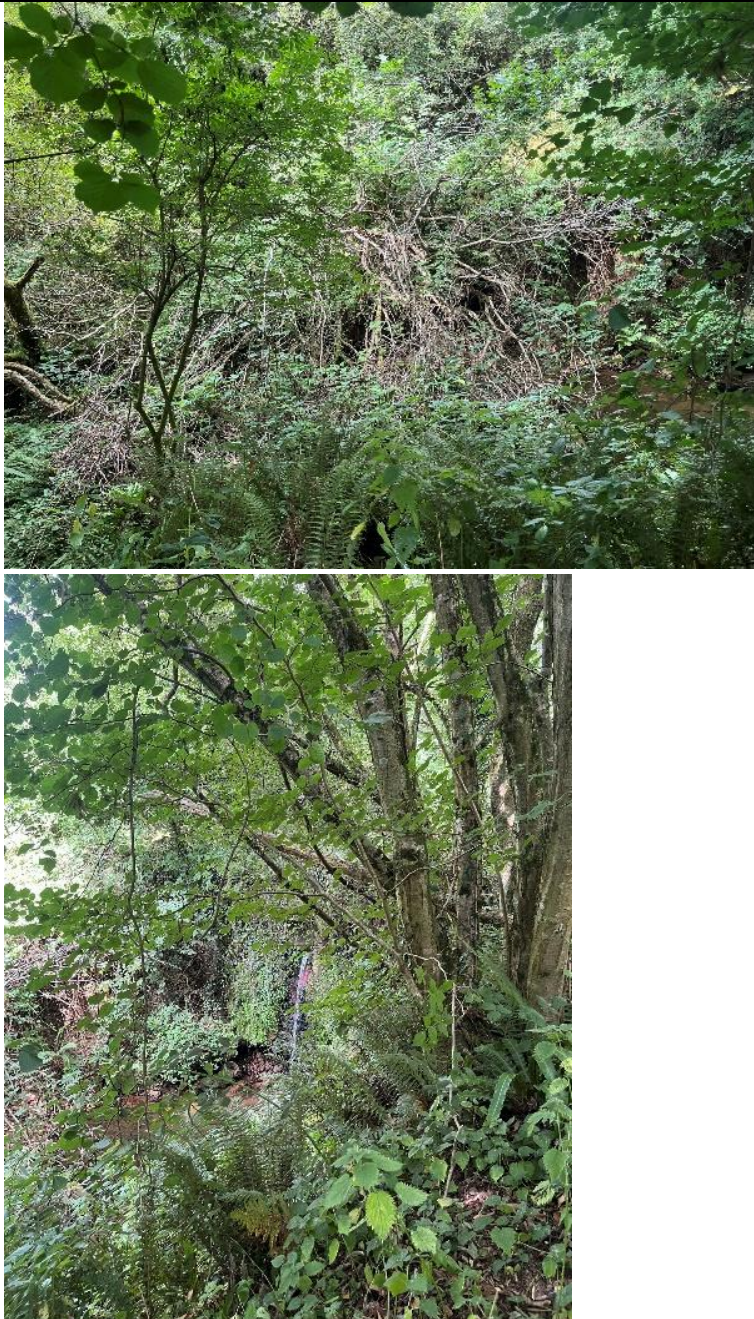
Description	Photograph
<p data-bbox="204 241 478 315">Burscombe Brook – SY 12639 90760</p> <p data-bbox="204 371 582 622">Steep banks of Burscombe Brook, with coarse woody debris present in stream. Perched culvert taking flow of brook and plunging 5m+ back into brook.</p>
