Westcountry Rivers Trust – Opening the Sid Catchment Assessment – River Sid - 2025

Barrier photos for **Lincombe Stream** LS1 – LS5

Extracted from Appendix 16

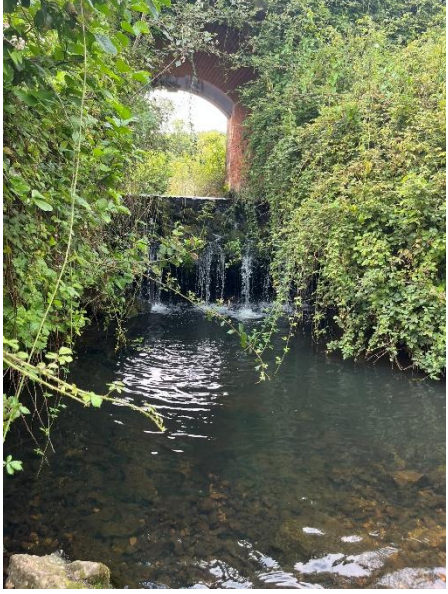
| Barrier ID | Waterbody | NGR | Date Visited | Photo | Type of Obstruction | Flows | Possible Action | Notes |
|---|---|---|---|--|---|---|---|---|
| LS1 | Lincombe Stream | SY<br>13487<br>92178 | 31.07.25 | | Bridge footing weir | non-adherent | | Stepped concrete weir as part of bridge footing. Think flow of water, 1.5m drop. Concrete and boulder construction. |

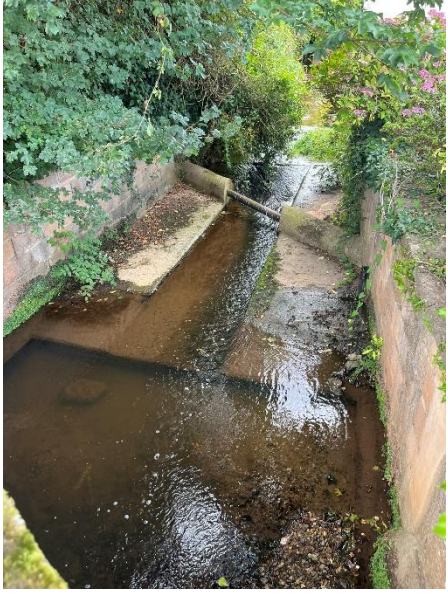
| Barrier ID | Waterbody | NGR | Date Visited | Photo | Type of Obstruction | Flows | Possible Action | Notes |
|---|---|---|---|--|---|---|---|---|
| LS2 | Lincombe Stream | SY<br>13917<br>91839 | 31.07.25 | | Modified channel bed | adherent | | Concrete channel bed with reveted banks on both sides. Channel notched in centre, with concrete slope. Pipe over river. |

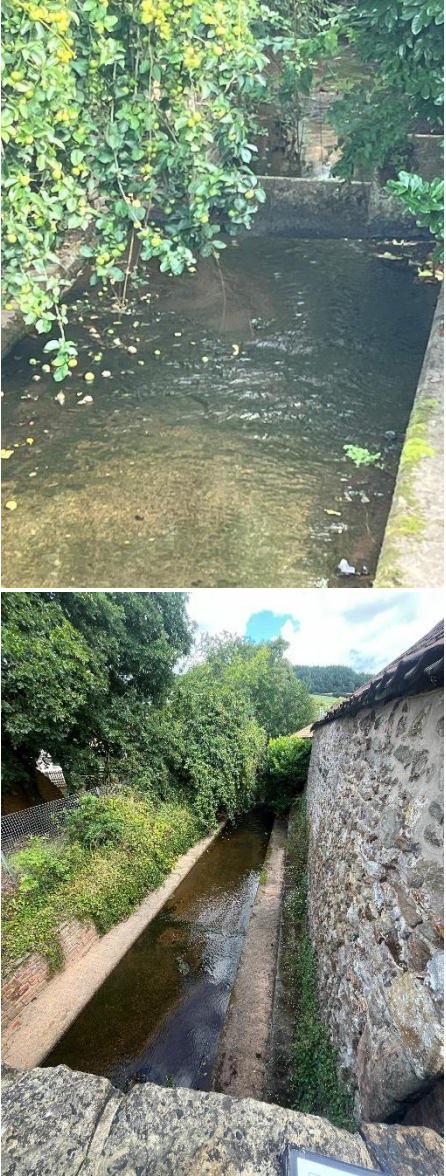
| LS3 | Lincombe Stream | SY13956<br>91819 | 31.07.25 | | Modified channel bed and weir | | | weir, possibly 2 steps. Viewed from road bridge US, would need access from school for better assessment. Appears to be a drop with concrete bed DS. |

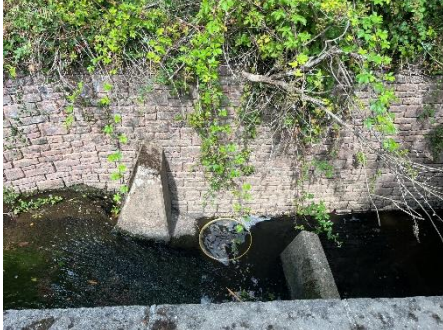
| Barrier ID | Waterbody | NGR | Date Visited | Photo | Type of Obstruction | Flows | Possible Action | Notes |
|---|---|---|---|---|---|---|---|--|
| LS4 | Lincombe Stream | SY 14053 91798 | 31.07.25 | A photograph showing a modified concrete channel bed and weir with concrete 'teeth'. The structure is made of grey concrete blocks and has two large, triangular concrete teeth protruding into the water. The water is dark and still. | modified channel bed and weir with concrete 'teeth' | adherent | | Modified concrete channel. Sloping concrete weir with two large concrete 'teeth'. 1m slope/drop |

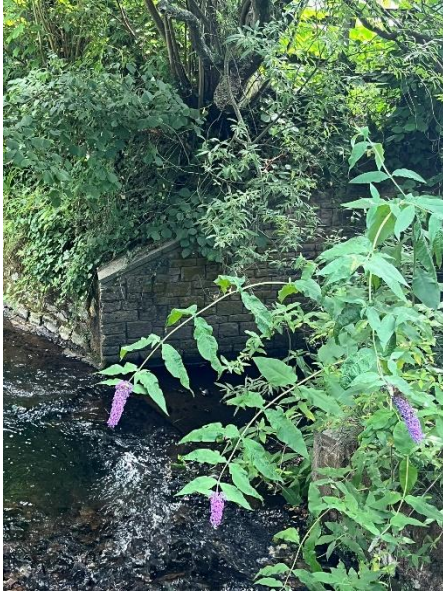
| Barrier ID | Waterbody | NGR | Date Visited | Photo | Type of Obstruction | Flows | Possible Action | Notes |
|---|---|---|---|---|---|---|---|--|
| LS5 | Lincombe Stream | SY 14059 91799 | 31.07.25 | A photograph showing a concrete lip into a modified channel at the confluence with River Sid. The lip is a concrete structure that has been partially submerged by the water. The water is dark and turbulent. There are green plants and purple flowers in the foreground. | concrete lip into modified channel | adherent | | Lip of modified concrete channel at confluence with River Sid. Lip drowned out in current low flows. |
