Appendix 7: Salmonid Habitat Walkover Maps – Roncombe Stream

Appendix 8: Habitat walkover Photos – Roncombe Stream

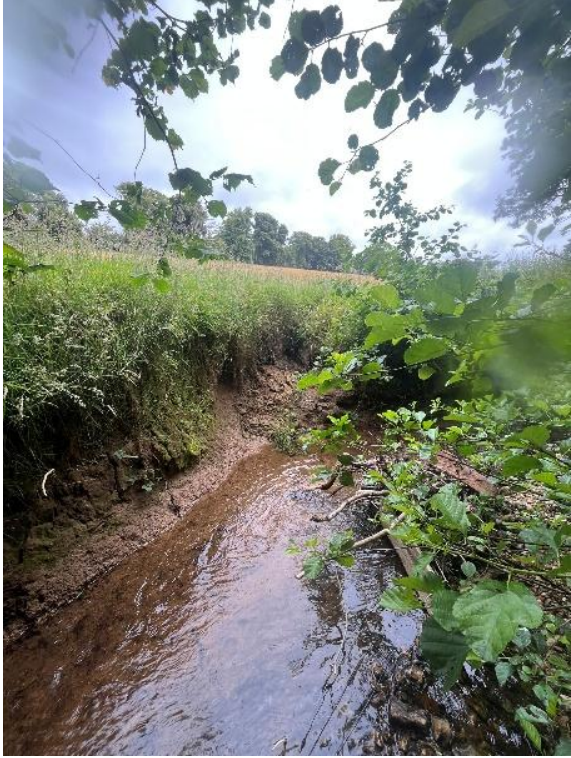
Description	Photograph
<p>Roncombe Stream – SY 14543 92333</p> <p>Incised and eroding clay banks on the Roncombe Stream. Large woody debris present in stream creating gravel accumulations upstream and scour downstream, resulting in habitat heterogeneity.</p>

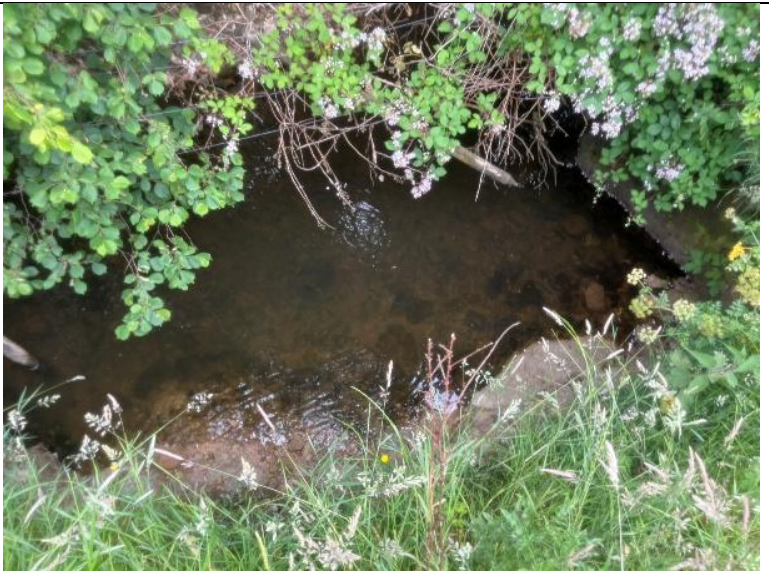
<p>Roncombe Stream – SY 14793 92393</p> <p>Deep eroded pool on true right bank, visible in photos is fence line hanging above pool. Gravels sedimented from erosive banks.</p>

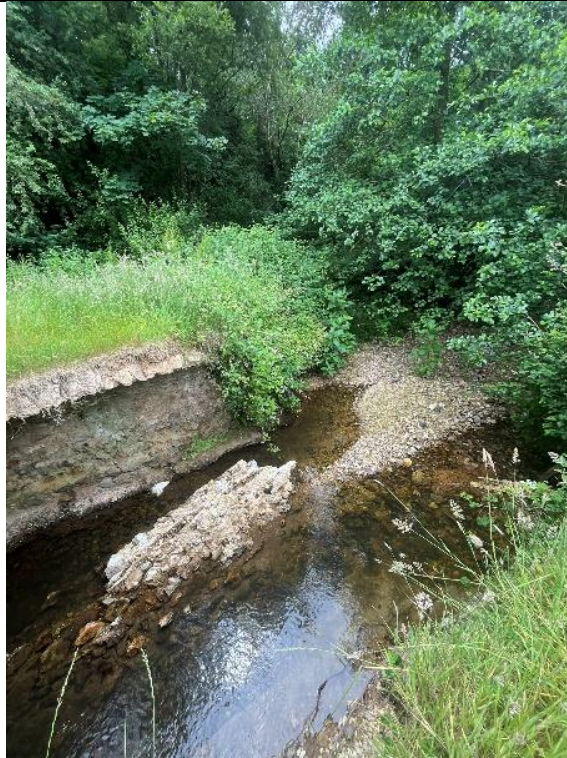
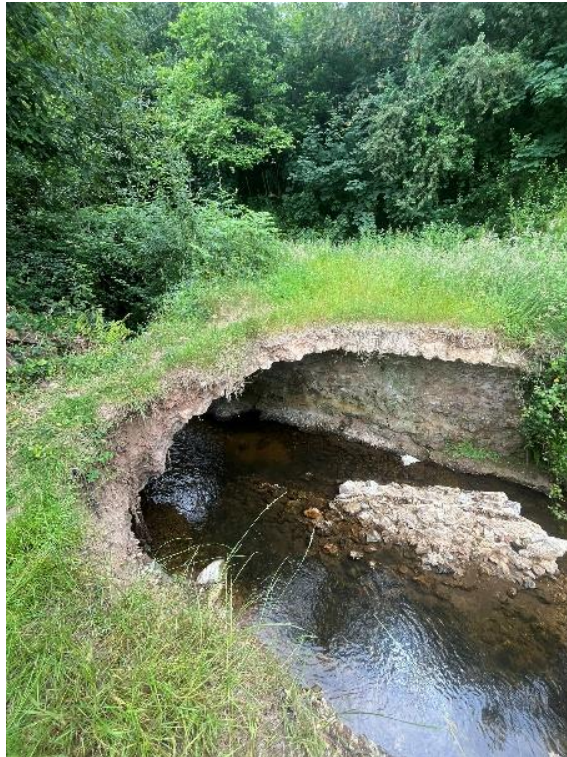
Roncombe Stream –
SY 14881 92421

Part collapsed historic packhorse bridge on Roncombe Stream. Not creating a barrier at time of survey, however if remainder of bridge collapses into the stream it could have the potential to cause a barrier to migration. Gravel bar downstream of bridge on true left bank, giving variation to channel and habitat types.

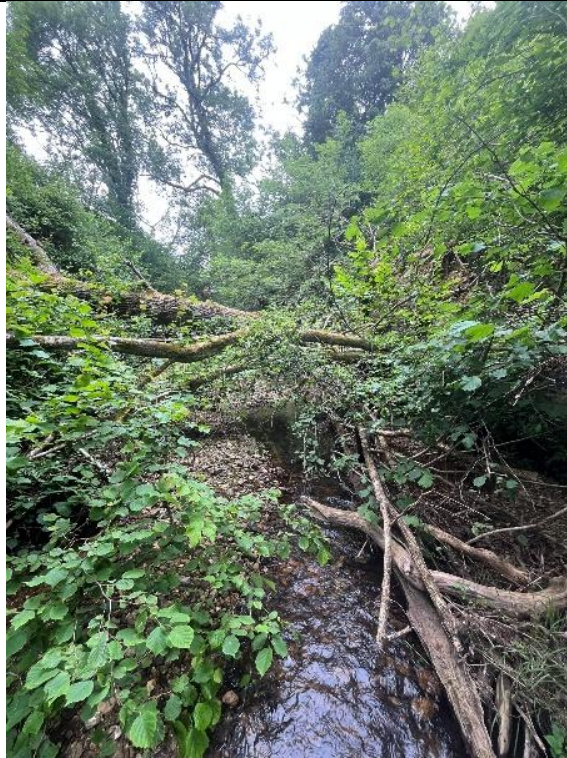
Roncombe Stream –
SY 15091 92703

Large woody debris present in Roncombe Stream. Structure is passable and not creating an issue for fish passage. Large wood in rivers allows for creation of habitat niches as well as mixed flow pathways creating sections that will trap sediment and areas of scour.

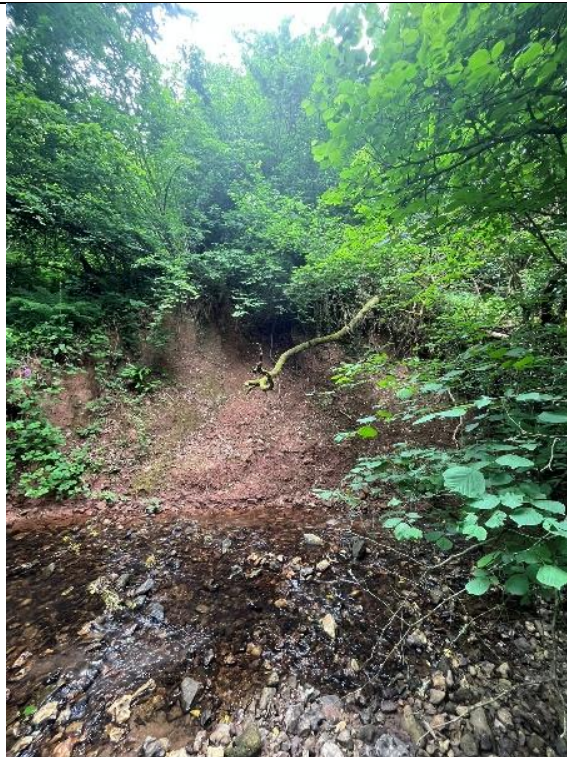
Roncombe Stream –
SY 15250 92971

Steep eroding true left bank of Roncombe Stream. Gravels and cobbles can be seen in the bank, resulting in substrate input to the stream.
