Westcountry Rivers Trust – Opening the Sid Catchment Assessment – River Sid - 2025

Barrier photos for **Roncombe Stream** RS1 – RS7

Extracted from Appendix 16

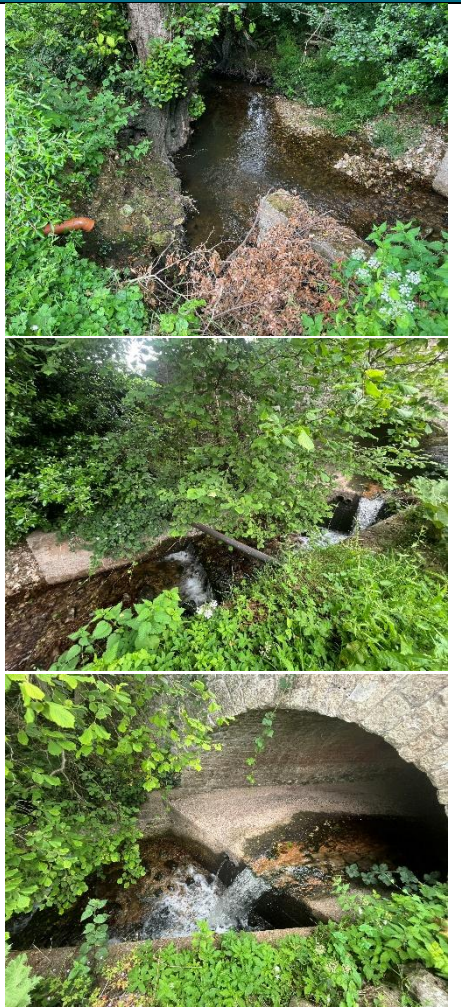
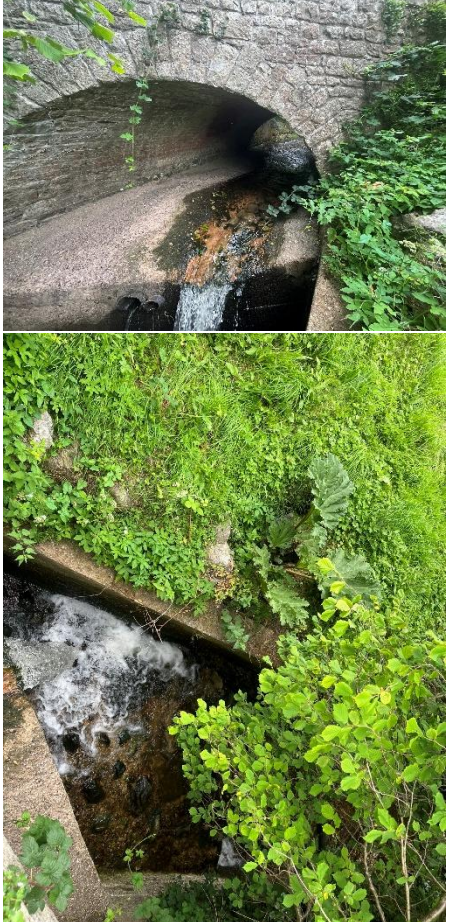
Barrier ID	Waterbody	NGR	Date Visited	Photo	Type of Obstruction	Flows	Possible Action	Notes
RS1 – Cotford Road Bridge Culvert	Roncombe Stream	SY 14233 92219	25.06.25

Weir/bridge footing	non-adherent	lower footing, baffles and pre-barrage	two step weirs up to 1m high bridge footing. Shallow channel of water through/under bridge. Impassable!

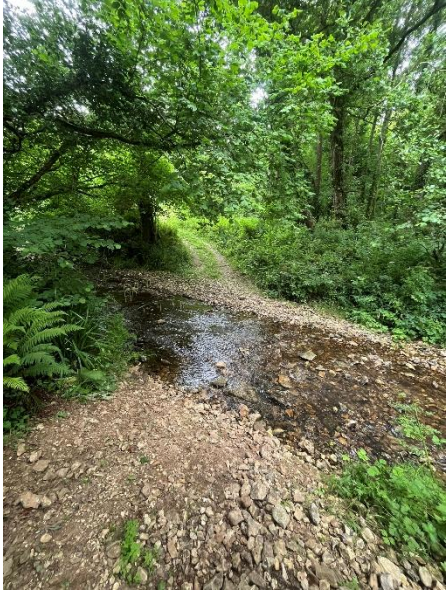
Barrier ID	Waterbody	NGR	Date Visited	Photo	Type of Obstruction	Flows	Possible Action	Notes
RS2	Roncombe Stream	SY 15066 92670	25.06.25

A photograph showing a stream crossing a gravelly path in a wooded area. The path is made of loose stones and gravel, and the stream flows through it. The surrounding area is lush with green trees and ferns.	ford crossing	adherent	Clear span bridge	no barrier, but ford could be replaced with clear span bridge to spare good fry habitat.

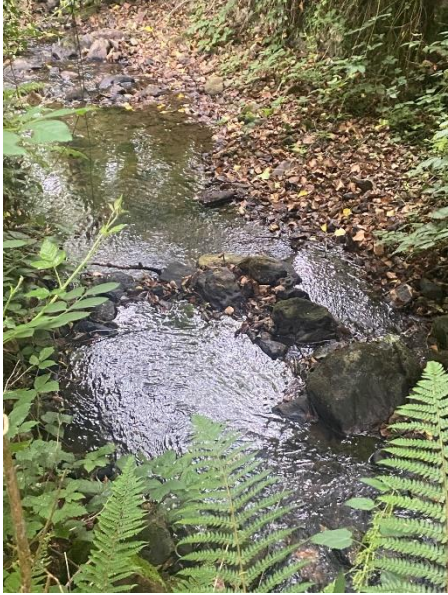
Barrier ID	Waterbody	NGR	Date Visited	Photo	Type of Obstruction	Flows	Possible Action	Notes
RS3	Roncombe Stream	SY 15681 94999	21.07.25

Stone ring/Bank	non-adherent	remove	small barrier, natural? Stone ring/bank acting as small dam with impassable chute

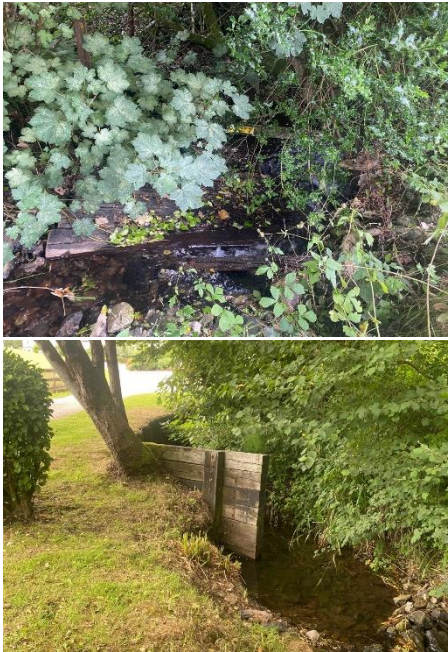
Barrier ID	Waterbody	NGR	Date Visited	Photo	Type of Obstruction	Flows	Possible Action	Notes
RS4	Roncombe Stream	SY 15747 94726	21.07.25

collapsed revetment	mixed	remove	old wooden sleeper revetment that has collapsed into stream blocking across horizontally
RS5	Roncombe Stream	SY 15887 94259	21.07.25

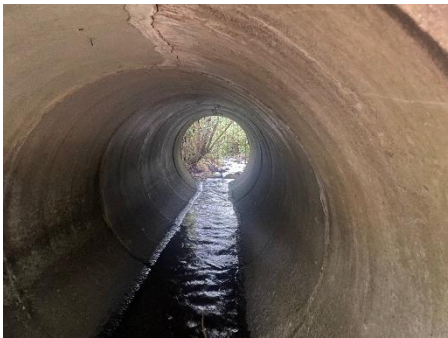
large concrete 2 pipe culvert under road	unknown	flexi baffles	downstream end of culvert is suspected to be impassable due to noise of water falling. Unable to confirm due to area not being fully visible/easily accessible. Approx drop DS end of culvert 30cm and non-adherent. Depth of water in culvert pipe 5-10cm

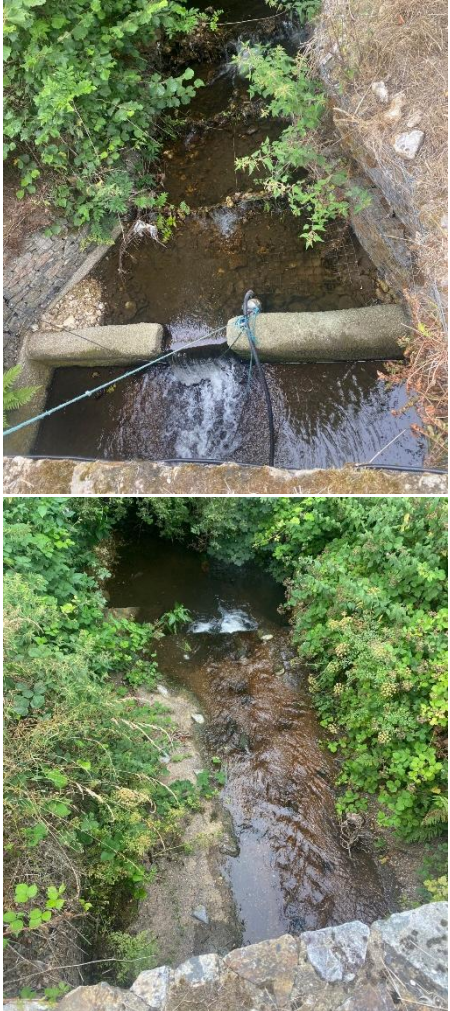
Barrier ID	Waterbody	NGR	Date Visited	Photo	Type of Obstruction	Flows	Possible Action	Notes
RS6	Roncombe Stream	SY 15762 94020	21.07.25

concrete apron of bridge with notched weir	2 ledges of non-adherent flow either side of bridge		US bridge banks revetted and banks and bed lined with chicken wire which could be harmful to DS migrants. Drop from notch in weir has head of 10-20cm, depth of water US and DS of weir 10-20cm. DS of bridge concrete extends for 2m, water flows off lip are non adherent for 20cm before landing in 50cm deep pool. depth of water over concrete 5-10cm.

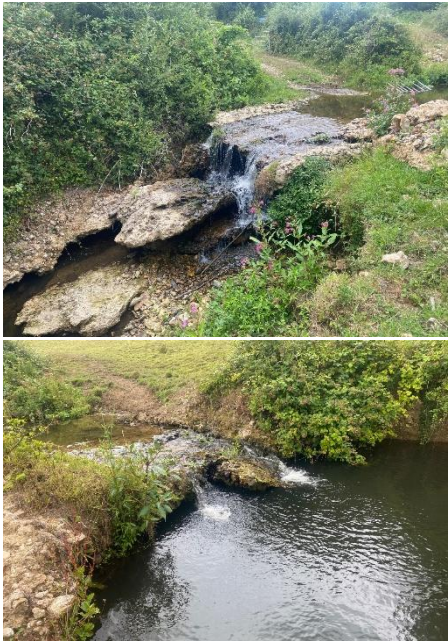
Barrier ID	Waterbody	NGR	Date Visited	Photo	Type of Obstruction	Flows	Possible Action	Notes
RS7	Roncombe Stream	SY 15648 93742	21.07.25

subsiding ford	non-adherent	remove and re-grade bed	old semi-natural ford crossing that has subsided, resulting in large impassable drop with shallow pool depth DS.
