Appendix 13: Salmonid Habitat Walkover Maps – Woolbrook

Appendix 14: Habitat walkover Photos – Woolbrook

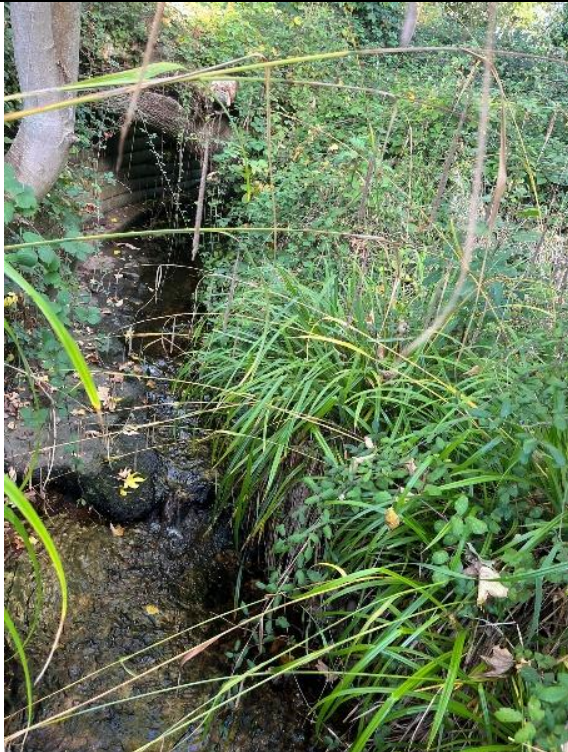
Description	Photograph
<p>Woolbrook – SY 12959 88662</p> <p>Channel reinforcement on true right bank (seen in the top right corner of photo) as well as bank revetment.</p>

A photograph showing a narrow stream channel with a dark, rocky bed. The right bank is reinforced with large, dark stones. The left bank is covered in dense green vegetation, including tall grasses and reeds. The water is clear and flows through the channel.

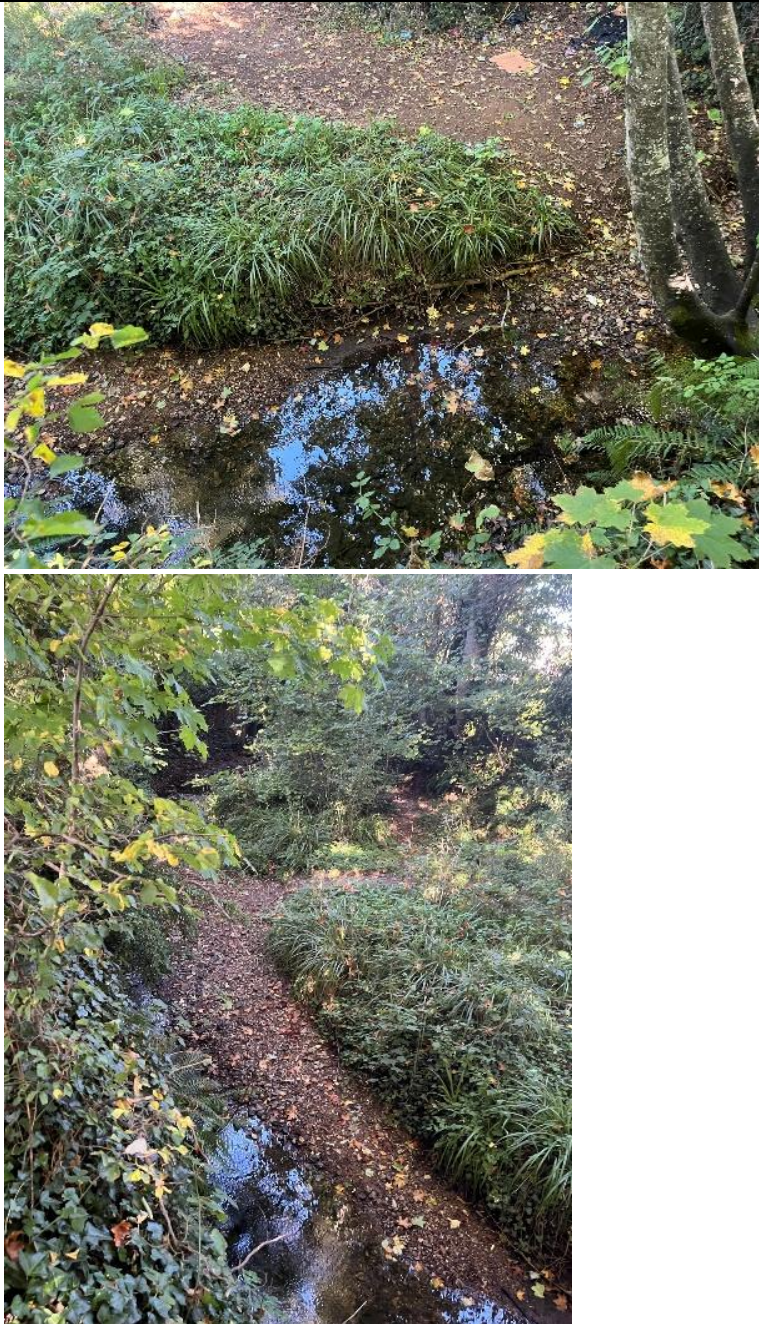
Description	Photograph
<p data-bbox="204 239 424 315">Woolbrook – SY 12634 89059</p> <p data-bbox="204 371 596 533">Steep true right bank. Litter present on true left bank, as well as erosion into the river.</p>

The 'Photograph' column contains two images. The top image is a close-up view of a riverbank with a steep, eroded right bank and litter on the left bank. The bottom image is a wider view of the same riverbank, showing the steep right bank and litter on the left bank.

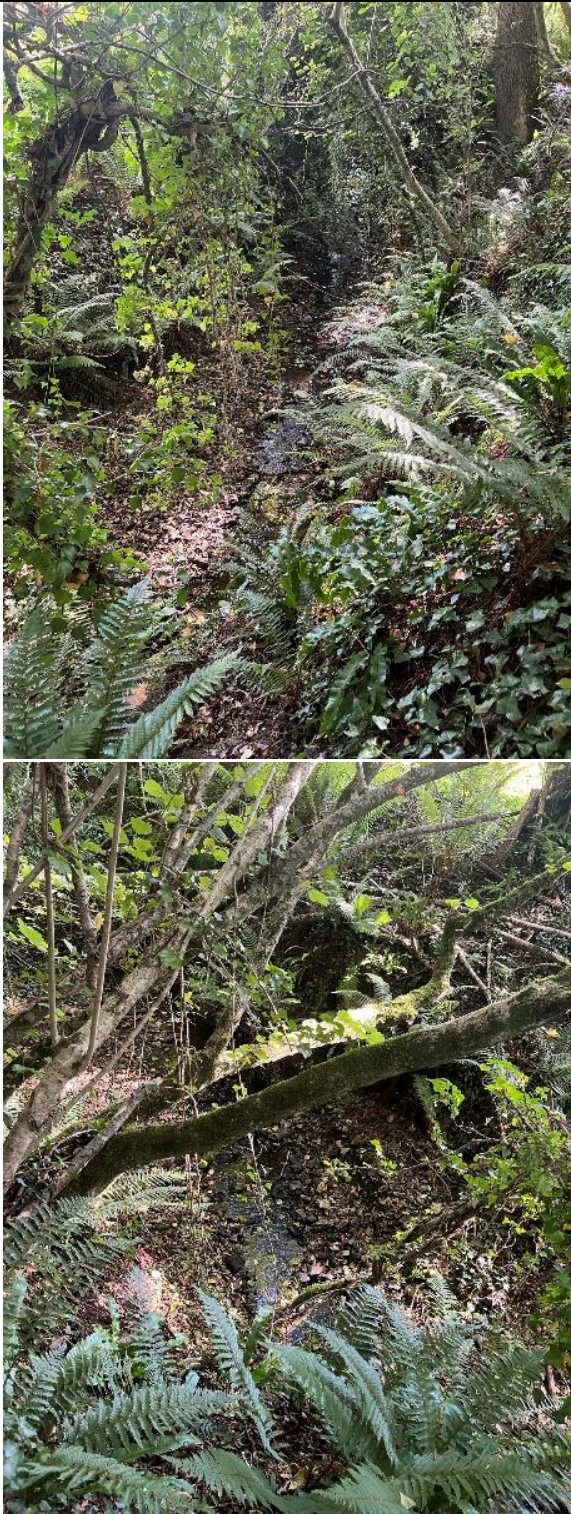
Description	Photograph
<p>Woolbrook – SY 11589 90048 to SY 11624 90708</p> <p>Upper section of Woolbrook above A3052. Habitat more natural, heavily overshadowed and steep valley banks. Very low flow throughout. Small stream making habitat definition less clear, mixture of fry and parr. Sections of large woody debris in stream.</p>
