Fish Pass Advisory Service Sidmouth site visit

12th January 2023

Background

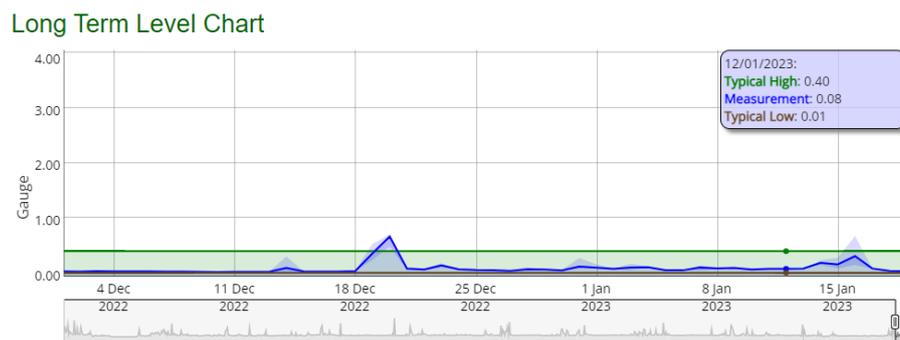
Despite recent high regional rainfall, the R. Sid did not appear to be running at a high level which aided the inspection of the structures in the area of interest. Historic river levels (Nov 2012 – Jan 2023) however, suggest that the level of 0.080m represents the level exceeded approximately only 15% of the time [measured at the ford crossing, EA gauging site ID 45216 (OS Grid: SY127876)] .

Figure 1 River Levels UK (Dec 2022- Jan 2023)¹

On the day of the site visit the fluvial flow is thought to be ~Q15 (see Figure 1) with a sufficiently deep route from the head of the beach through to the lower weir (tidal weir) close to the true right bank.

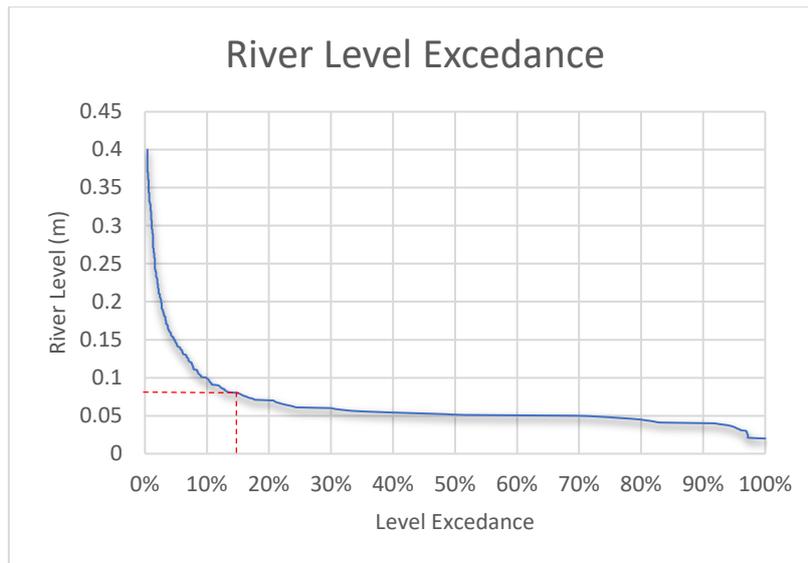
Figure 2 River Level exceedance (ID 45216)

This finding indicates that the river level at the ford was within about 20mm of the level exceeded only 10% of the time which would be a normal upper expectation of flow or level for migratory salmonids to migrate. Interpolating the “Low Flows” flow duration curve provided by Fishtek (assumes no abstraction upstream) the Q15 flow should be of the order of $1\text{m}^3\text{s}^{-1}$ or about six times the Q95 flow that might normally be associated with the minimum for fish pass operation. Eels on the other hand would normally be expected to migrate at lower flows between $\sim\text{Q99}$ and Q70 .

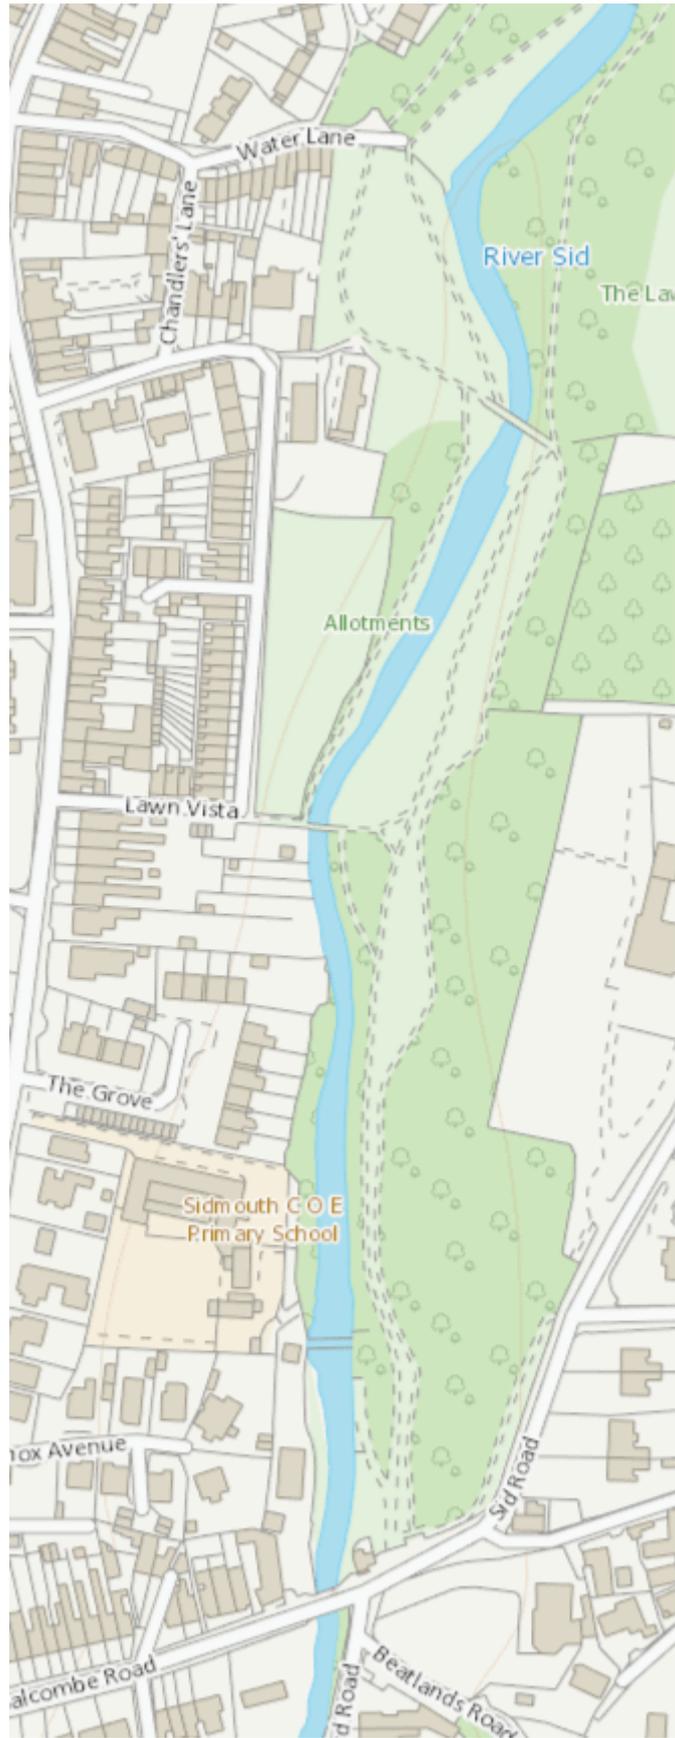
Upstream of School weir there was approximately 120m of river displaying the effects of impoundment by the weir and its’ predecessor a few metres upstream. Above the impounded reach there was a reach of at least $\sim 230\text{m}$ of cobble and small boulder which was shallow and fast flowing. Whilst no elevation measurements were taken the reach showed features typical of slopes around 1%. Passage of migratory salmonids is likely to be limited in low flow periods due to the shallow depths in such reaches. The passage of eel and elver is unlikely to be impacted by low flow periods in this reach.

Figure 3 Map from Salcombe Rd upstream

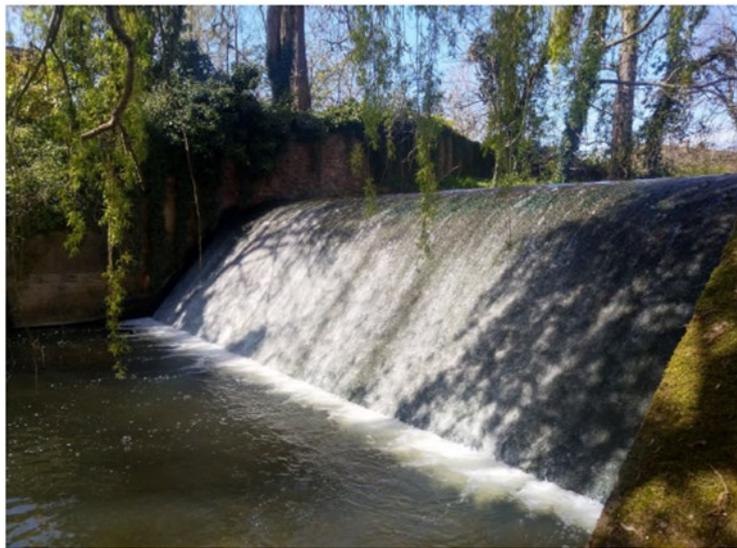
School Weir is reported by the technical note by Fishtek Consulting² to have a head loss of approximately 3m making it a significant barrier to migratory salmonids and European eel. Options for improving passage at the weir were put forward by Fishtek including a two flight Larinier pass and a rock ramp type pass. Approximate costs for the options were provided but each had significant constraints that could alter the suggested costs significantly. These included the proximity of both sewer and high voltage services parallel to the river. At present, the depth of these services is unknown and therefore they represent a risk of impacting the viability of the options put forward. In addition, there are several mature trees lining the true left bank that form part of the character of the “Byes” park for local residents. Bank reinforcements or significant earthworks could require the removal of some of the trees or impact their survival.

Figure 4 School weir

The Fishtek note highlighted these constraints but there may be some scope to investigate approaches that attempt to limit the impacts on the reach upstream and utilise the structures that are already in place. For example, if the slope of the riverbed above the impounded reach was ~1% then there might be scope to regrade the reach upstream of the old weir so that this weir is approximately 1.2m lower. A standard notch for the passage of migratory salmonids would normally be designed to have a width of 0.3-0.6m and a depth of 0.25m. The Q95 flow for the R. Sid is estimated at $0.149 \text{ m}^3\text{s}^{-1}$ by Fishtek which is slightly more than the calculated discharge for a 0.6m wide notch as described³. That would mean the weir “shoulders” would normally run a trickle of water except in very low flows. Some additional facilities to assist the passage of eel would also be required but could be incorporated at bank walls for easy maintenance.

Such weirs with notches would normally be designed to accommodate a fall in water level of no more than 0.45m. Depending on the construction of the main School Weir it may be possible to lower this weir to effectively form a pool between the old weir and the new weir. Another constraint

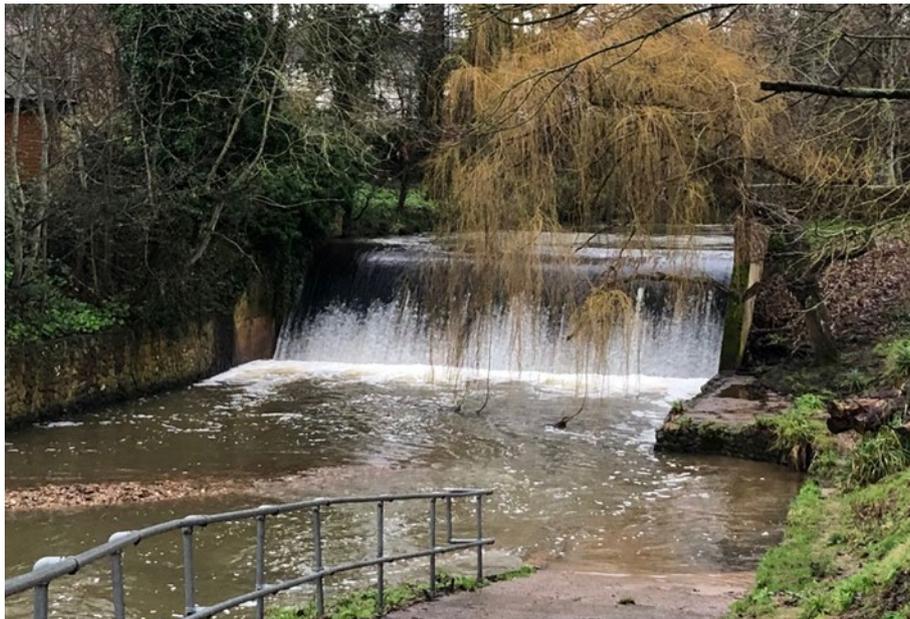
normally considered when forming pools between weirs is the power density of the water in the receiving pool. That is related to the magnitude of the drop into the pool, the volume of the receiving pool and the range of discharge over which the structure is intended to operate over for fish passage. Normally the power density should not exceed 150 Wm^{-3} so that fish do not become confused by the turbulence in the pool. The lower weir might be expected to have a notch of the same dimensions as the notch in the upper weir so that water the water level in the pool rises in a similar fashion to the level above the upper weir.

Figure 5 School weir from downstream with access ramp and bedload accumulation

Drawing these considerations together then the combination of 1.2m of river regrading followed by two standard notch loss of elevation accounts for 2.1m of the required 3m of head loss. Thus an additional head loss of 0.9m would be required between the lower weir and the point where it is deemed that flood conveyance must be maintained upstream of the road bridge. We discussed on site the potential for “ArmorLoc” or similar products to be used to provide an engineered slight impoundment below the current school weir that could allow bed movement through the weir notches and past the “ArmorLoc” impoundment. Such an impoundment could be shaped to provide a lower section for low flows whilst not significantly impeding higher flows or sediment.

If it were possible to include two chutes into the lowered weirs in addition to the upstream river regrading then perhaps 2.7m of head loss might be accommodated leaving only a more minor 0.3m of head loss to be found below the newer weir.

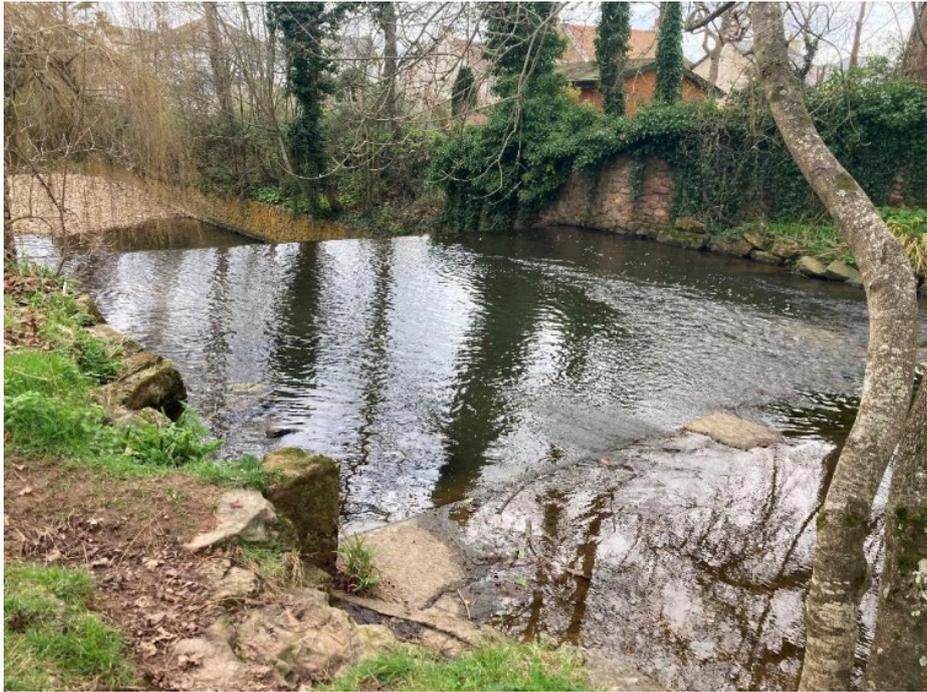
The upper weir also appeared to have a significant longitudinal dimension which may allow the formation of a chute as opposed to a notch in the weir. The advantage of creating a chute is that in such constrained conditions a greater head loss may be achievable in a single drop and still be passable for migratory salmonids. In such cases where the chute is possible then a difference in elevation 0.5m from the invert of the chute (highest point) to the downstream water level is allowable. The width of the chute should be designed so that at flows that fish can access the weir the depth of water in the chute is a minimum of 150mm and that the consequential water velocities do not exceed $\sim 3\text{ms}^{-1}$. Care should be taken that water does not spill laterally from the weir into the chute at discharge less than Q_{10} . A consequence of this approach is that the likely range of operation of the chute would be limited to moderate to high flows which may be appropriate given the future passability of structures below School Weir. If these design limitations could be met, then potentially $\sim 0.75\text{m}$ difference in water level could be possible. If the lower School Weir was also of sufficient “thickness” then a similar head loss might also be possible.

Figure 6 Historic weir a few metres upstream of School weir (source Fishtek 30-3-2022)

[If school weir could not be lowered but the historic one could along with some river regrading, then perhaps the single flight pass around school weir would be feasible. However, the combined cost of all these elements might still be high compared to the dual flight Larinier pass option and may mean that the aesthetic appeal of the skim of water over the weir is not normally present.](#)

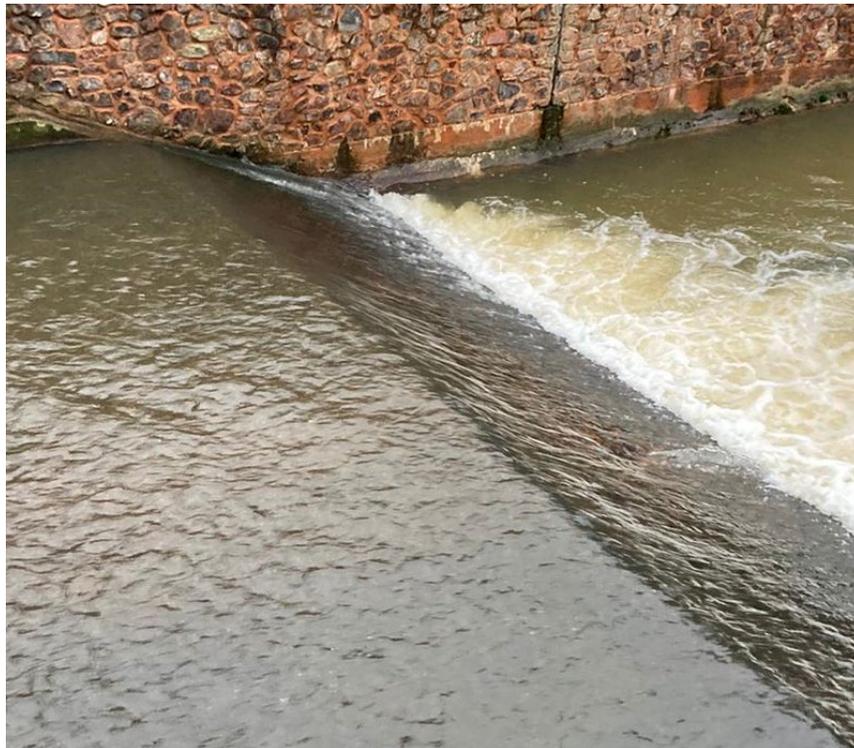
The ford crossing the River Sid (Mill Street) is approximately 200m downstream of School weir and represents a significant obstruction to fish passage for both migratory salmonids and eel. Two key features combine to impact fish passage, a steep (~ 1:2) sloping weir downstream of the ford (Figure 7) and a long horizontal concrete upper section of wide river channel over which vehicles cross the river at an oblique angle (Figure 8). This apron would be relatively shallow at all but moderate to high flows.

Figure 7 Sloping weir immediately downstream of the ford

Eel passage may be possible over the lower half of the flow range by simply augmenting the sloping weir to near the crest on each of the sides of the weir to provide a climbing surface for juvenile eel. This could be as simple as bonding suitable small pebbles to the sides of the weir face. Cleaning regimes should limit whole weir cleaning to ensure there is always a significant biofilm/algal surface to provide a more eel friendly surface for passage. The tops of these roughened areas should allow direct access to a low velocity path over the upper ford area even at low flows.

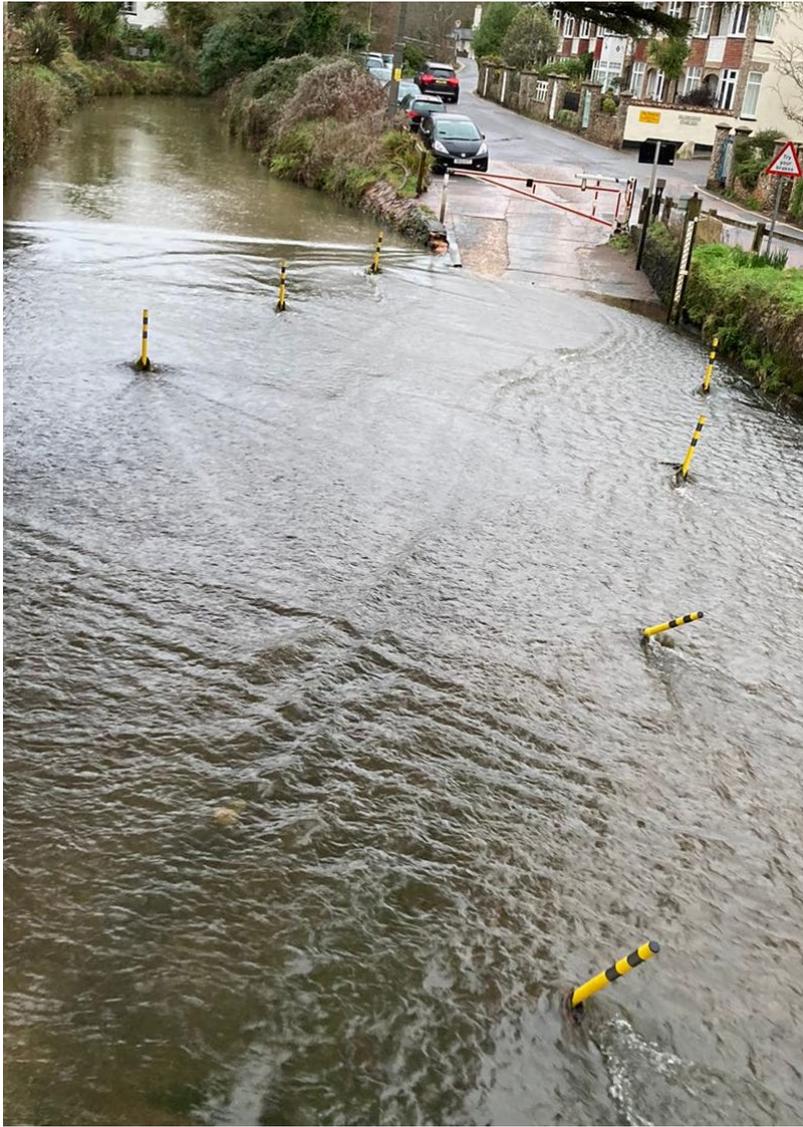
Figure 8 Ford across the River Sid

The second feature that challenges migratory salmonid fish passage is the presence of a relatively wide and shallow apron above the weir. The aerial view suggests that the longitudinal length of the upper apron is approximately 30m long and is extensively used as a vehicle ford when water depths allow. Ideally, the relatively flat apron might be modified to provide a slightly deeper longitudinal route for fish that has sufficiently gently sloping sides to maintain the operation of the ford. It may be that the ford could be normally closed when salmonids are migrating and so it may be possible to avoid any requirement to provide a deeper channel for fish on the upper apron. There is a clear requirement to identify when migratory salmonids are likely to be able to access this reach of the river.

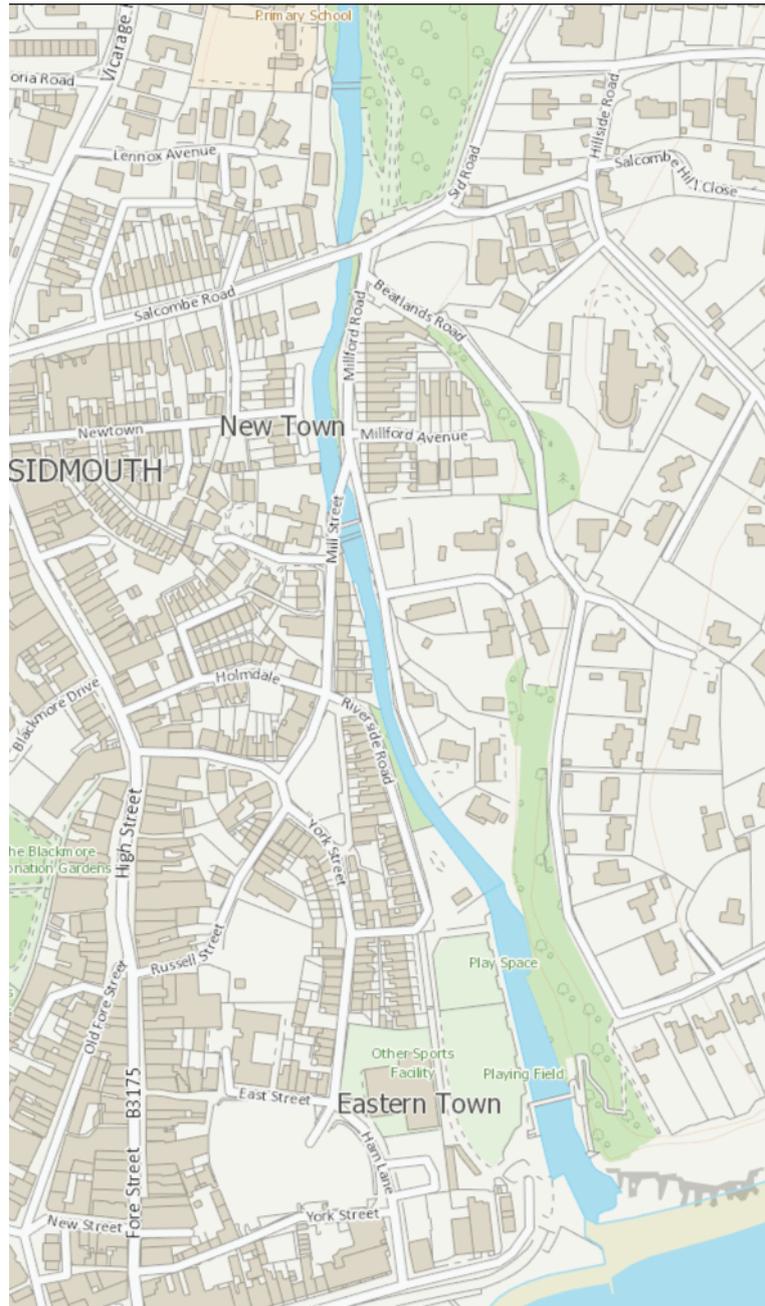
Figure 9 Map of the Lower River Sid from School Weir to the sea

Downstream of the ford weir are both lateral and longitudinal structures that appear to occupy the extent of the anti-scour apron below the weir (see Figure 9). Migratory salmonids have been reported to accumulate below School Weir at high flows and so this demonstrates that the ford weir is passable at high flows. Measures to extend the flow range over which fish can surmount the ford weir should include a reduction of the head loss on the steep downstream face of the weir. Such mitigations may be possible by augmenting one of the lateral structures visible in the stilling basin (Figure 9, roughly indicated by the orange dashed line). The choice of positioning of the notch or gap could be influenced by the risk of erosion and the ease of maintenance. Normally the head loss associated with one pre-barrage fall would be limited to 0.45m and engineered to have an adherent nappe to limit air entrainment at the notch. It may be advisable to maintain sediment conveyance by designing a notch to extend to near the riverbed, but this will be dependent on the discharge range thought to be relevant to migratory fish access. The longitudinal structures may provide the

opportunity to reduce head loss further by introducing another pre-barrage between the weir and the lateral structure mentioned above. Breaks in the longitudinal structures would be needed if they are not drowned by the downstream pre-barrage to allow free access to the pre-barrage notch.

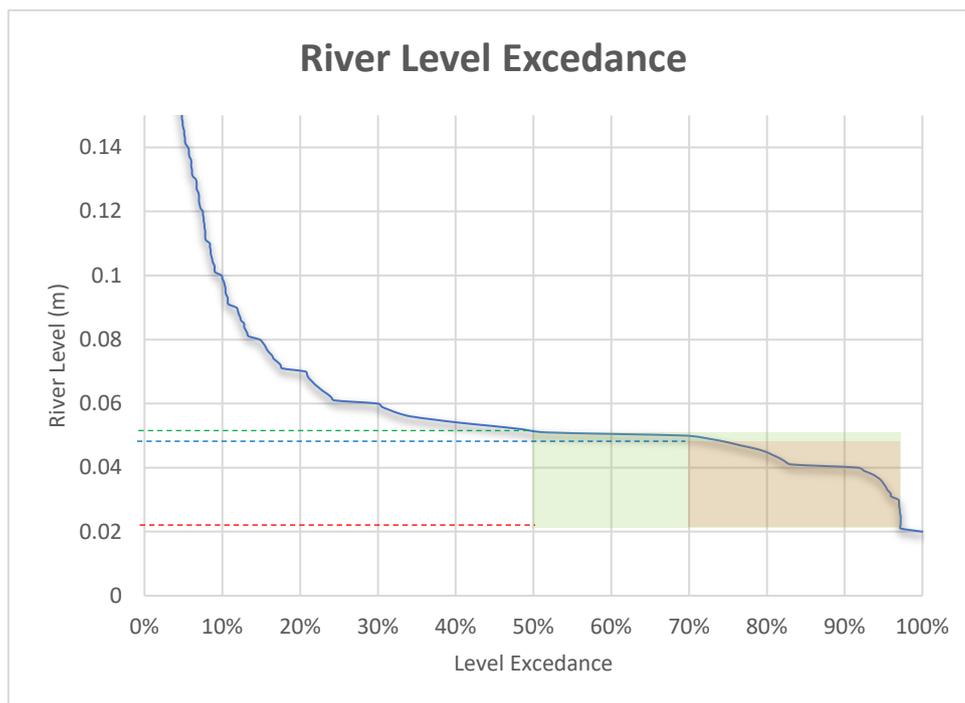
Figure 10 Detailed water level exceedance curve (ID 45216)

The curve above (Figure 8) shows more clearly that the change in water level at the Ford monitoring site from that exceeded 99% of the time to that exceeded 70% of the time is a difference of only ~30mm (orange area). Further to this, if the level exceedance is extended to 50% of the time (green

area) the level difference is still only ~32mm suggesting that measures to enhance eel passage could operate over a wider range of flows than the minimum guidance with virtually no extra costs of implementation relating to water level.

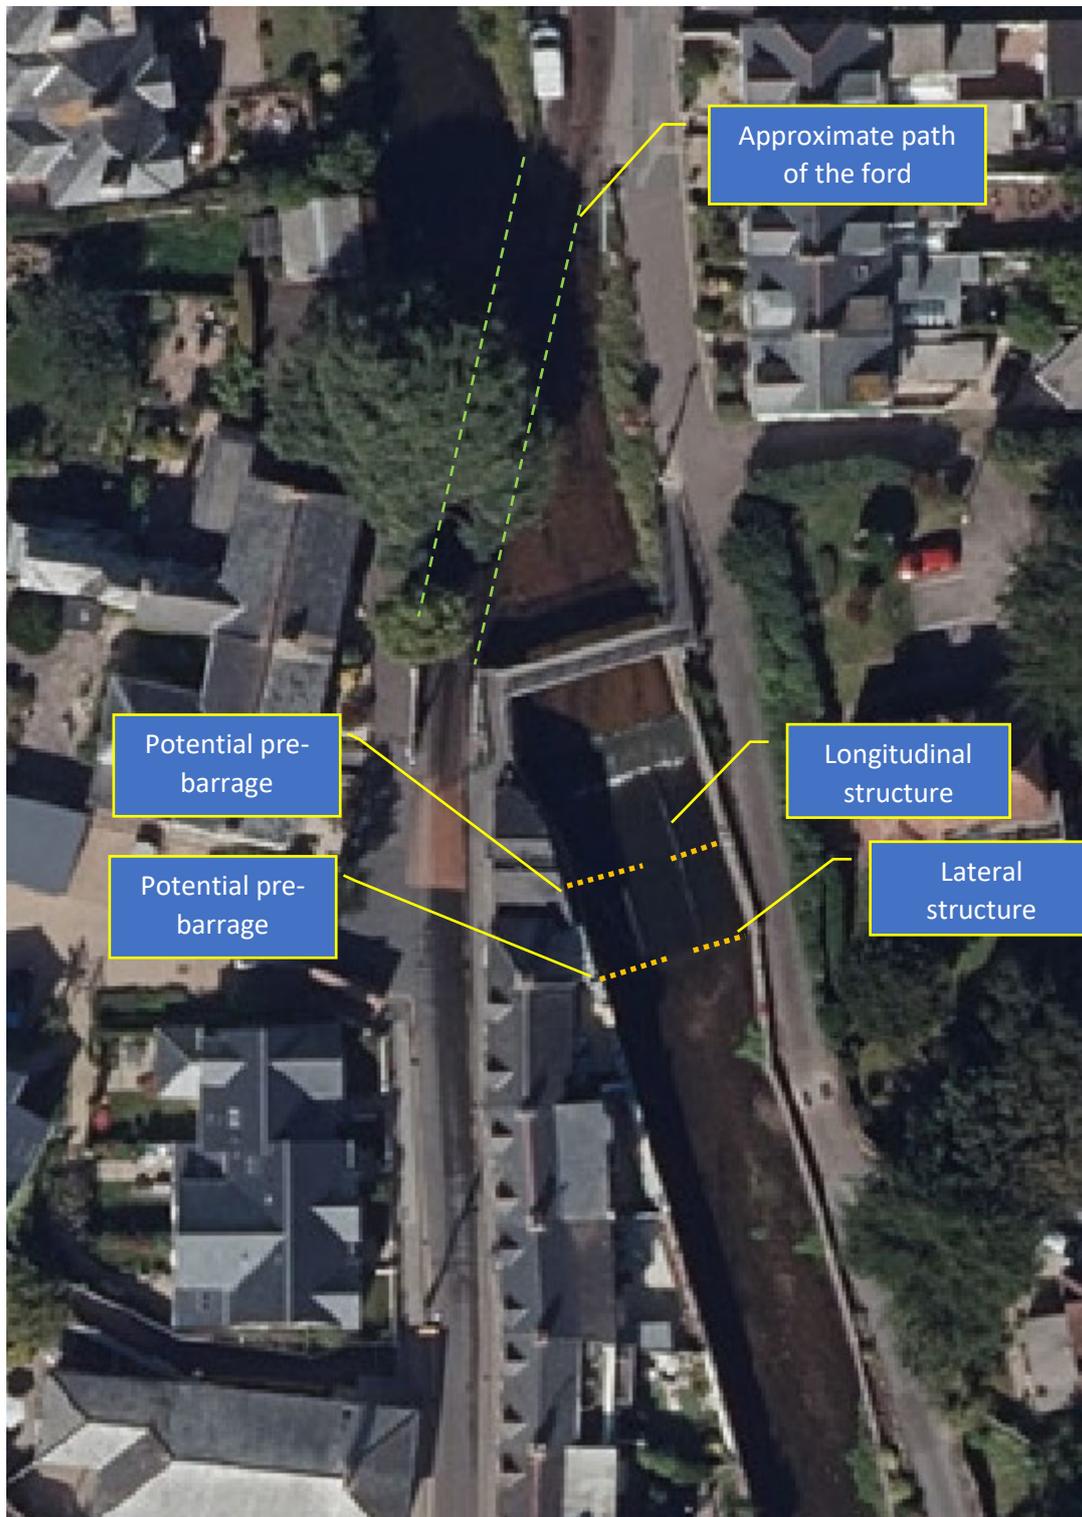
Figure 11 Ford weir aerial view

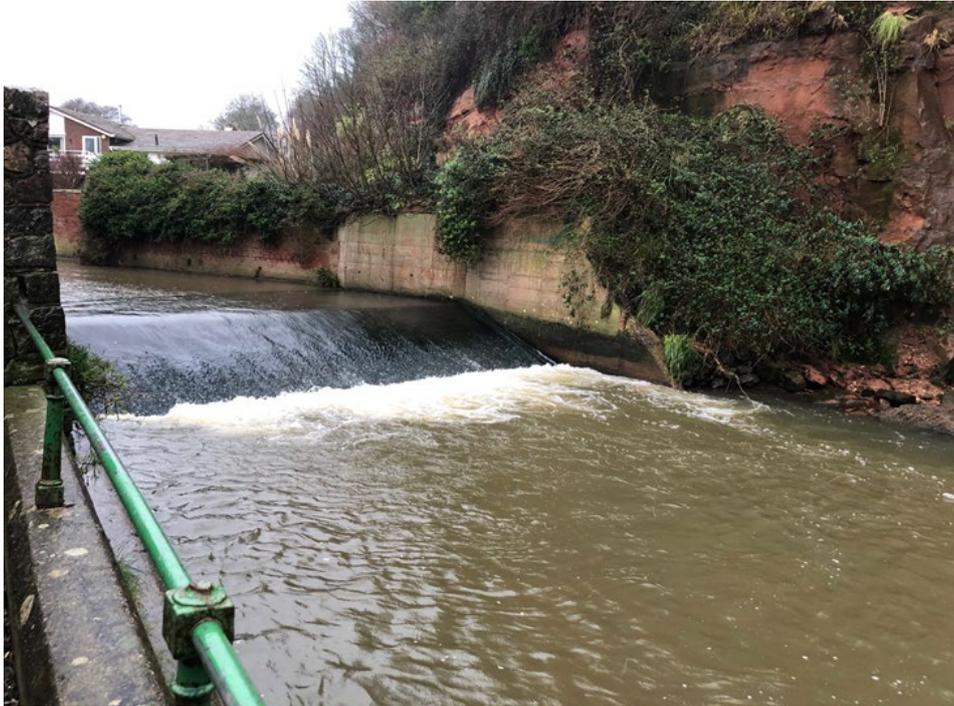
The lowest weir on the R. Sid is approximately 210m downstream of the ford weir and 155m upstream of the high-water mark on Sidmouth beach. The issues for fish passage are similar to the ford weir upstream but perhaps not as acute. The downstream face of the weir appears to have a steep gradient of perhaps 1:2 with a shallow apron upstream of the crest. The direction of the river changes at this point veering to the left looking upstream.

Figure 12 Lower weir (tidal weir) view from true right bank downstream

On the day of the site visit there was a clear region of low velocity approach to the true right side of the weir (see Figure 10). Local observations of when fish are in the vicinity should give useful evidence if a particular side of the weir is preferred. If the depth of water on the top of the weir is less than around 150mm when fish are known to run this reach then it may be useful to consider attaching low level timbers to the top apron of the weir to partially increase water depth.

It is sometimes possible to improve fish passage on triangular profile weirs with the addition of Low Cost Baffles (LCB's). These have been used with success but on weirs with a slope no greater that $\sim 1:4$. Therefore they are unlikely to be helpful here without a re-profiling of the downstream slope which is likely to be a significant cost. Alternatively, and with a likely lower effectiveness, would be the addition of a transverse baulk structure on the weir face to reduce the slope of the falling water and to increase depth on the weir face. They tend to be of low cost but have variable success depending on the nature of each installation. The actual degree of fish passage difficulty would depend to a significant extent on how much the downstream level is influenced by fluvial flow and tide level. It may be that the weir is not a significant impediment for a significant portion of the tide and therefore measures such as the installation of a baulk would still extend the period of time and

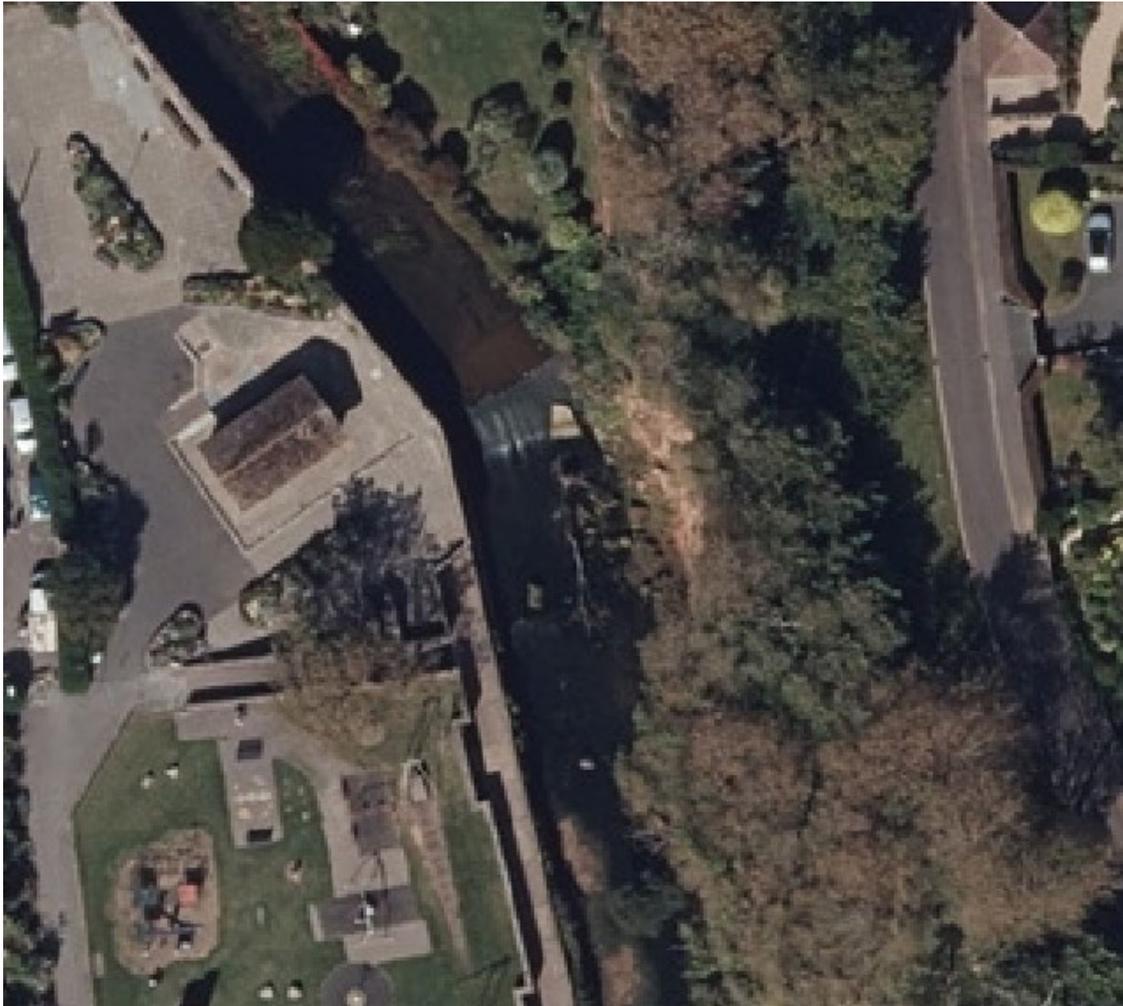
Figure 13 Lower weir (tidal weir) aerial view

The aerial picture (Figure 11) appears to show that at times the true left of the weir has a shallower approach with large boulders scattered to the true left of the channel. The downstream glaucis of the weir is also longer on that side of the weir.

Similar approaches for the improvement of eel passage discussed for the ford should apply to this weir. As the crest length of this weir is approximately the same as at the ford upstream (12m) the water level change estimated for the ford might be expected to be very similar to this weir.

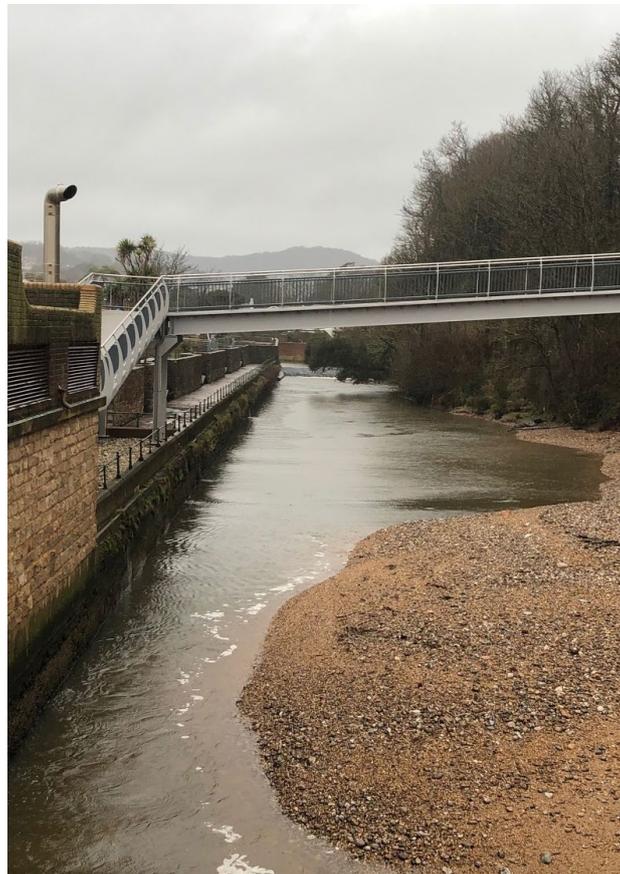
Figure 14 River Sid immediately upstream of the beach

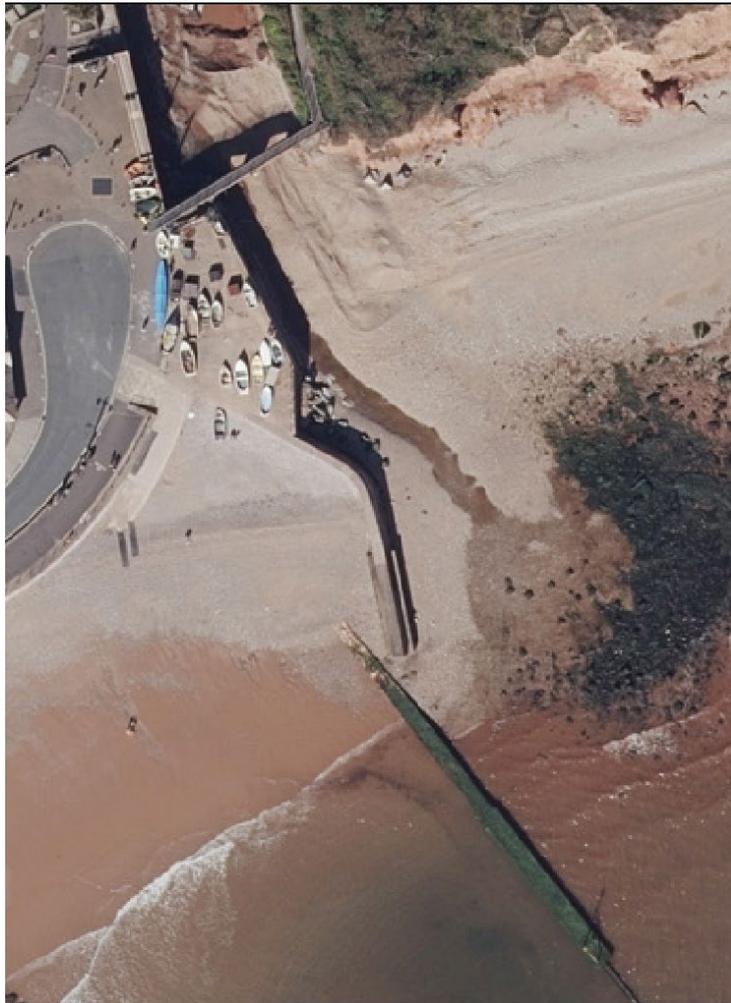
The aerial view at low tide shows however that the flow of the river over the current beach is likely to be too shallow for much of the tidal cycle. Tide marks on the true right wall (algae) and on the beach opposite (seaweed) (Figure 12) suggest that at high water there would be of the order of 0.5m extra depth of water on this area and likely to back up the water level to the tidal weir.

Figure 15 Aerial view of the mouth of the River Sid at low tide

Since these changes could represent an increase to the impediment of migratory fish the changes suggested by the beach management plan should be evaluated to check compliance with the relevant environmental legislation to protect fish passage.
