# Appendix 9: Salmonid Habitat Walkover Maps – Lincombe Stream

## Appendix 10: Habitat walkover Photos – Lincombe Stream

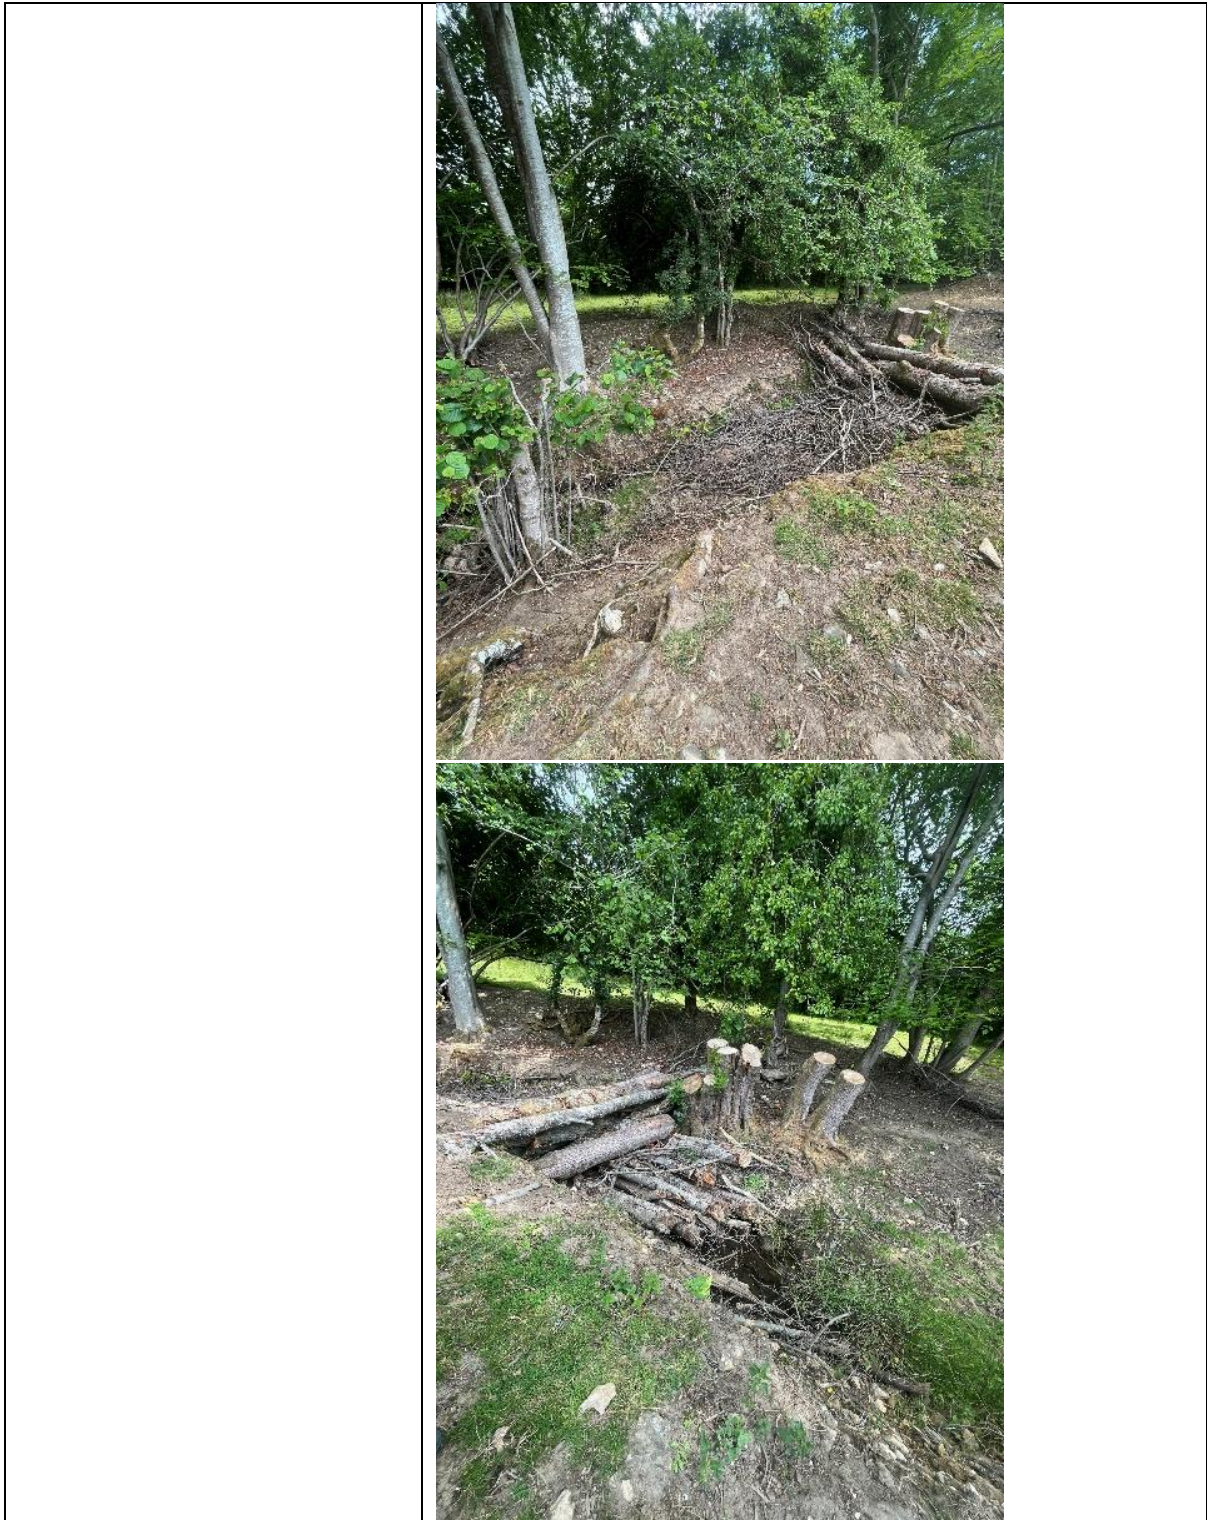
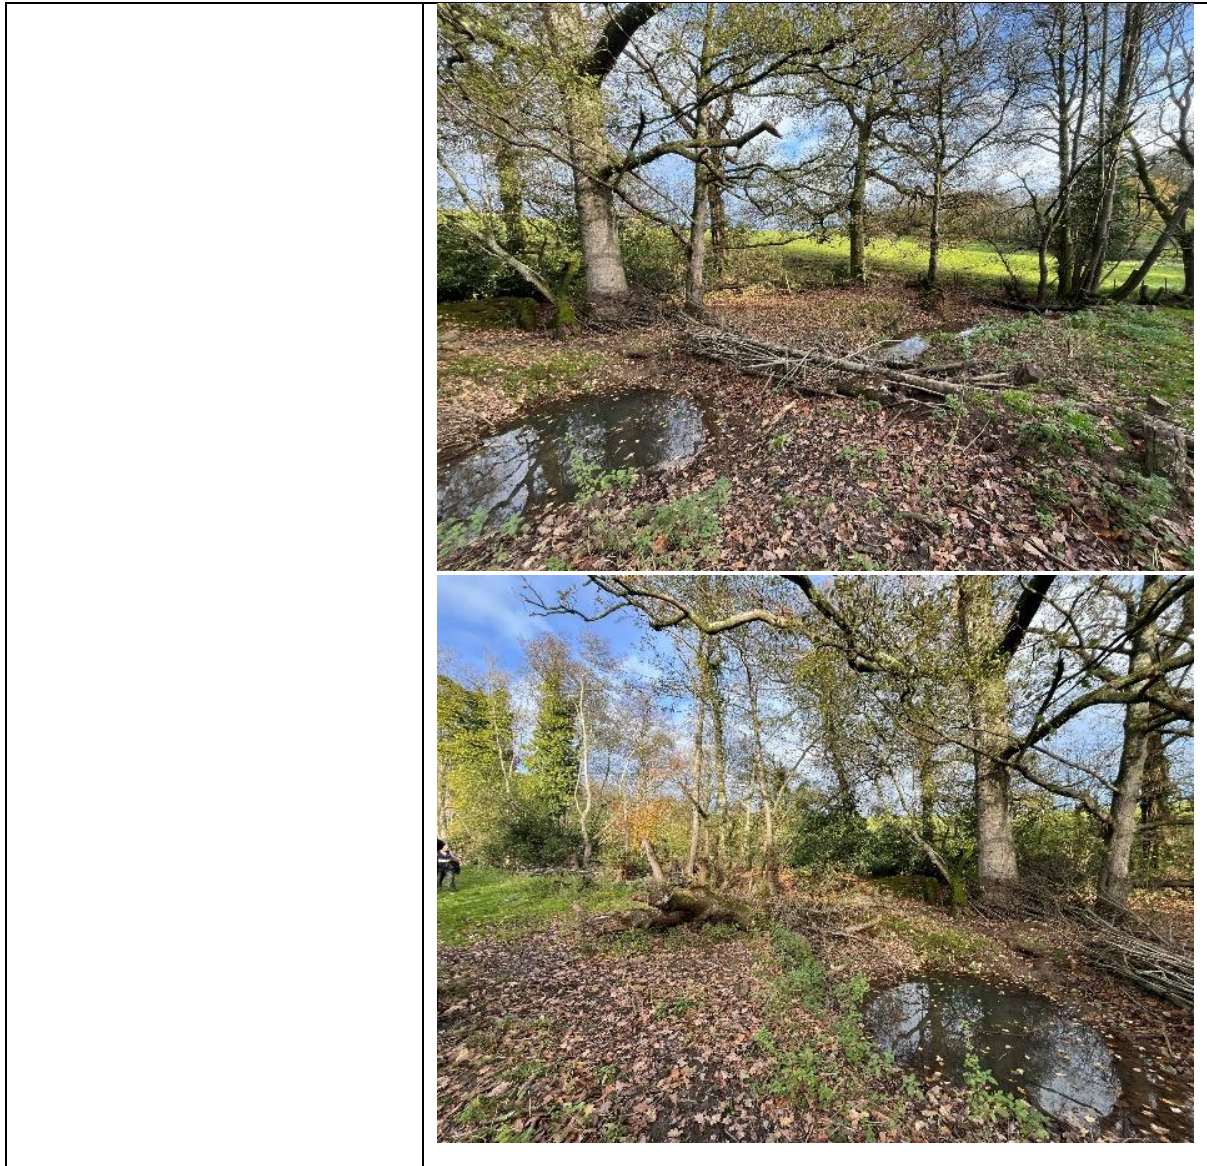
Large woody dams on the Lincombe Stream with sections in-filled with brash. No flow visible at time of survey in late May. Photo 2 shows a pocket of potential spawning gravels if there was more flow present, unable to determine extent of previously available habitat due to scale of NFM interventions.

Revisit to Sidbury Manor on 28.11.25 seen in photos 5 and 6 shows pools forming from winter rainfall, however no flow visible over or through the woody structures.

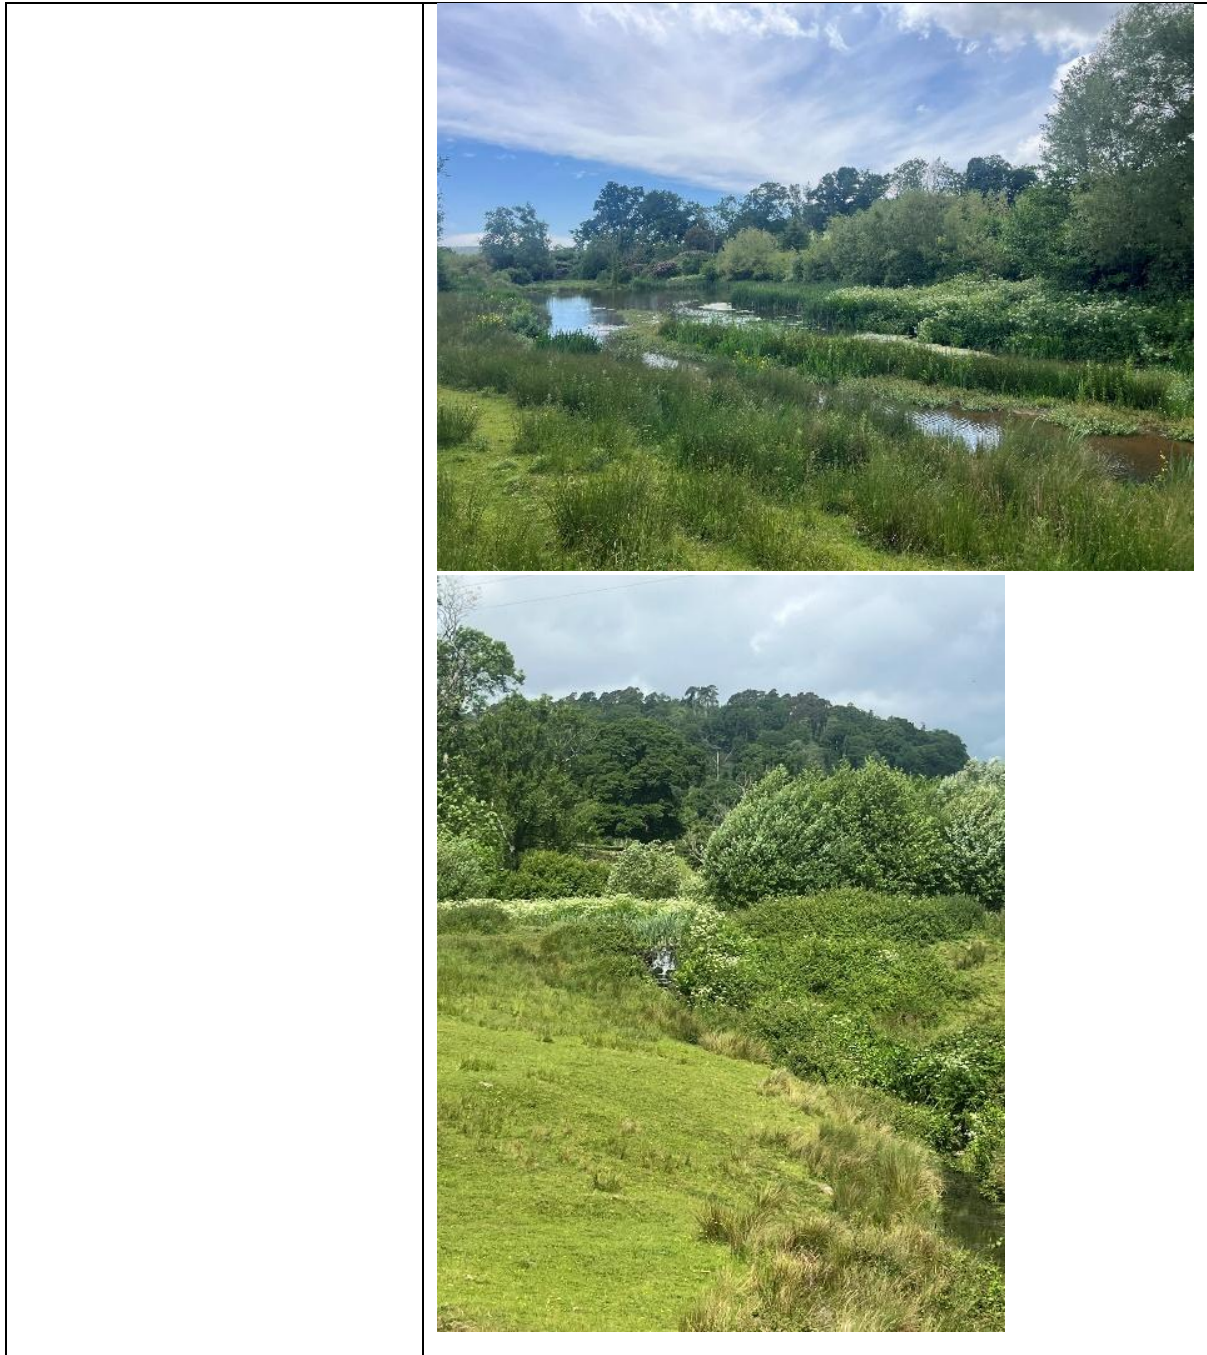
Lincombe Stream –  
SY 13288 92441 to SY 13471  
92181

Series of on-line historic dams and ponds at Sidbury Manor, the most downstream of these likely limits the passage of migratory fish (barriers above this and NFM were not included in the barrier prioritisation exercise. The ponds have become sedimented over time resulting in low water depth and succession of emergent plants.

Although no migratory species can access the Lincombe Stream above these dams, it is possible that resident populations may be present. It is recommended for future NFM works that fish surveys are conducted.

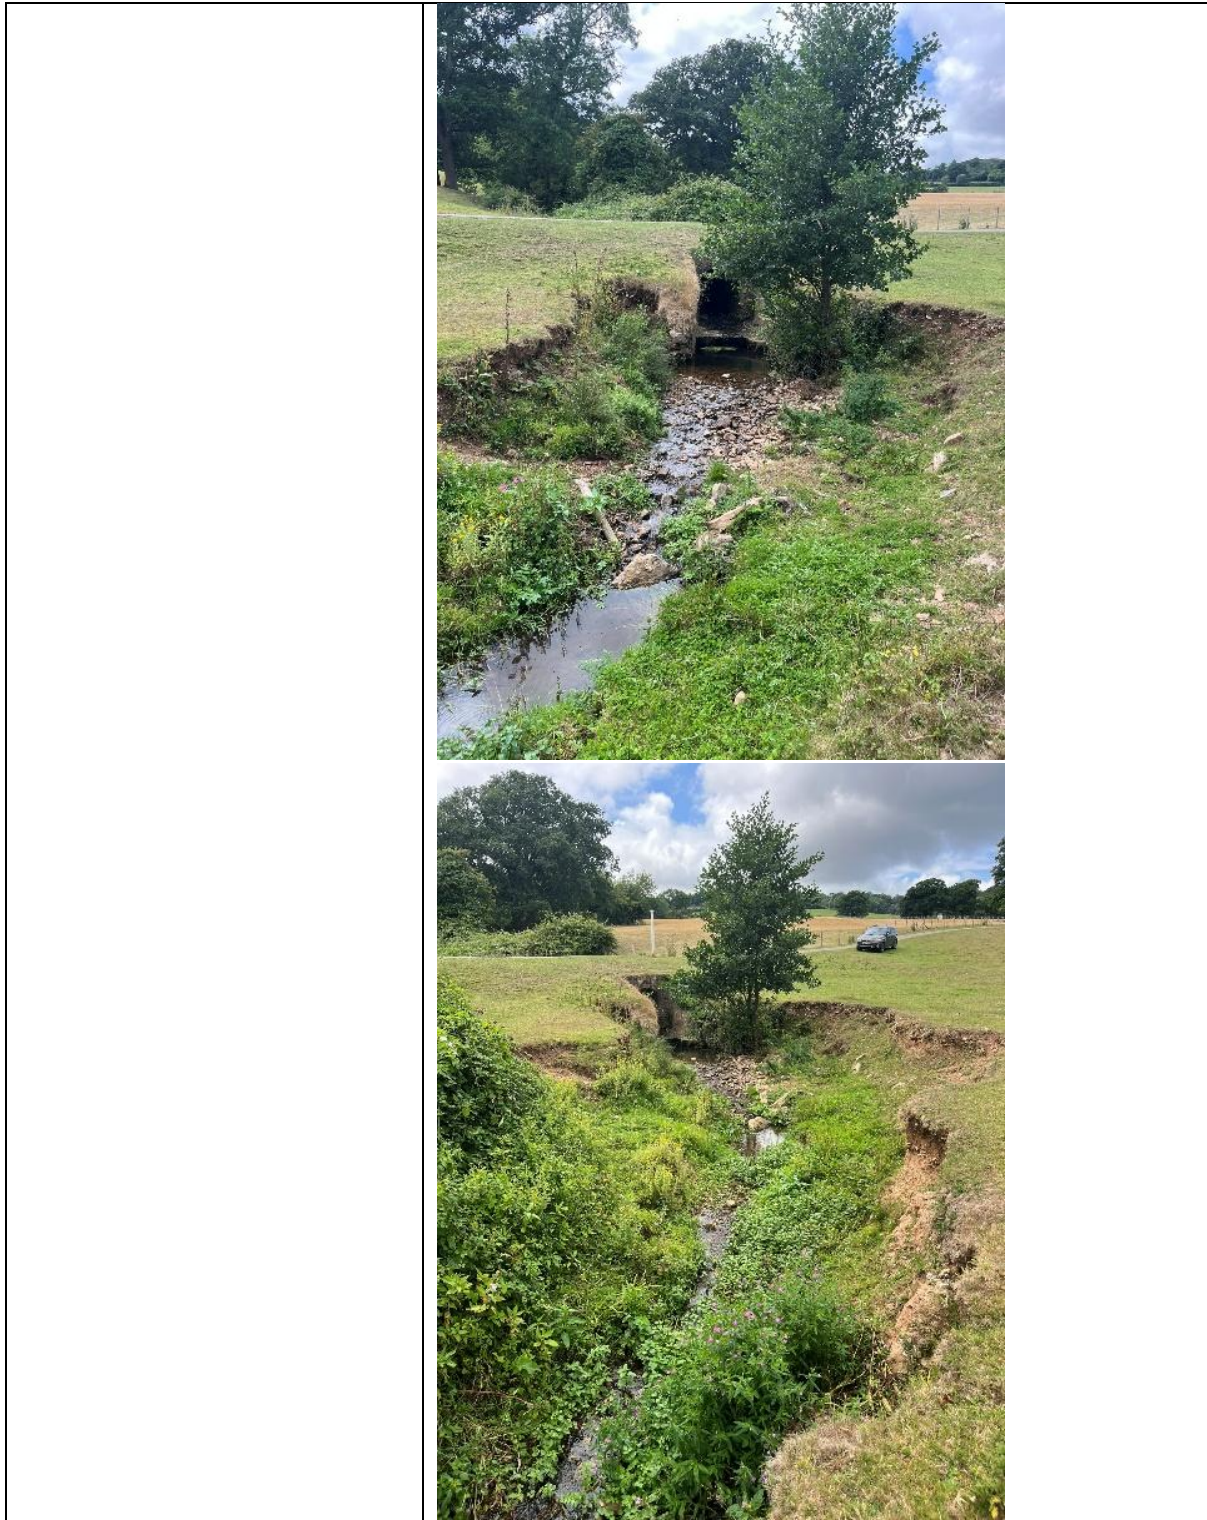
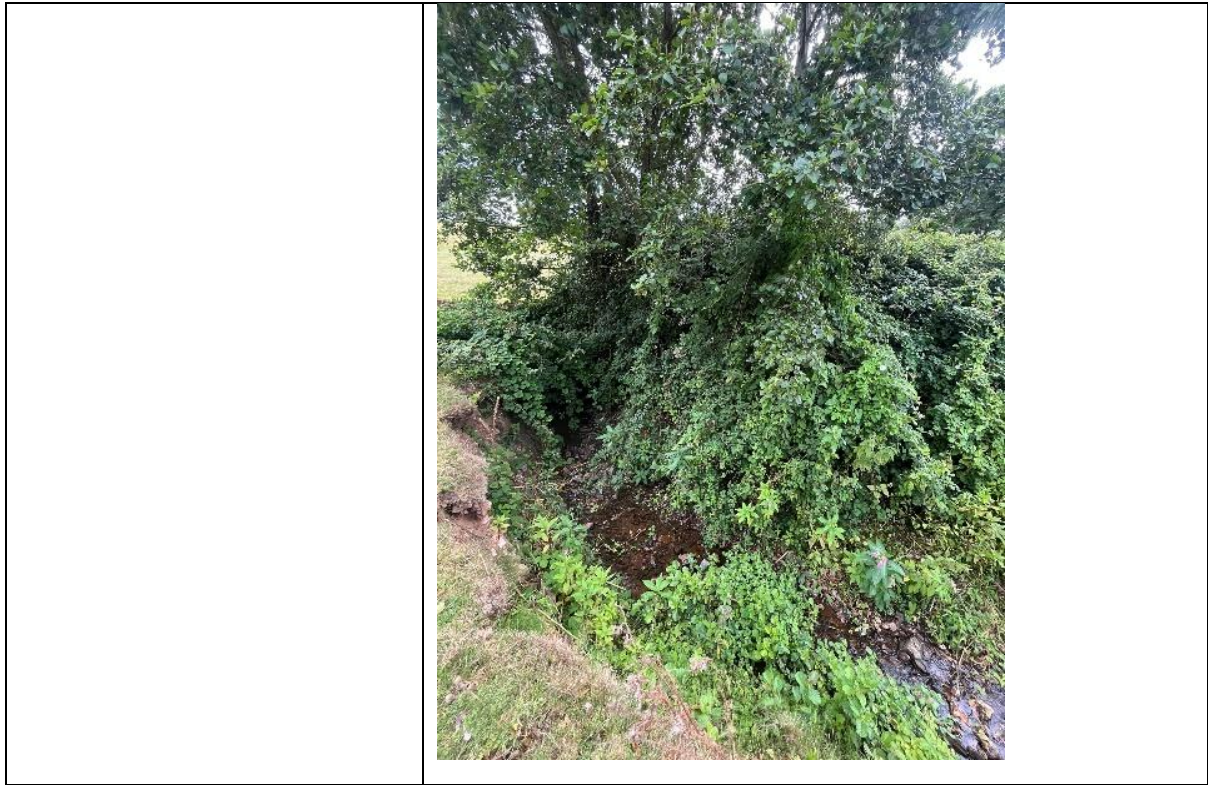
Lincombe Stream –  
SY 13571 92009 (Two  
Goyles')

Perched culvert on Two  
Goyles, not included in  
barrier prioritisation as  
tributary was not a focus  
area. Relatively deep pool  
below structure, but shallow  
through culvert.

Mixture of juvenile and  
adult habitat downstream  
of culvert, banks incised and  
eroding.
