# Appendix 5: Salmonid Habitat Walkover Maps – Snod Brook

## Appendix 6: Habitat walkover Photos – Snod Brook

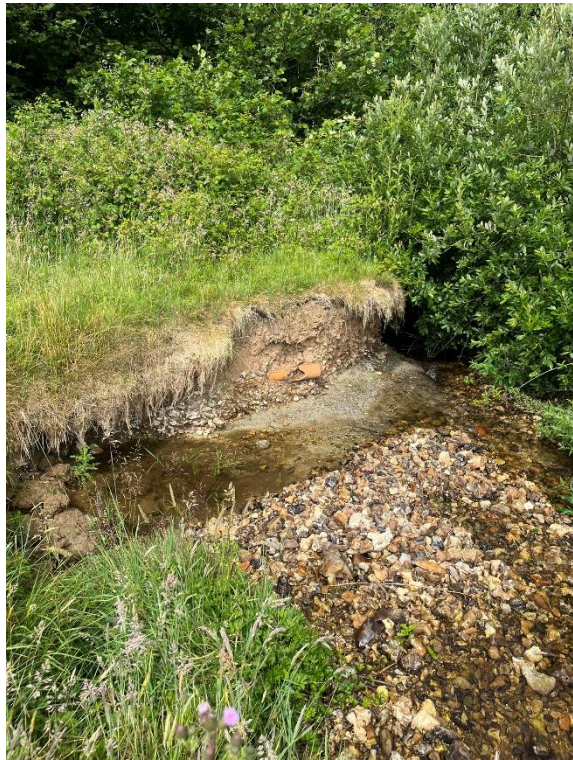
Snod Brook -  
SY 15313 90805

Favourable gravel cobble mix providing good conditions for spawning. Both banks are incised and eroding, and there is no riparian buffer on true left bank resulting in animal access to Snod Brook.
