Westcountry Rivers Trust – Opening the Sid Catchment Assessment – River Sid - 2025

Barrier photos for **Woolbrook** WB1 – Wb31

Extracted from Appendix 16

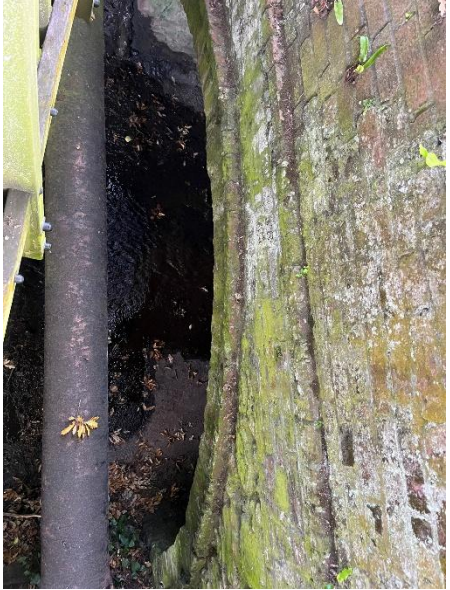
WB4	Woolbrook	SY 12732 88877	09.10.25

sloping weir/slucice at top of bridge apron	adherent		steep slope on weir, directly US of bridge apron. Slucice gate not active

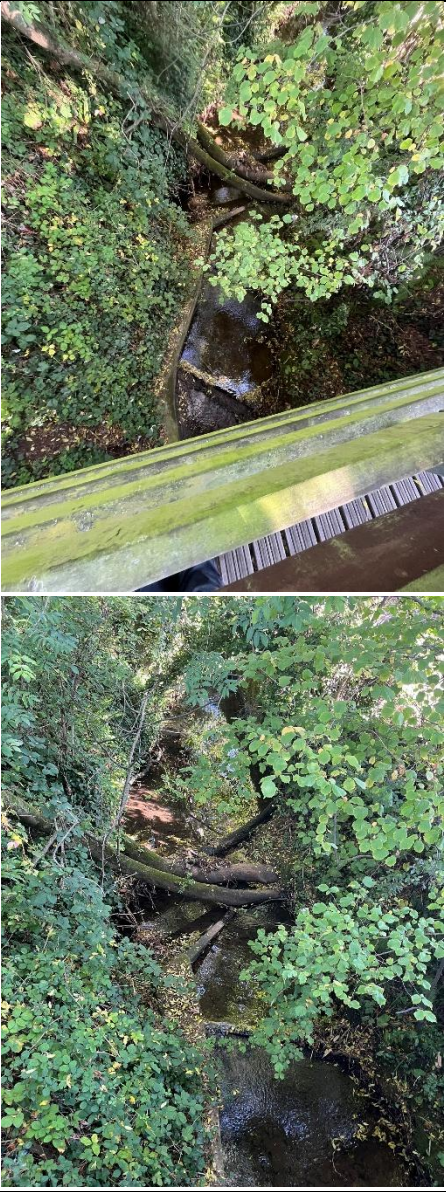
series of stepped weirs	going through structure		four step weirs with pools under footbridge. Revetted right bank eroding behind. Flow going through concrete structures rather than over lip
